### **3.12.2 LOCKLAND INCINERATOR**

Facility Name: Lockland Incinerator

Location: West terminus of Davis Avenue along the east side of I-75 south

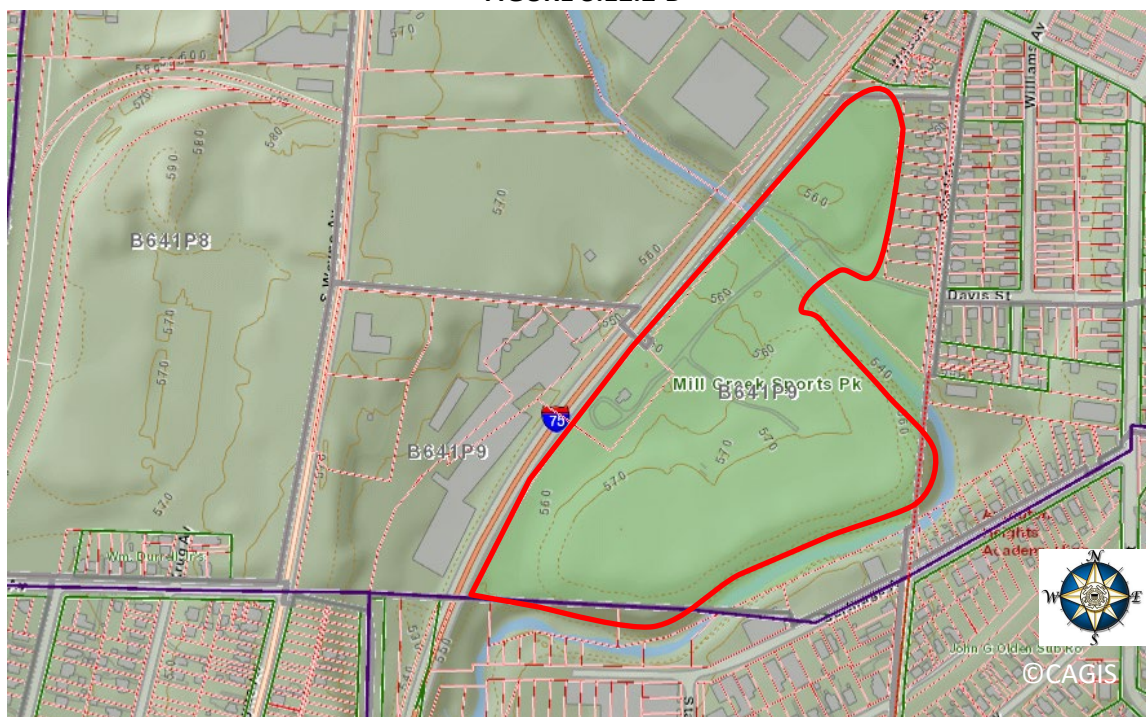
**FIGURE 3.12.2-B**

SRW Environmental Services completed a Phase I Property Assessment to meet the requirements of OEPA's Voluntary Action Program (VAP) in 2001. This assessment indicated that a Phase II Property assessment was necessary in order to issue a No Further Action letter for the property. A total of 13 monitoring wells were installed for the Phase II. These wells were spread out over the entire property and locations can be found on Figure 3 of the Phase II report dated 6/4/2001. Four waste material samples were submitted for asbestos analysis. The samples revealed the presence of asbestos fibers ranging from less than 1% to 20%. The report also noted *"waste material in the northern parcel was predominantly soil, sand, metal, glass, plastic, clothing, and ash whereas waste material in the southern parcel was primarily a homogenous mass of asphaltic shingles"*.

Weekly gas monitoring was performed from February 5 – March 26, 2001 at the monitoring wells. All wells consistently contained 1 – 2% methane except one (MW-4A) which typically contained 61 – 73%. The report notes that MW-4A is located in waste and is *"approximately 230 ft. from the closest property boundary"*.

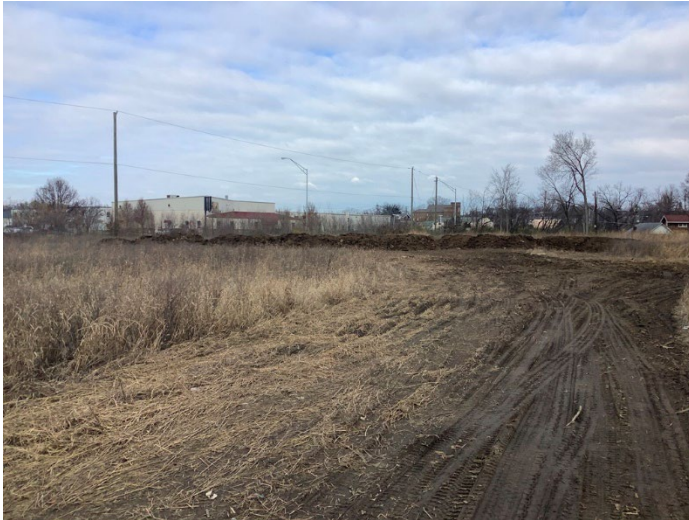
Northern Parcel

The site was inspected by HCPH on December 28, 2021. The inspector noted that clearing of vegetation and earthwork activities related to the most recent Rule 513 approvals are ongoing at the property. Both the northern and southern parcels had been mostly cleared of vegetation. Some soil had been stockpiled on the northern parcel.

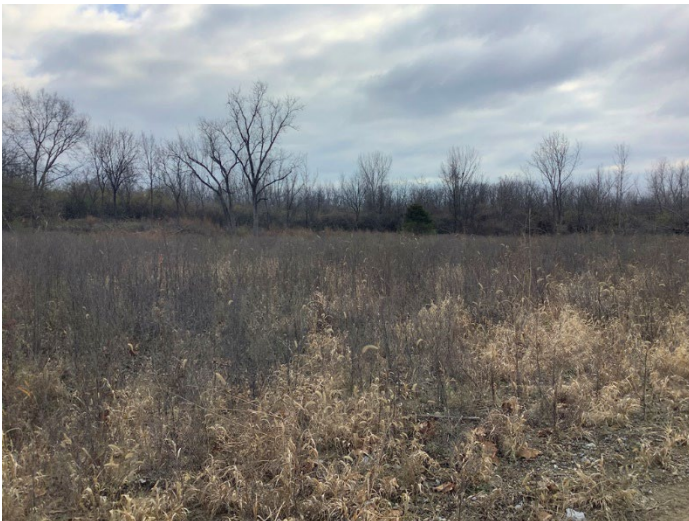
Southern Parcel

Construction activities related to the rule 513 authorizations are currently ongoing at the property. The old incinerator building is still present on the southern parcel.

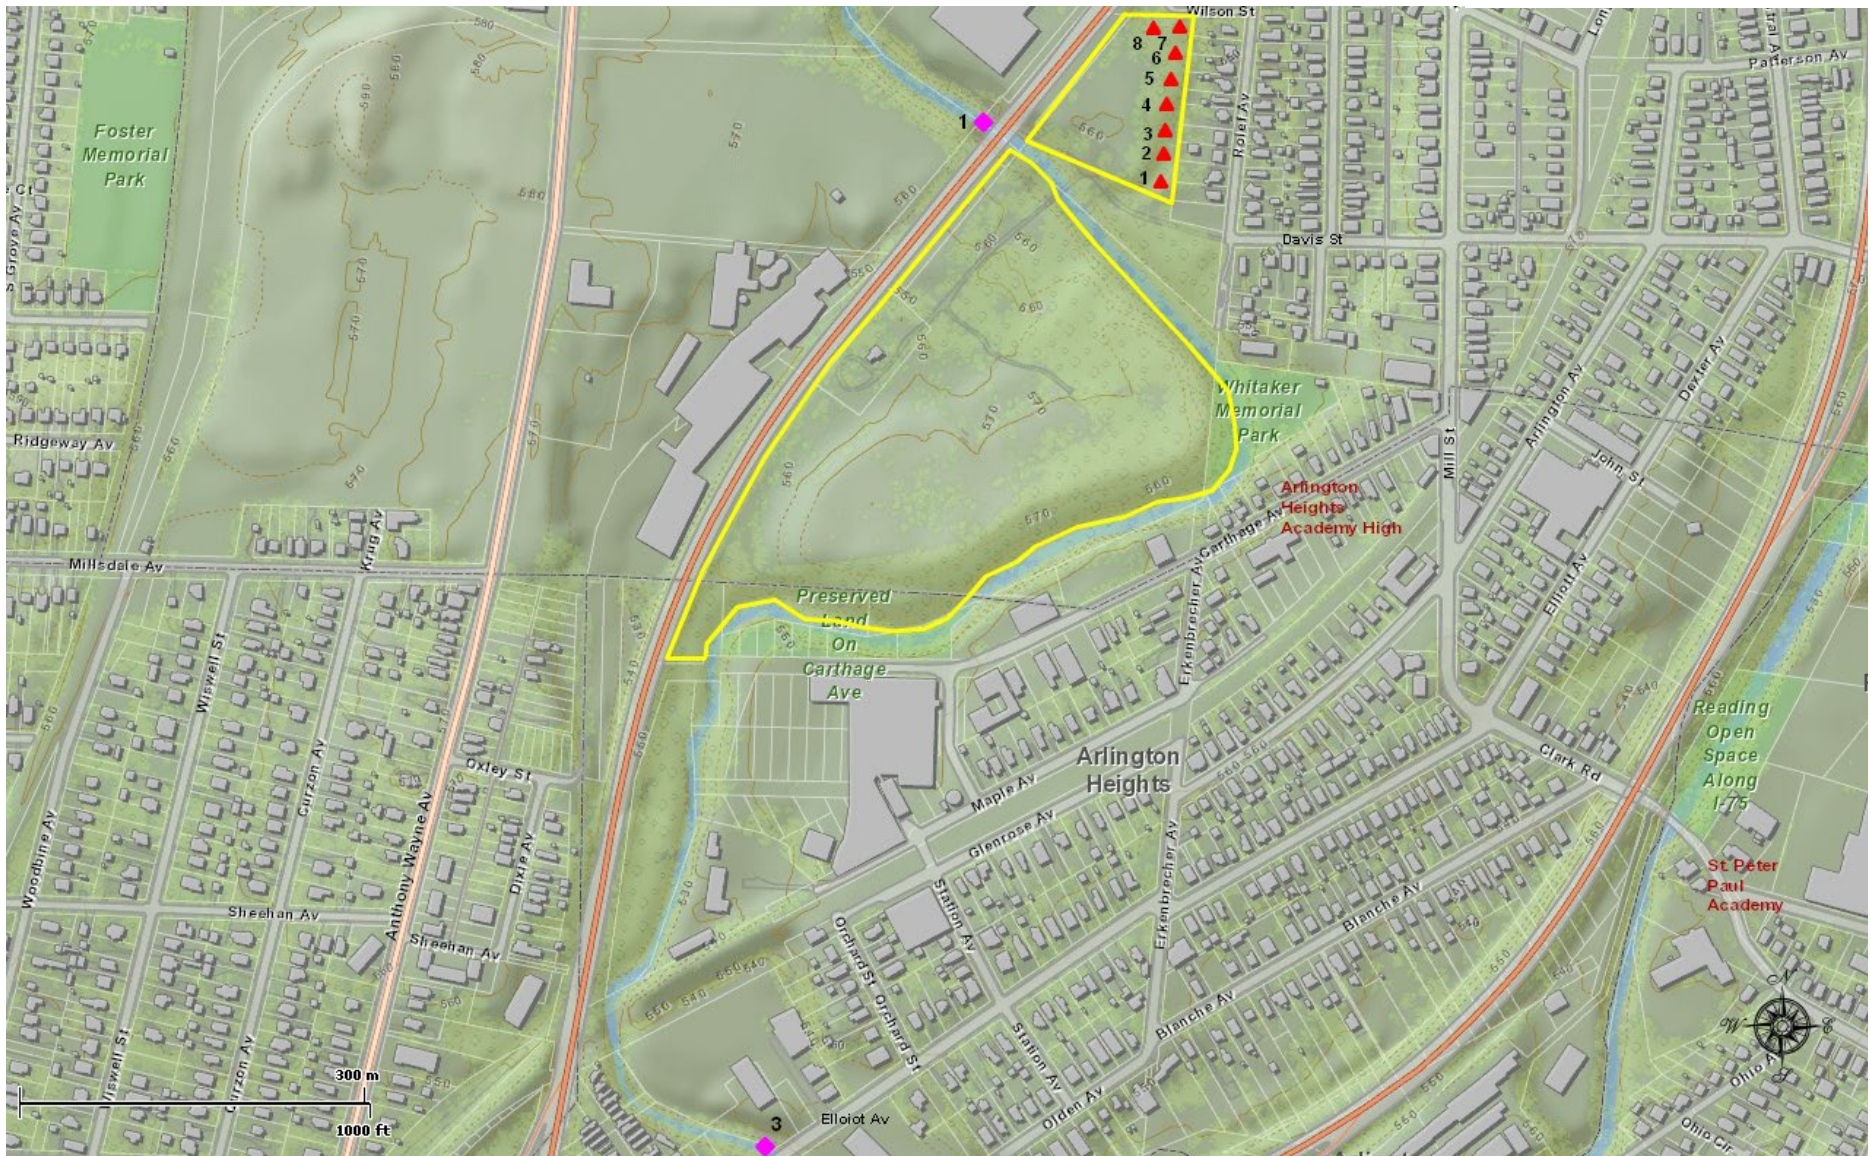
**Figure 3.12.2-C**  
**Lockland Incinerator**  
**Closed Landfill**

Gas monitoring was conducted at the Lockland (Incinerator) Landfill on December 28, 2021. The sampling locations are shown on Figure 3.12.2-C and results are provided in Table 3.12.2-B. During 2021 monitoring there were 3 detections of methane ranging in concentration from 2 to 44% LEL. Due to the detection of methane at >25% LEL, additional puchbar locations were monitored to the east of sample # 4 until concentrations of <25% LEL were observed. During 2020 monitoring there were 3 detections of methane. The concentrations encountered ranged from 3 to 5% LEL. During 2019 monitoring there were no detections of methane. During the 2018 monitoring, methane was detected at each sample point excluding sample location 5. Methane concentrations ranged from 2-20% LEL. During 2017 monitoring, methane was detected at very low concentrations (2-5% LEL) in 7 of the 8 sample points. Methane was detected at sample point 2 at a concentration of 0.2 % methane (4% LEL) during 2016 monitoring. Methane was detected in 2016, 2010, 2007, and 2006 in low levels (between 2% and 5% LEL) at sample locations 1-3. This area was not monitored in 2001 and 2002 because a study was performed in 2001 by a consulting firm. The final report was provided in 2002 and is discussed above.

During March 2010 monitoring a concentration of 211 ppm of carbon monoxide (CO) was detected at sample point 3. During the ten monitoring events from 2010-2020 CO has been detected in several locations with concentrations ranging from 3 to 92 ppm. During 2021 monitoring CO was detected in six sample locations with the highest reading being 152 ppm at sample point 4. According to landfill fire experts, CO levels over 1000 ppm with lab confirmation indicate a subsurface fire. CO levels between 100 – 1000 ppm are suspicious. Since 2010 and 2021 sampling resulted in a level of 211 ppm and 152 ppm respectively HCPH will continue to closely monitor this area. OSHA's eight-hour time weighted average (TWA) for carbon monoxide is 50 ppm. The immediate danger to life and health (IDLH) level for carbon monoxide is 1200 ppm. This is an open area, so one would not expect carbon monoxide levels to reach the IDLH level. *(Sampling data for this landfill is in the files at Hamilton County Public Health)*
