3.16.1 PAUL WILLIS CLOSED LANDFILL

Facility Name: Paul Willis Landfill
A.K.A.: Furlong Clean Fill Site
Location: 8073 Furlong Drive
Parcel #: 63000300110
Lat, Long: 39.204671 -84.703800
Region: Cleves, OH 45002
Owner: Mt Hope LLC @2
Operation (yrs): 1966 – 1976 (based on records)

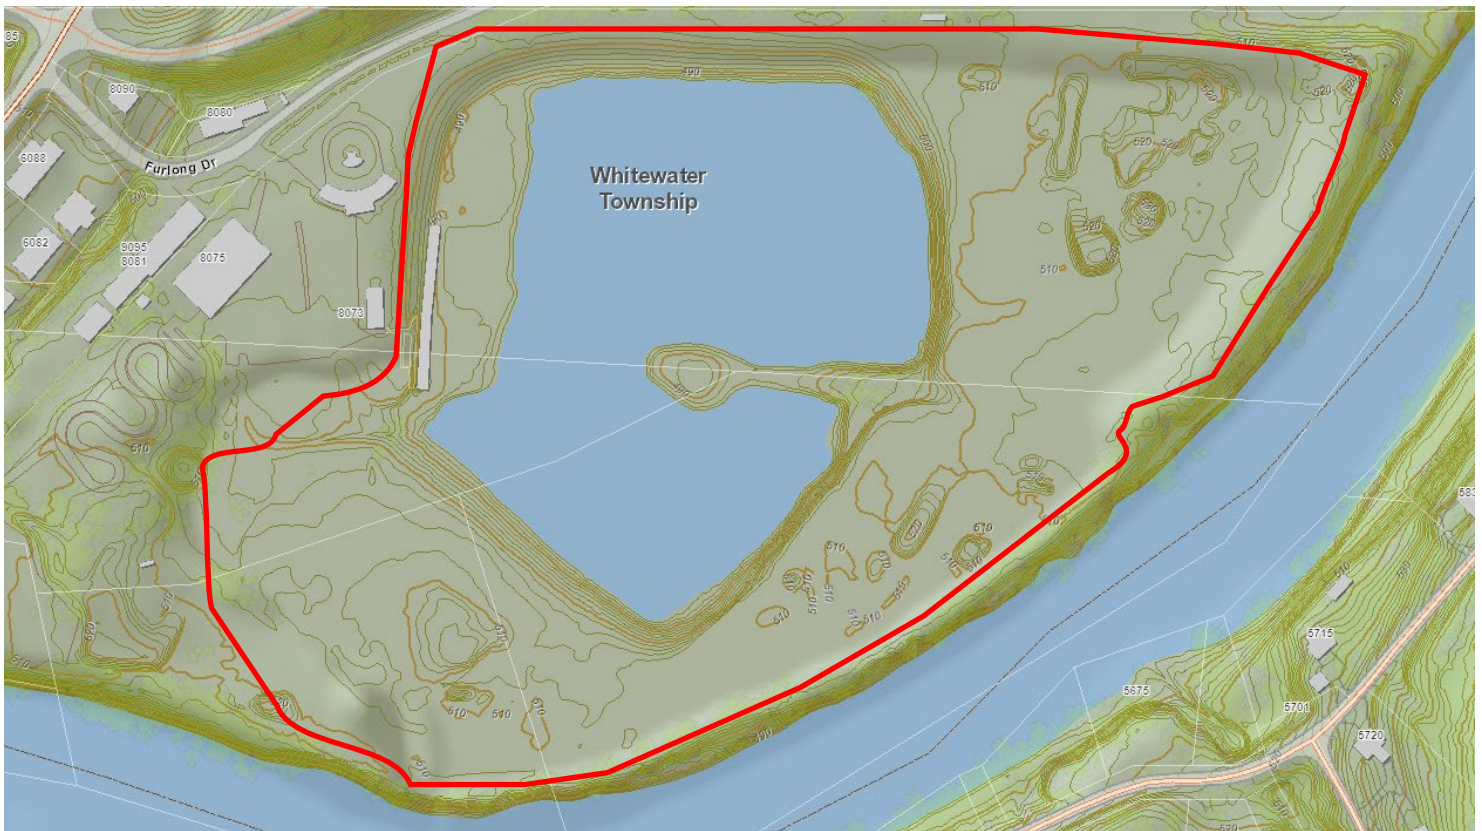
FIGURE 3.16.1-A

Records indicate that waste disposal occurred from as early as 1966 and continued, to some extent, to as late as 1976. Topography of the former landfill was created as demolition debris was filled into the former gravel pit. While operating as a landfill, the former gravel pit was approximately half filled with the remainder covered by a pond with a small central island. Figure 3.16.1-A illustrates the topography of the site prior to the current clean hard fill project.

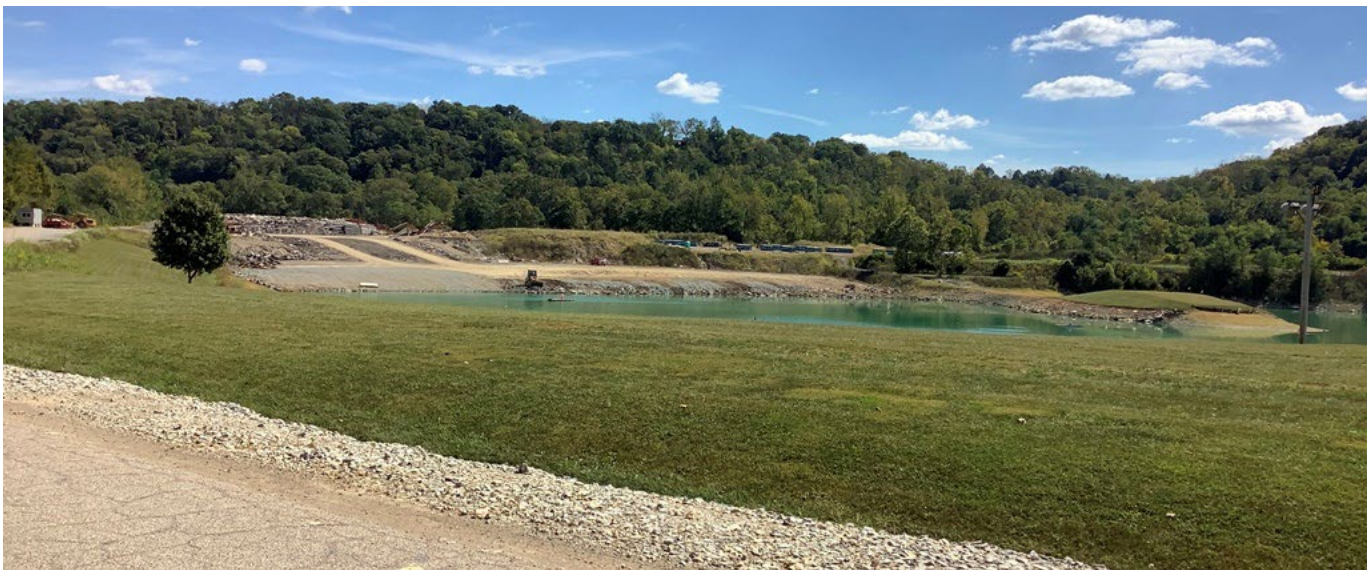
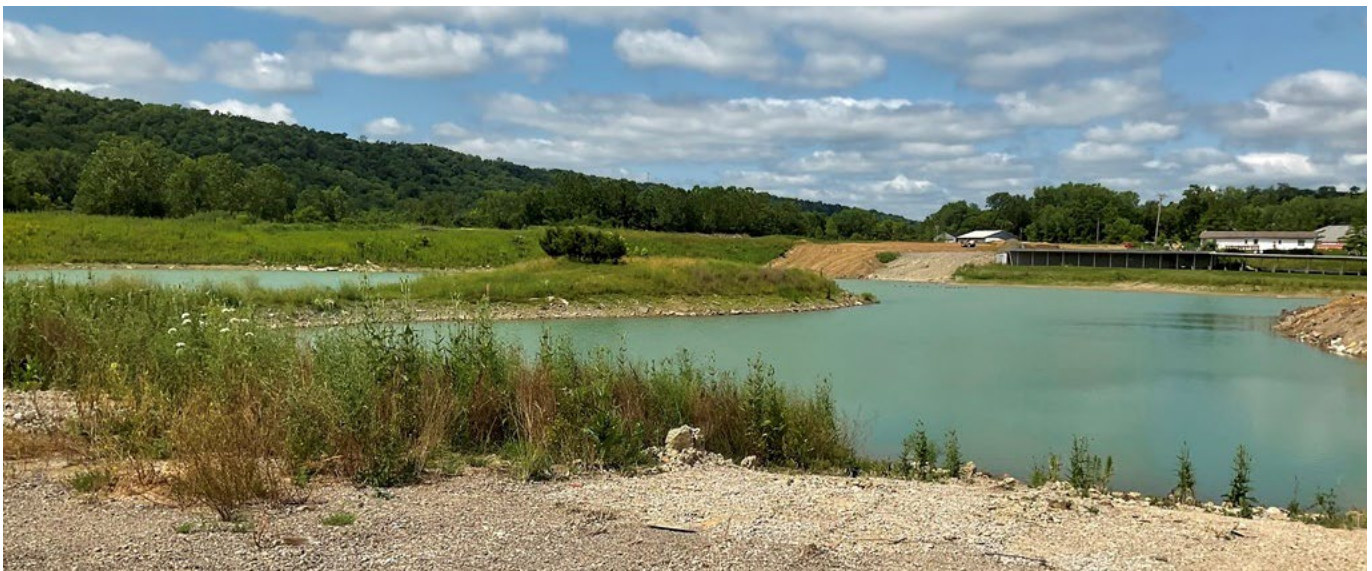
SITE PRESENT DAY

Property was previously used as a recreation area including a miniature golf course, batting cages, and a driving range. Buildings and infrastructure remain but is no longer in use. The property is an active clean hard fill site with concrete crushing and material storage also occurring on the property.
