#### 3.19.1 SCHWEITZER LANDFILL

Facility Name: Schweitzer

Location: 325 Clark Street

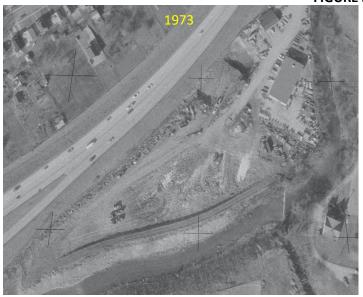
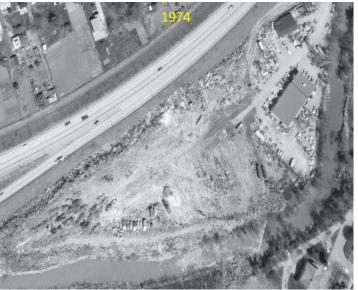
The fill was approved by Arlington Heights zoning in a letter dated June 11, 1970, by ODH in a July 15, 1970 letter, and in a letter dated July 24, 1970 Schweitzer Construction made application for a license with Hamilton County Board of Health. The fill was used for disposal of Philip Carey Corporation and later Celotex. Materials include asphalt, asphalt impregnated paper, roofing shingles, and asbestos-cement slurry. This material was then covered daily with onsite material and construction materials from Schweitzer Construction. Detail plans for proposed modifications to the landfill along with an application for permit to install was received by the OEPA December 20, 1974, and approved in a March 6, 1975, letter. Figure 3.19.1-A shows aerials from 1973 and 1974 when the landfill was in operation.

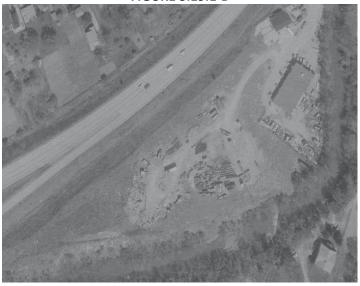
**FIGURE 3.19.1-B**

According to a September 14, 1984, letter from the OEPA the site had a record of "poor operational compliance". Review of inspections performed from 1971 through 1977 indicated inadequate cover, improper grading, and waste in the Mill Creek. In a letter dated December 21, 1977, the Village of Arlington Heights notified the landfill that they must cease acceptance of waste by the end of the year due to complaints and violations. During a January 10, 1978, meeting Schweitzer landfill, Arlington Heights, Hamilton County Board of Health, and the OEPA agreed that no waste would be disposed of after July 15, 1979 (this is probably a typo and should be July 15, 1978) and that no asbestos material could be accepted. In a January 12, 1978, letter to Mr. Schweitzer HCGHD indicated that asbestos material had been found in the landfill. Two additional inspections of the landfill were made in August and September of 1978 during which the operator was told to place additional cover and to grade certain areas of the landfill. Figure 3.19.1-B shows an aerial photo from 1980 after the facility had been closed. Figure 3.19.1-C shows the present-day topography of the site.

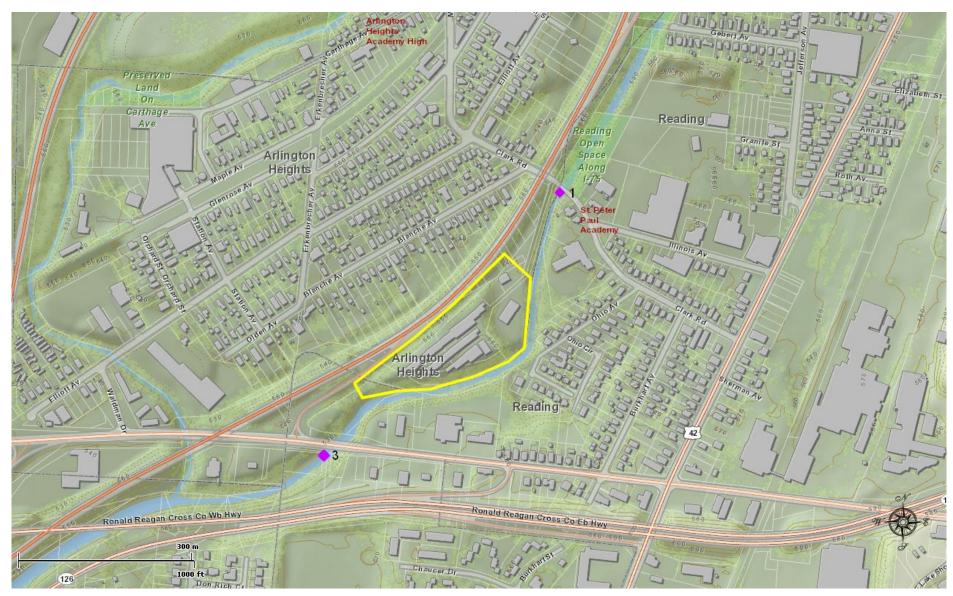
## **Figure 3.19.1-D**

The Mill Creek flows along the east and south side of Schweitzer Landfill from north to south. Steep banks border each side of the creek in this area. The creek was sampled above and below the landfill. The sample location (S-1) upstream and north of the landfill is located near the Clark Road Bridge. The sample site is characterized as a pool, just north of a spillway, with a rocky bottom. The mid-landfill sample location (S-2) has not been sampled since 2001. S-3 is below the landfill, under and south of Galbraith Road, and below a spillway. The southern sample site (S-3), is an area with both shallow, rocky riffle areas and 2-4 foot deep pools. Access to the shallow riffle areas is occasionally not possible depending on stream conditions (flow volume, depth of pools, etc). Samples around Schweitzer Landfill were collected on October 13, 2021 (Appendix A). The samples were collected during normal flow as the area had received approximately 1.5 inches of rain during the previous 14 days, none of which occurred over the 5 days prior to sampling. The referenced locations are shown on Figure 3.19.1-D.
