3.3.5 CINCINNATI MILACRON LANDFILL

Facility Name: Cincinnati Milicron
A.K.A.: N/A
Location: Northwest of the intersection between Highland Avenue and Ridge Road
Parcel(s): 52002700011, 52002700089, 52002700076, 52002700054
Lat/Long: 39.169625 -84.428920
Region: Columbia Township
Owner: Frayer Enterprises LLC, Cole Lo Cincinnati [Ridge] OH LLC, Ridge & Highland Properties LLC
Operation (yrs): Pre 1956 – 1970's

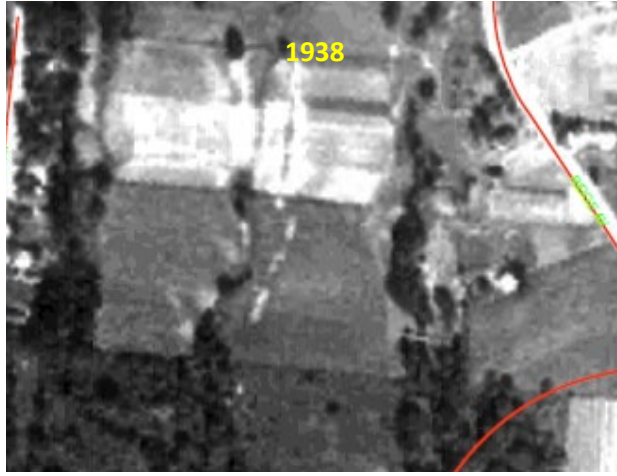
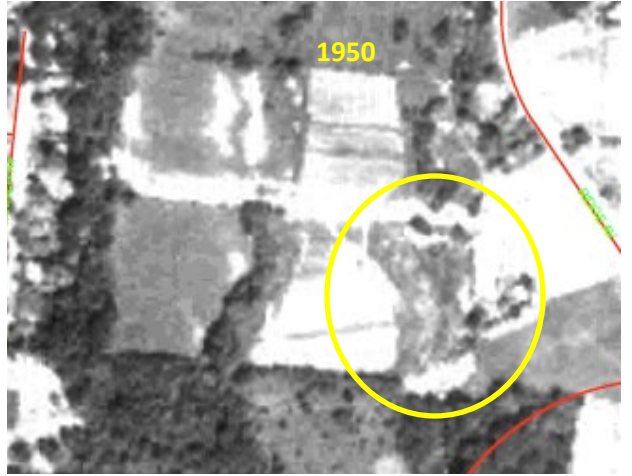
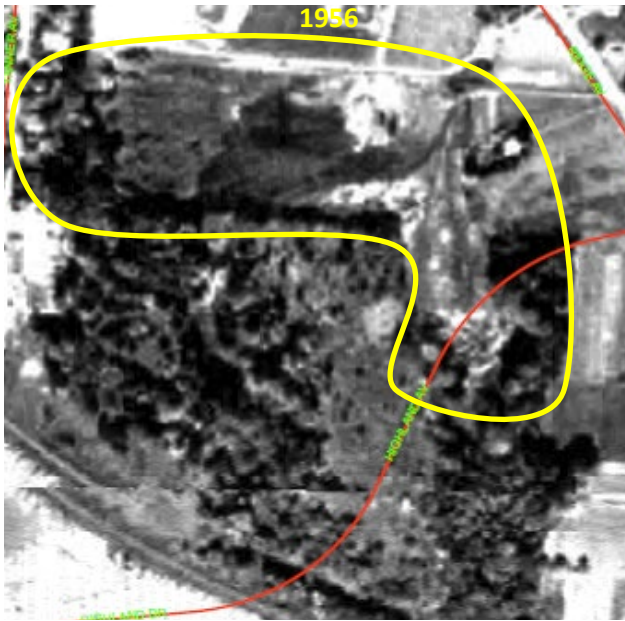
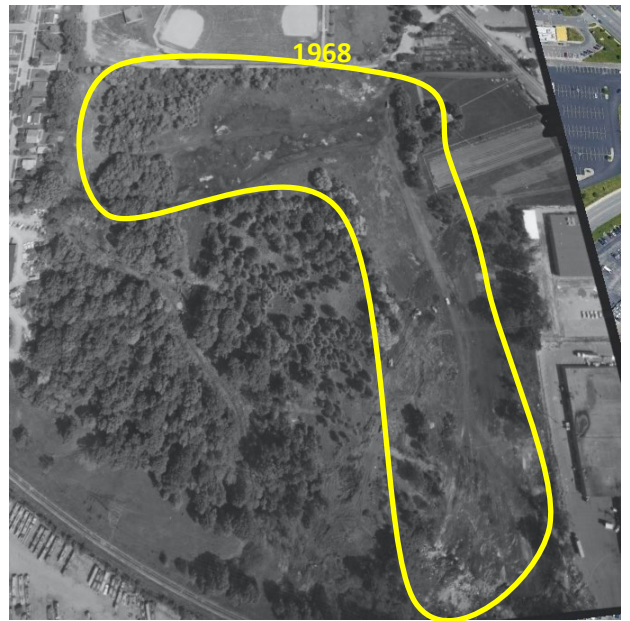
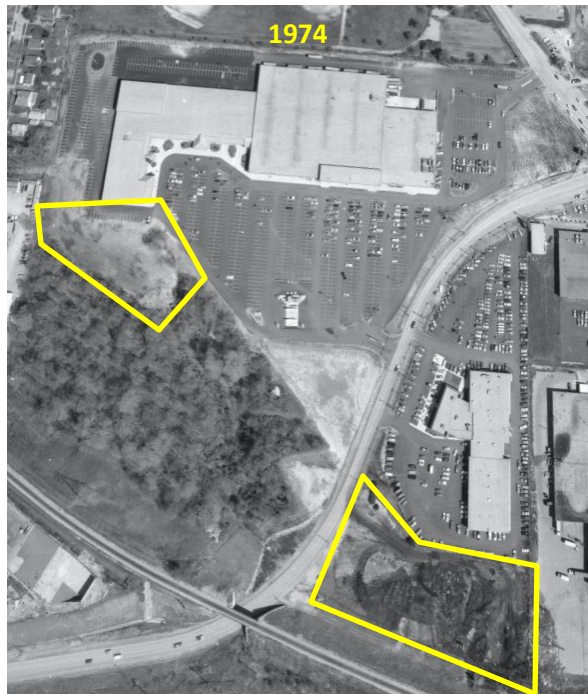
FIGURE 3.3.5-A

There is no documentation as to when the landfill began operation. However, you can see in the following aerials (Figure 3.3.5-A) that the area was undisturbed in 1938 and a small area is disturbed in the eastern ravine by 1950. Unfortunately, the picture is not clear enough to see if filling is occurring. By 1956 you can clearly see the dark fill being placed on the property south of the baseball fields. In 1968 filling continues south of the baseball fields and filling is also occurring along the eastern edge of the area. By 1974 buildings have been constructed in the former fill areas, Highland Ave has been constructed in its present-day location, and filling is confined to two smaller areas.

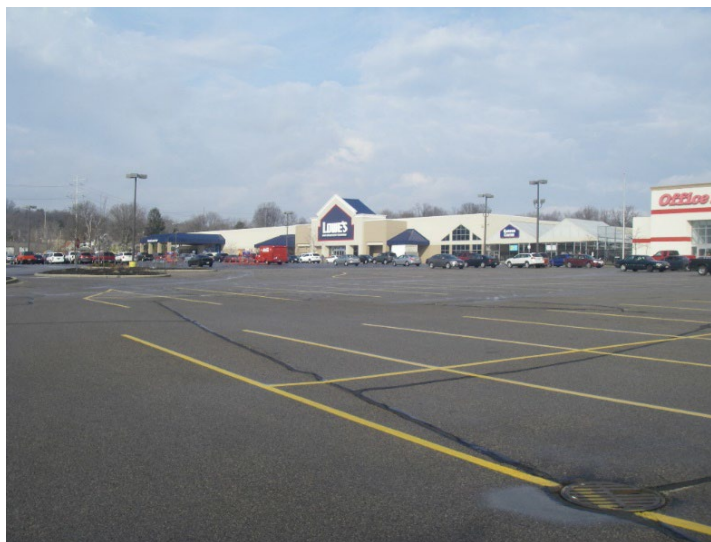
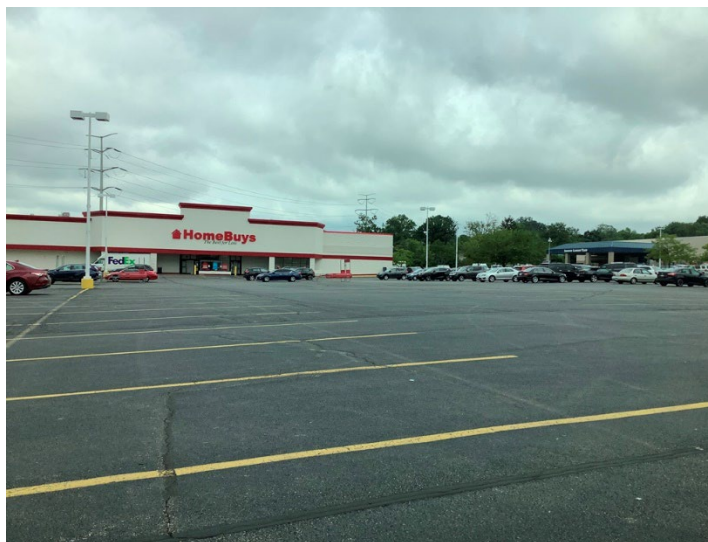
The site is mostly paved to provide parking for a strip mall, Lowes, and other stores/businesses.
