### **3.1.4 Anderson Township Landfill**

Facility Name: Anderson Township Landfill

Location: 8331 Broadwell Road. Southwest corner of Broadwell Road and the railroad tracks in Anderson Township, Ohio.

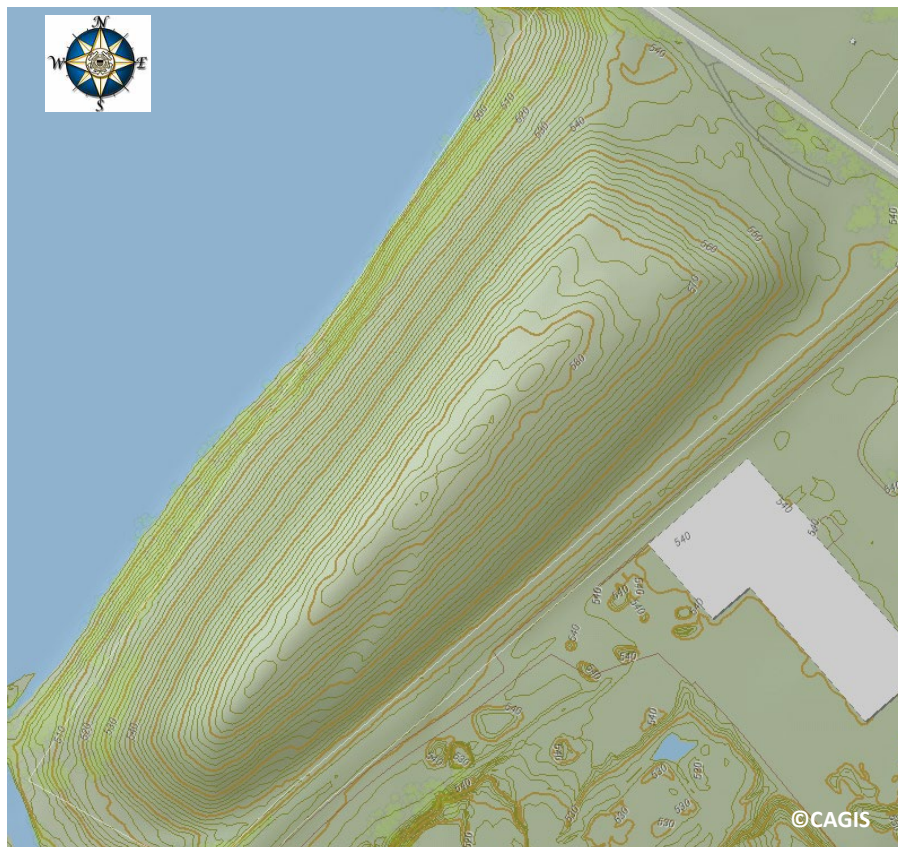
**FIGURE 3.1.4-A**

The landfill is comprised of approximately 23 acres. The top of the landfill is approximately 590' above mean sea level while the bordering Broadwell Road to the North and the railroad tracks to the East reside at approximately 540' above mean sea level. A former gravel pit operation borders the site to the South and West (now a small pond). The base of the landfill to the South and West is approximately 500' above mean seal level. Figure 3.1.4-A illustrates the topography of the site below:

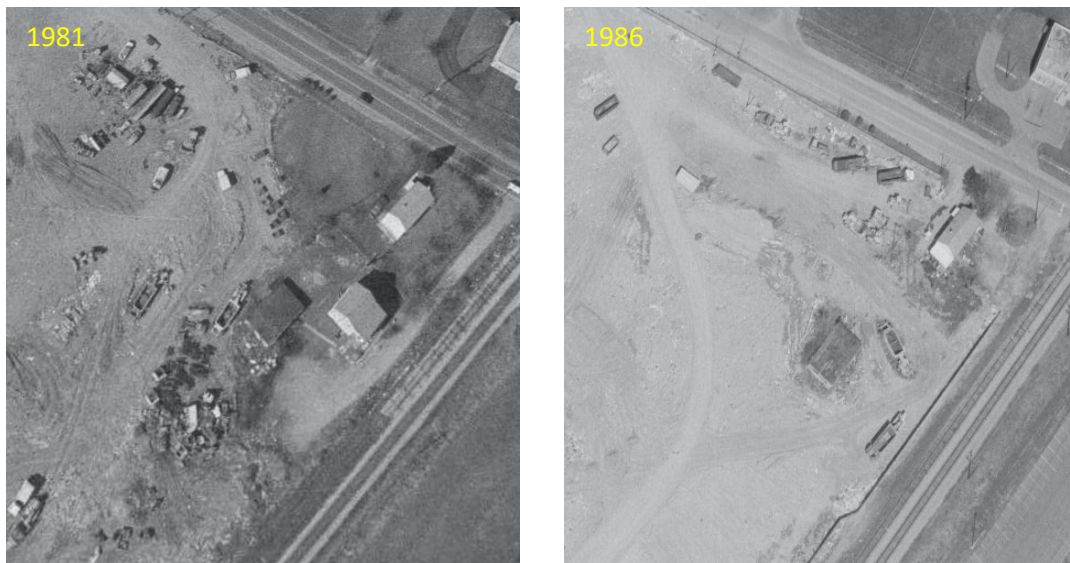
**FIGURE 3.1.4-B**

In the spring of 1982, methane, linked to the landfill, was discovered seeping beneath the building of the Didier Taylor Refractories Corp (formerly located at today's Evans Warehouse, east of the landfill across the railroad tracks). At this time, Rumpke immediately took over operations of the landfill in an attempt to properly vent the gas and control the problem. On May 3, 1983 at 6:05 a.m., an explosion occurred at a residential house formerly addressed as 8339 Broadwell Road. The house was located near the eastern corner of the landfill between the landfill and the railroad tracks. In Figure 3.1.4-B three structures are apparent in this area during 1981 while only two are present in 1986. The explosion caused \$30,000 worth damage and moved the two-story frame house off its foundation. No one was injured, a 17 year-old woman residing upstairs at the time escaped.

Immediately following the May 3, 1983 explosion, Soil & Material Engineers Inc. conducted an investigation of gas migration at the residence and adjacent yard. It concluded that combustible gases originating from the Anderson Township sanitary landfill had migrated into the property. As a result, methane monitoring surrounding the site was initiated and continues today. As of November 2008, Rumpke is approved by Ohio EPA to conduct

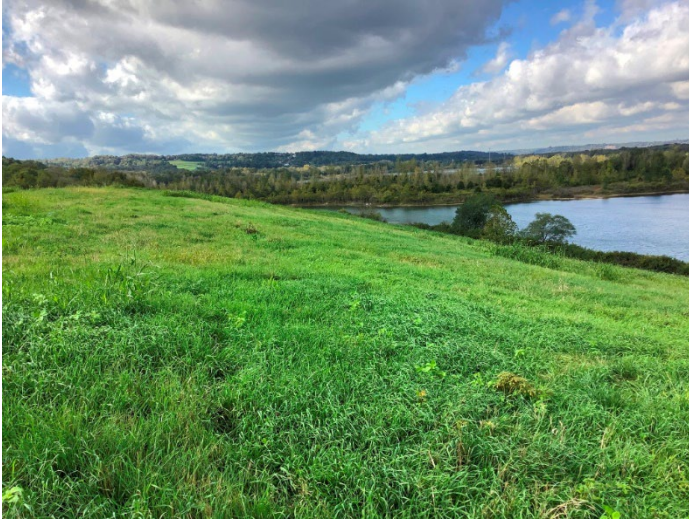
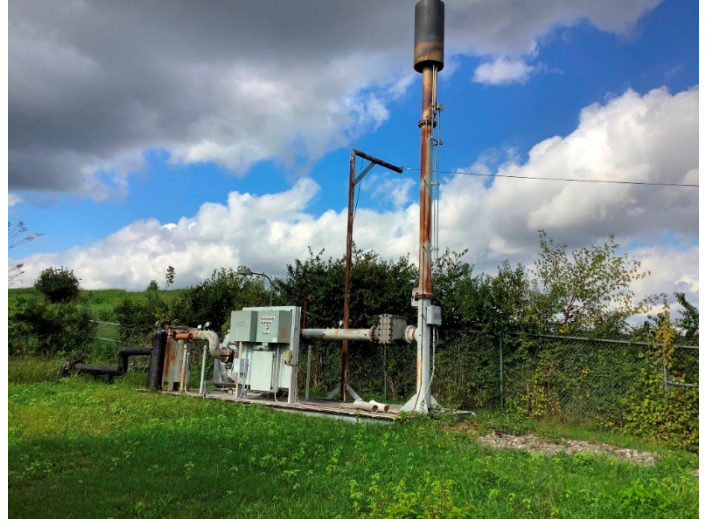
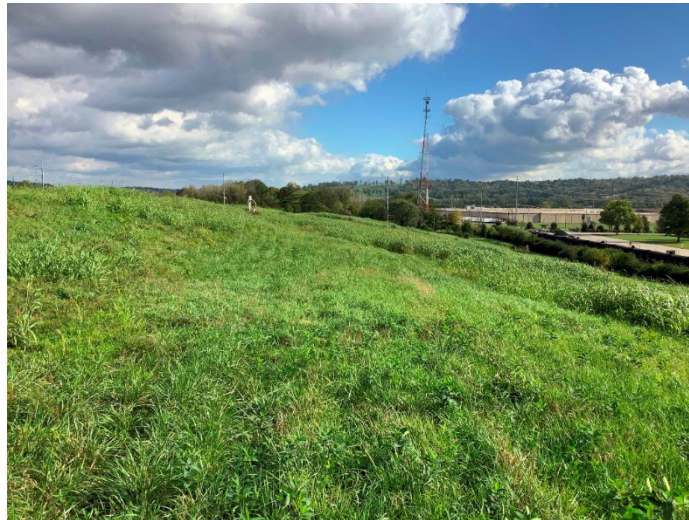
The site was last inspected by HCPH on October 12, 2021. The inspector noted that the cap appeared to be in good condition and no violations or nuisance conditions were observed on the site.

Today, the landfill is covered with grass and weeds. Several gas extraction wells exist throughout the landfill and a flare is situated on the Northeast corner of the property. Present day photographs taken of the site follow:

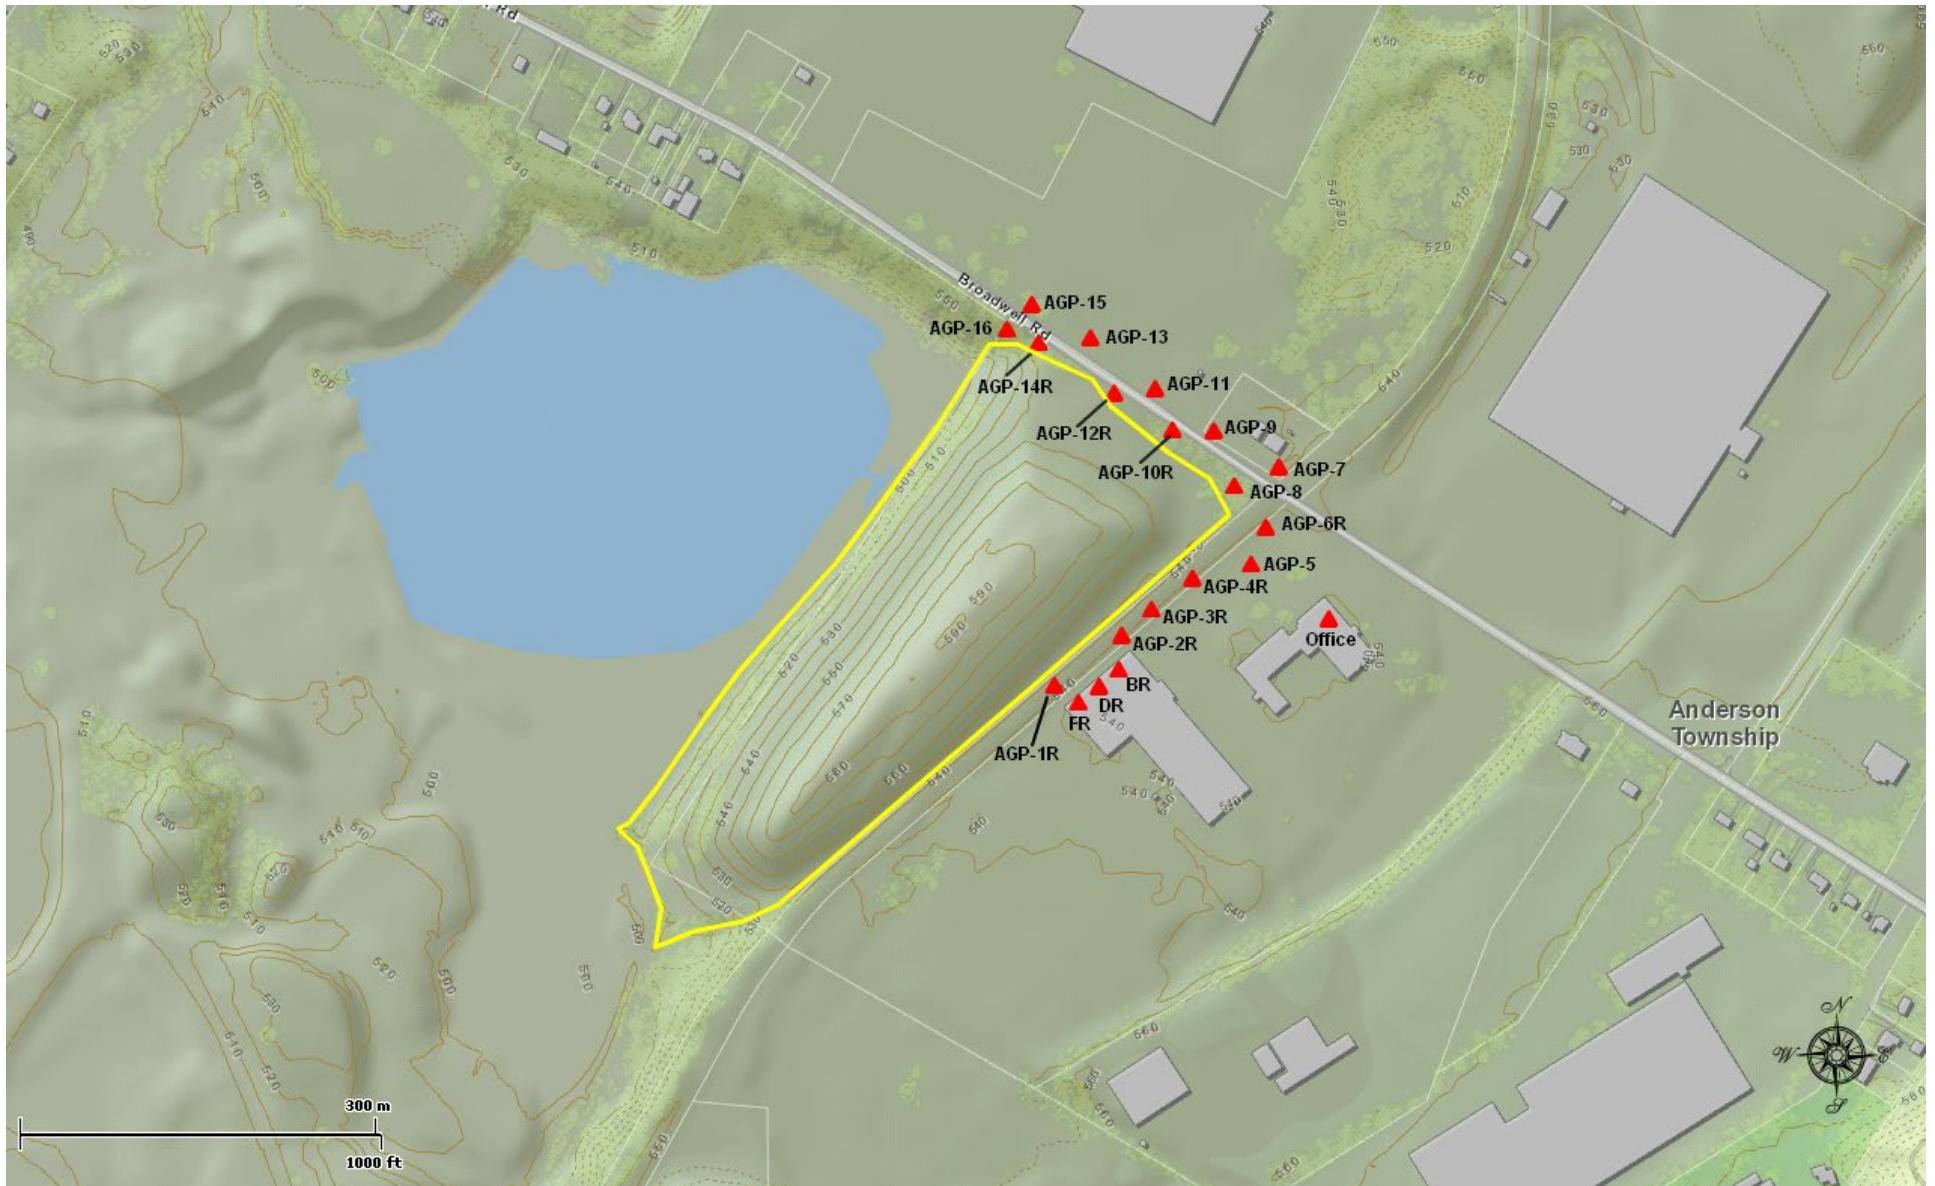
Figure 3.1.4-C

Monitoring of methane gas at the Anderson Closed Landfill was completed on a biannual basis in 2021 at the locations (Figure 3.1.4-C) indicated in the facility's explosive gas monitoring plan. Sampling has been completed on a biannual basis since the beginning of 2009. In 2021 sampling was completed on May 18, 2021 and November 19, 2021. The second annual monitoring event began on November 16, 2021 and methane was detected in gas probe AGP-3R at a concentration of 90.6%. Additional monitoring was completed on the warehouse property adjacent to the landfill during which no additional detection of methane occurred. This monitoring including punchbar monitoring, monitoring of storm water drains, and monitoring inside the warehouse. During inspection of the wellfield, flare, and cutoff trench it was discovered that EW-4 had been bumped during mowing resulting in "*minor vacuum loss*". EW-4 was repaired and adjustments were made to the well field and cutoff trench. Additional monitoring of AGP-3R occurred on November 17, 2021 which detected methane concentrations below the exceedance threshold. The annual monitoring event was completed on November 19, 2021, during which all locations (including AGP-3R) were monitored and no detection of methane occurred at any location. The facility was subsequently allowed to continue monitoring on a biannual basis.

Prior to 2021, the last time methane was detected was during November 2014 monitoring. Methane was detected (50 % LEL) in AGP-2R. After adjustments were made to the cutoff trench, this location was rechecked on November 12, 2014 and no gas was detected.

In November of 2012 there was an explosive gas threshold exceedance at AGP-3R. As a result of the exceedance adjustments were made to the gas collection system. Gas monitoring was performed the next day on November 20, 2012 and again explosive gas was detected in AGP-3R. As required by the facility's Explosive Gas Monitoring Program weekly monitoring was implemented. A required 30 day report was submitted December 18, 2012. The report indicated that additional adjustments and repairs had been made to the gas collection system. In the report it was also documented that no detection of explosive gas had occurred since November 28, 2012, meaning no explosive gas had been detected for four successive monitoring events over a three week period. Therefore the 30 day report dated December 18, 2012, was also submitted to satisfy the final report requirements and sampling frequency was returned to a semi-annual basis.

Prior to the 2012 detection, the most recent detections of methane gas had been January 21, 2003 and February 15, 2002. During these monitoring events AGP-12R had detectable levels of 0.9% and 1.7% methane respectively. No gas has been detected in AGP-12R since January 2003. Monitoring will continue to be done by Rumpke on a semi-annual basis for all monitoring locations. (*Data for this landfill is in the files at Hamilton County Public Health*).
