3.12.3 LOCKLAND SHEPHERD LANE LANDFILL

Facility Name: Lockland Shepherd Lane

Location: 611 Shepherd Lane

Operation (yrs): 1969 – 1983

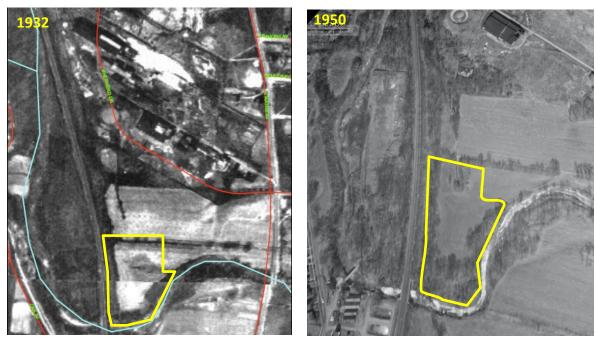
FIGURE 3.12.3-B

Some waste from these processes was buried on site in shallow unlined pits, but the location of these pits is unknown. After the closure of DuPont-Lockland works in 1951, the site sat vacant until 1958 when a developer bought the site and turned it into an industrial park. In aerial pictures from 1932 and 1950 (figure 3.12.3-B) it appears that the landfill area is untouched and the plant is contained to the area north of the future landfill.

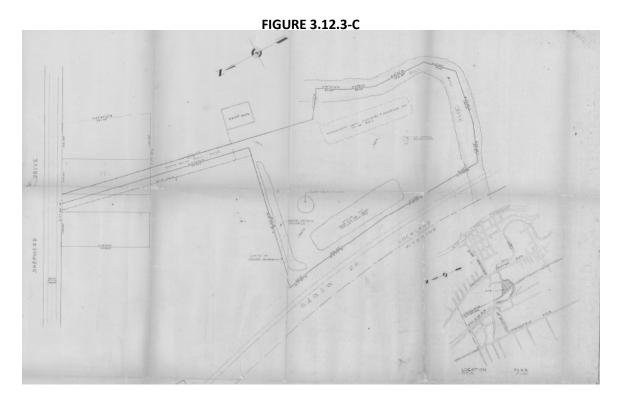
This site map above (Figure 3.12.3-C) was originally submitted in 1969 by Lockland, but this version is dated 1976 and shows the location of a completed pit and an active pit. The site was operated by Lockland until December 31, 1983, when the village's lease with the property owner expired. In February of 1984 the village indicated they had an opportunity to buy the site and inquired about obtaining a license. The village was informed that the site would not meet the hydro geological requirements of the solid waste rules, but that the site could be used to dispose of clean fill including construction and demolition materials. At the time this type of operation required no license.

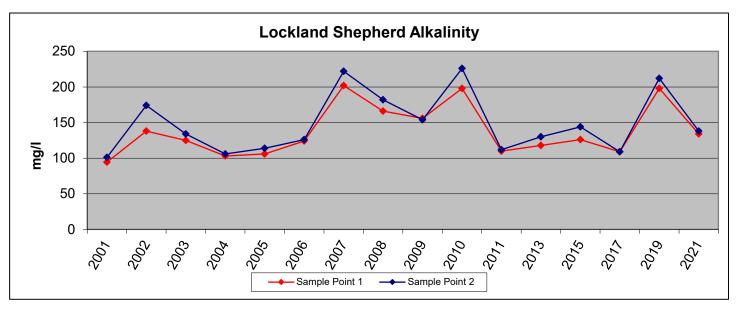
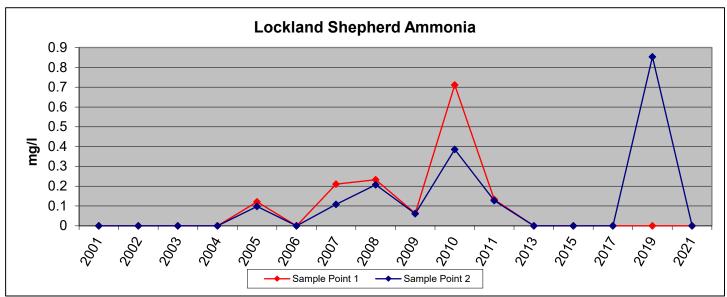
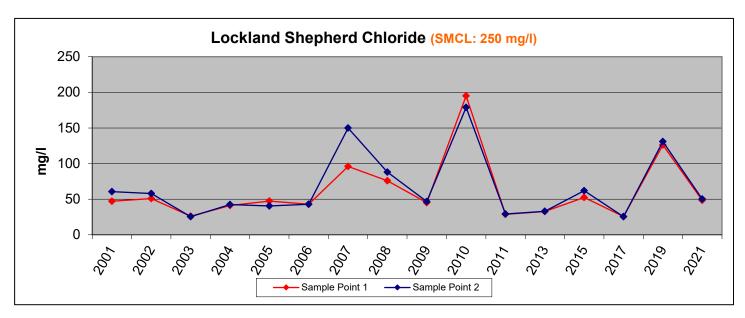
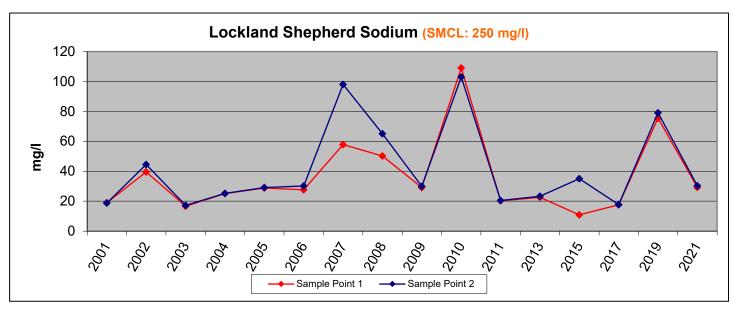
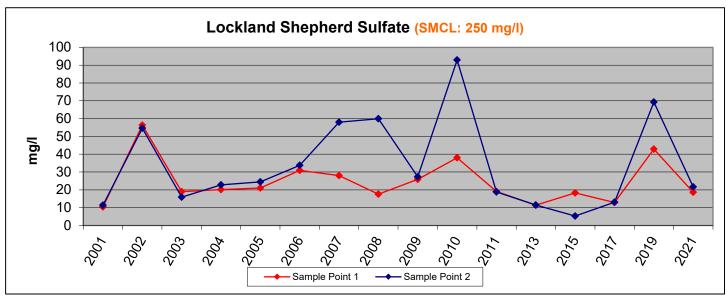
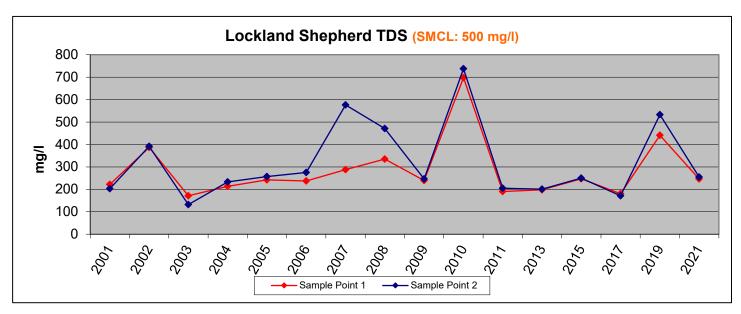
In 2010, alkalinity, chloride, sodium, sulfate, TDS, ammonia, and conductivity all exhibited highest levels since sampling began for both upstream and downstream samples (Appendix A). During subsequent sampling events in 2011, 2013, 2015, and 2017 concentrations of the above mentioned compounds returned to previously observed levels. In 2019 sampling results again increased to concentrations approaching those observed during 2010. For 2021, concentrations have trended downward and generally returned within ranges historically observed. Alkalinity, chloride, sodium, and sulfate all showed a decreasing trend when compared to 2019 and all remained below their respective SMCL's. During 2019 sampling, ammonia concentrations at sample point 2 were 0.853 mg/L. During 2021 sampling, ammonia concentrations were below the detection limit for both sampling locations. Iron fell below the SMCL (0.3 mg/L) at the upstream sample location (0.233 mg/L) while the downstream sample location (0.756 mg/L) exceeded the SMCL. Manganese exceeded the SMCL at both sampling points, however, the concentrations were within the elevated levels annually observed across the watershed. All other compounds remained below their respective MCL, secondary MCL, or action level at all sampling locations. Surface water chemical data is illustrated for Lockland Shepherd Lane Landfill in the graphs on the subsequent pages.

During 2019 sampling, many surface water chemical data parameters showed an increasing trend. No corresponding decrease in number or type of biological organisms has been observed during 2019 or 2021 monitoring. In 2021, 8 organisms were found at sample point 1 with 7 of them indicative of high or moderate quality (Table 3.12.3-A). This is a slight increase in the number of organisms found at this location compared to the last several sampling events where 5 (2019) and 6 (2017) organisms were observed. At the downstream sample point, 6 total organisms were observed with 5 of them indicating high or moderate water quality. This compares to 6 total organisms observed in 2019 and 4 organisms observed in 2017. The Health District staff will continue to monitor the biological water data in this area for any trends.

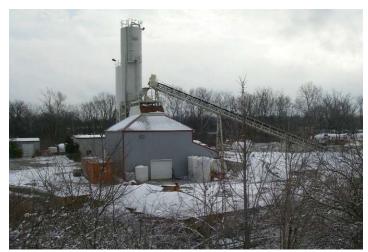
Currently a concrete company operates a plant on the site with equipment and material storage on top of the former landfill area.

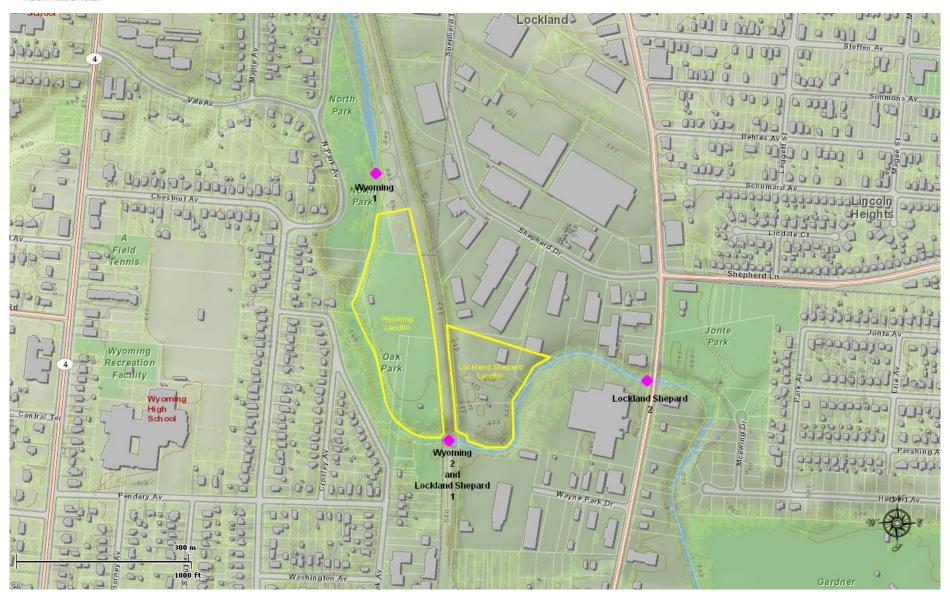
Figure 3.12.3-D

The West Fork of the Mill Creek flows along the south and east sides of the Lockland (Shepherd) Landfill. Stream samples are taken above (S-1) and below (S-2) the landfill. The Lockland landfill at Shepherd Lane is located adjacent and below the Wyoming landfill. Samples around Lockland Shepherd Lane Landfill were collected on October 13, 2021. The samples were collected during average flow as the area had received approximately 1.5 inches of rain during the previous 14 days none of which occurred over the 5 days prior to sampling. Both S-1 and S-2 sample locations consists of pools and riffles with a gravel and rocky bottom. The referenced locations are shown on Figure 3.12.3-D.

Wyoming and Lockland Shepherd Closed Landfills
