3.12.4 LOVELAND HARPER AVENUE LANDFILL

Facility Name:	Harper Avenue Landfill
A.K.A.:	Loveland Harper Landfill
Location:	East end of Harper Avenue Loveland, Ohio; Adjacent to west bank of the Little Miami River, Immediately North of Kealhofers's Run Creek.
Parcel(s):	62100020001
Lat/Long:	39.273066 -84.260486
Region:	Loveland
Owner:	City of Loveland
Operation (yrs):	1968 – 1980

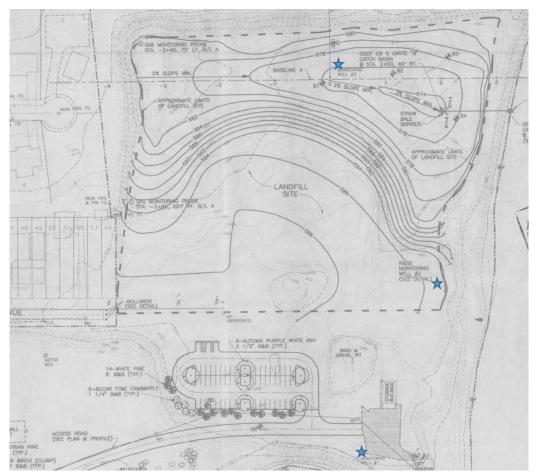
FIGURE 3.12.4-A

According to a 1994 letter from the Ohio EPA when the facility closed it did not close in accordance with the rules which requires a slope no less than 1%. This resulted in a depression on the surface of the landfill which allowed ponding and percolation of surface water into the waste. Three groundwater monitoring wells were installed at the landfill in 1986 and in March 1987 the OEPA discovered the wells were contaminated with low concentrations of Toluene, Methylene Chloride and Benzene. The OEPA determined that the low concentrations were a minimal threat to human health, welfare, or the environment. Locations of the monitoring wells (\star) are shown in Figure 3.12.4-A.

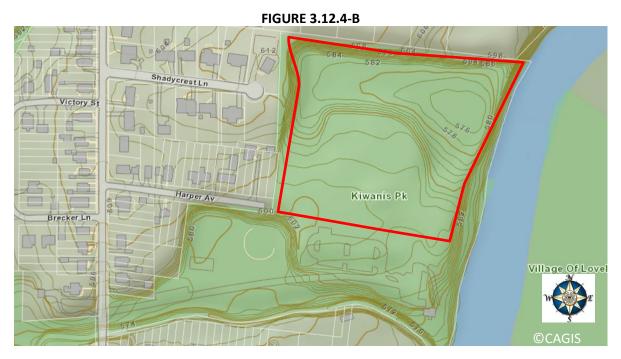
A closure plan was submitted by the City of Loveland and was approved on January 19, 1995. The city was ordered to complete closure activities by October 30, 1995. On December 4, 1996, the OEPA sent the city a letter informing them of conditions at the landfill that were still in violation of the closure plan. The final closure certification report was approved on December 16, 1997, by the OEPA. Present day topography is shown in Figure 3.12.4-B.

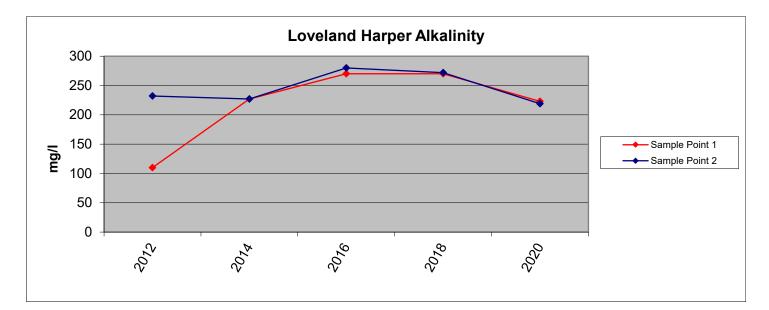
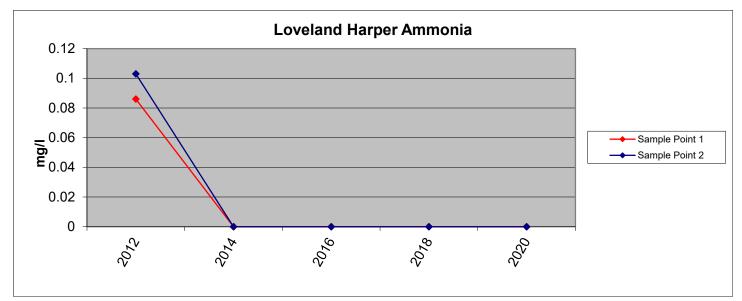
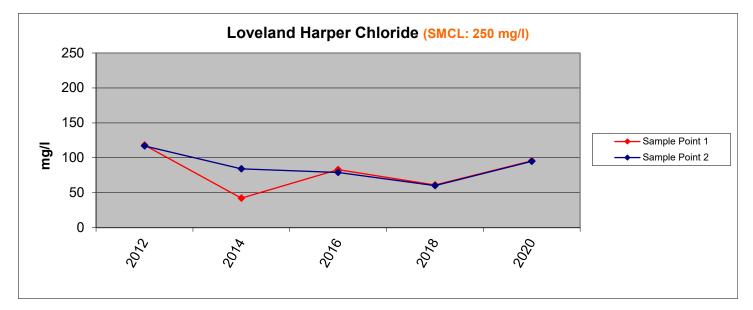
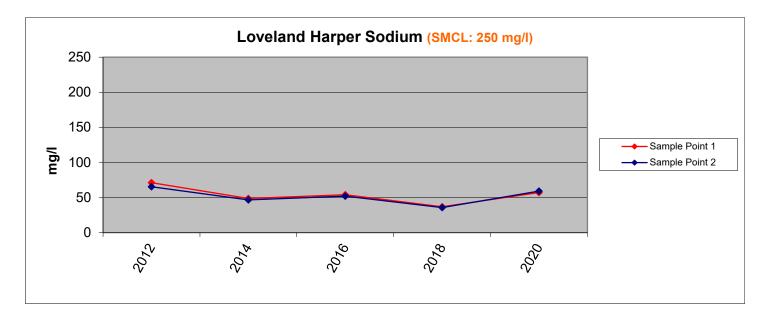
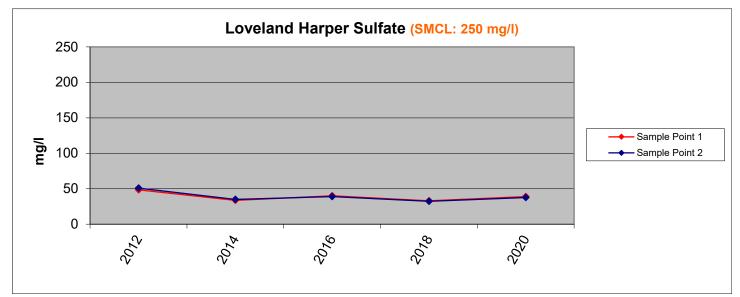
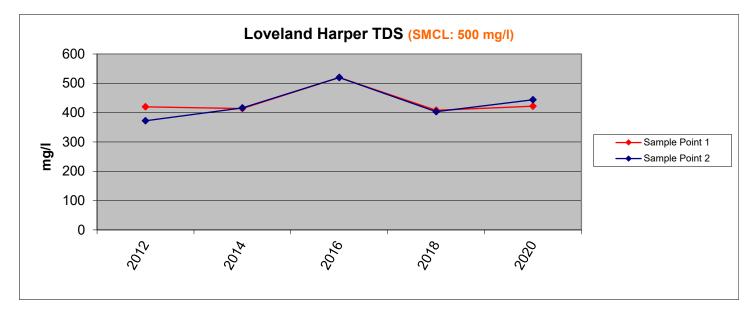
Since these locations have only been sampled five times (2012, 2014, 2016, 2018 & 2020) few trends are evident at this time. During 2016 sampling TDS exceeded the SMCL of 500 mg/L at both sampling locations. Subsequent sampling in 2018 and 2020 have resulted in concentrations of TDS below the SMCL at both sampling locations. During initial sampling in 2012 Iron (0.39 mg/L) was slightly above the SMCL of 0.3 mg/L at S-1. During the next three sampling events Iron was below the SMCL at both locations. During 2020 sampling S-1 was again slightly above the SMCL at 0.311 mg/L. All other parameters sampled for have been below their respective Maximum contaminant level (MCL) or Secondary Maximum Contaminant Level (SMCL) during each of the five sampling events from 2012 through 2020. No significant differences were observed when comparing results from the downstream sample to the results from the upstream sample. In 2014, a difference was noted between the upstream and downstream concentrations of chloride. However, both S-1 (42.1 mg/L) and S-2 (84.2 mg/L) had concentrations well below the SMCL of 250 mg/L. Surface water chemical data is illustrated for Loveland Harper Landfill in the graphs on the subsequent pages.

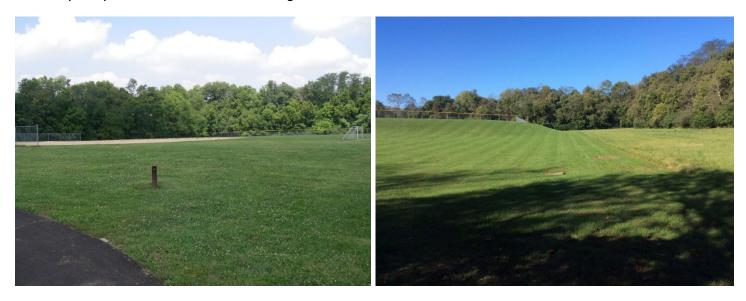
Figure 3.12.4-C Loveland Closed Landfill Harper Avenue

The Little Miami River runs along the east side of the Loveland Harper Landfill. Samples are taken above and below the landfill (Appendix A). Samples around Loveland Harper Landfill were collected on October 14, 2020. The river had average flow on the day of sampling. The upstream and downstream samples were in shallow (1'), gravelly, rocky riffle areas of the river. The shallow areas had rapid flow across the rocks. The referenced locations are shown on Figure 3.12.4-C.

The city had their explosive gas monitoring plan (EGMP) approved on January 3, 2003. Gas monitoring is conducted by City of Loveland personnel. Monitoring consists of sampling each of the fourteen permanent gas monitoring wells on-site (Figure 3.12.4-C). Prior to 2020 gas monitoring had been completed monthly for more than 15 years. In a December 27, 2019, letter to the City of Loveland Ohio EPA noted that the facility has been conducting monthly gas monitoring of the landfill to meet the requirements of contingency monitoring per Section 8.6.2 of the EGMP. The letter indicated that requirements for cessation of the contingency monitoring have been met and the city may return to semi-annual monitoring. However, the facility has failed to complete the first semi-annual gas monitoring event during the last two years. Ohio EPA issued notice of violations in August 2020 and August 2021 for failing to complete the first semi-annual monitoring event.
