3.13.2 MIAMITOWN CONSTRUCTION AND DEMOLITION DEBRIS LANDFILL

Facility Name: Miami town Landfill

Location: 5966 State Route 128. Situated south of State Route 128, approximately 0.75-mile southwest of Interstate 275/74 in Whitewater Township, Ohio.

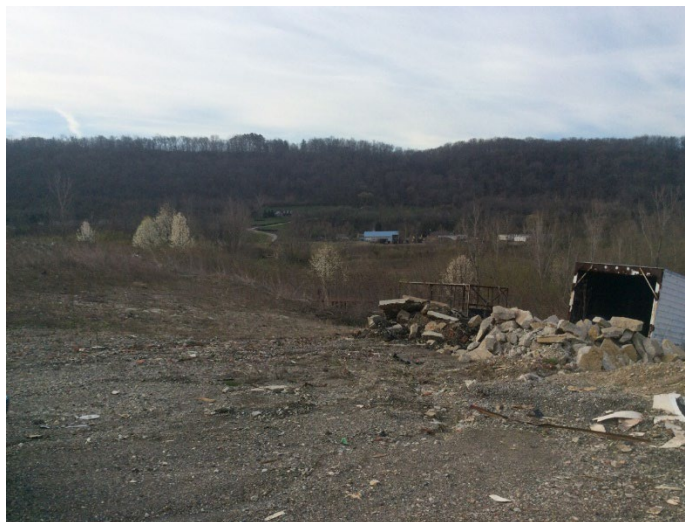
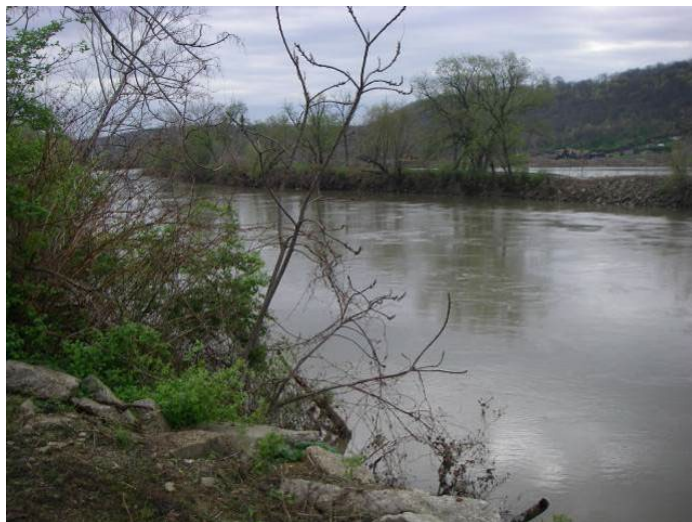
Figure 3.13.2-B
Miami town Landfill
State Route 128

Upstream and downstream sample sites are identical to Carmical Closed Landfill as shown in Figure 3.13.2-B. See Appendix A for chemical data. See section 3.3.2 (Carmical Closed Landfill) for discussion, graphs, and tables of both chemical and biological sampling data.

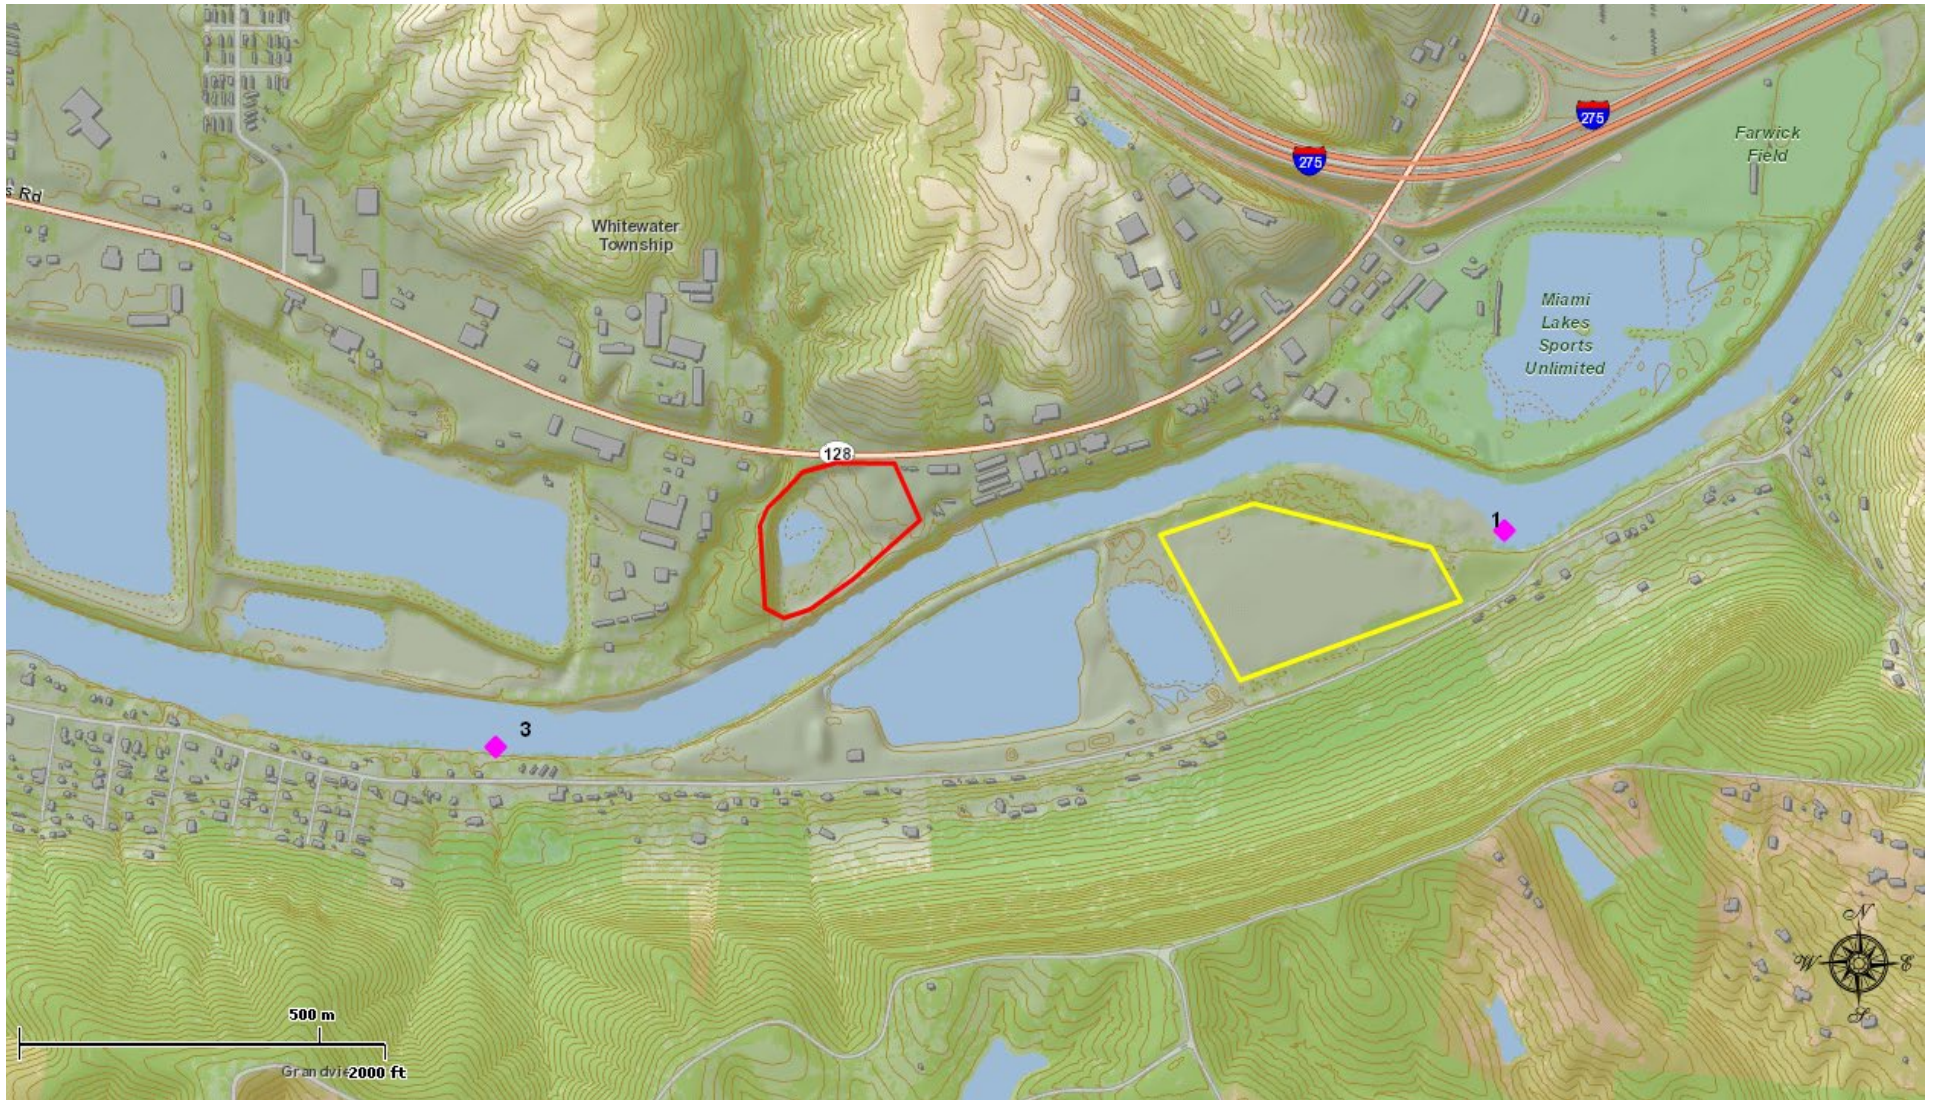
- ◆ = Surface Water Sampling Location
- = Approximate Limits of waste (Carmical)
- = Approximate Limits of waste (Miami town)
