3.13.3 MIAMIVIEW ASH LANDFILL

Facility Name: Miamiiview Road Ash Road Landfill

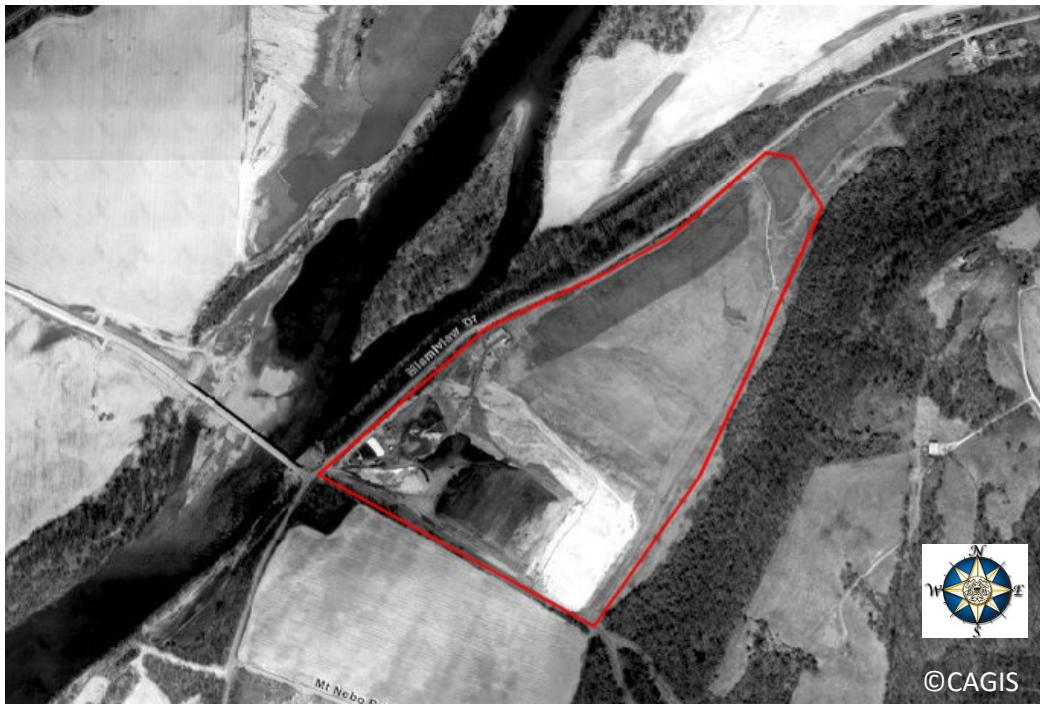
FIGURE 3.13.3-A

In 1993, a Permit to install (PTI) was issued for leachate collection, pH neutralization, and sedimentation systems for the landfill. NPDES monthly reports were provided to the Health District from June 1995 through April 1997. Monitoring for pH, conductivity, TSS, and Oil & Grease as part of the NPDES permit occurred at that time. The NPDES was not renewed when the site ceased operation in 1997. Figure 3.13.3-A is an aerial photograph from 1996. You can see in the aerial that the northern part of the site has been filled and the southern end of the property is used for current disposal of the fly ash and bottom ash.

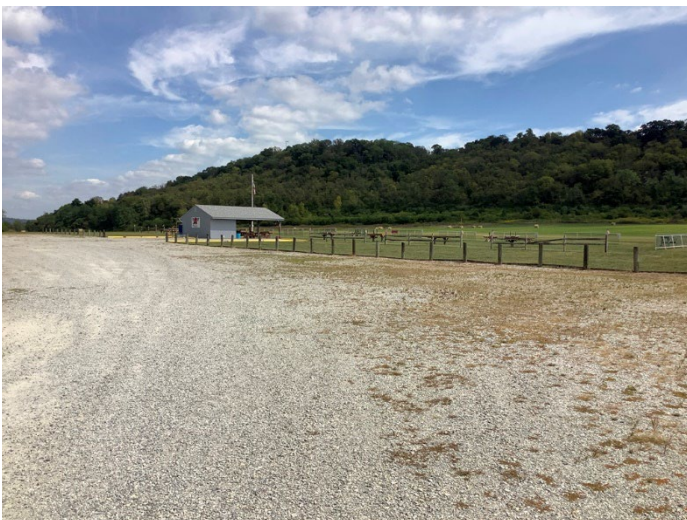
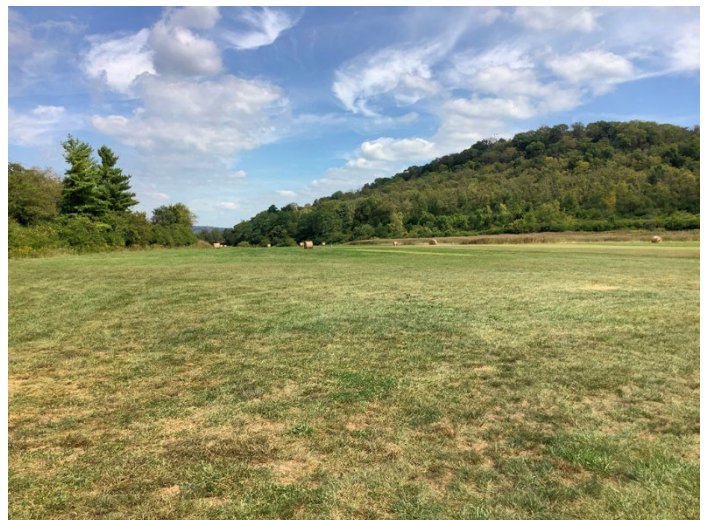
Today, the property is an open field utilized by Air Masters RC Flying Club as a model airplane flying field.
