3.15.2 OLD GALBRAITH ROAD LANDFILL

Facility Name: Old Galbraith Road Landfill

Operation (yrs): 1958 – 1965

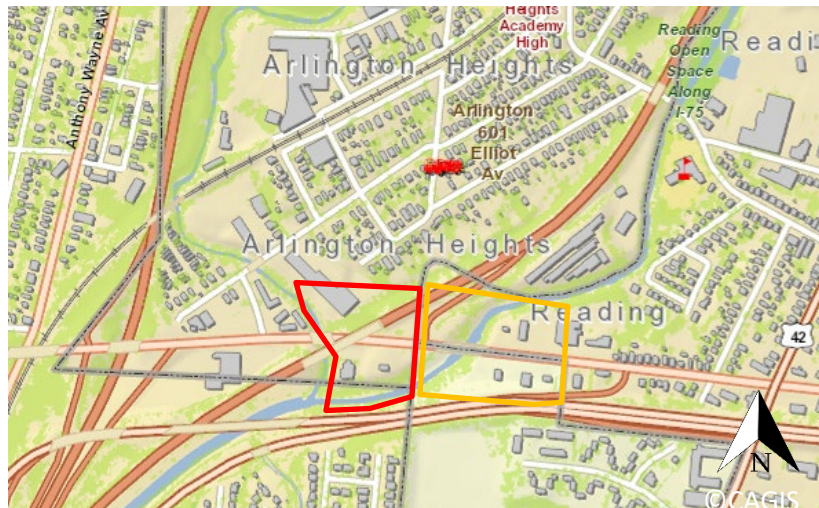
FIGURE 3.15.2-A

As seen in Figure 3.15.2-A that there is only a small area (outlined in red) that meets the location criteria of 200 yds. north and south of Galbraith Road, in Arlington Heights, and East of the Mill Creek. However during review of aerial photos, it does not appear as though filling occurred on the north side of Galbraith Rd. in this area.

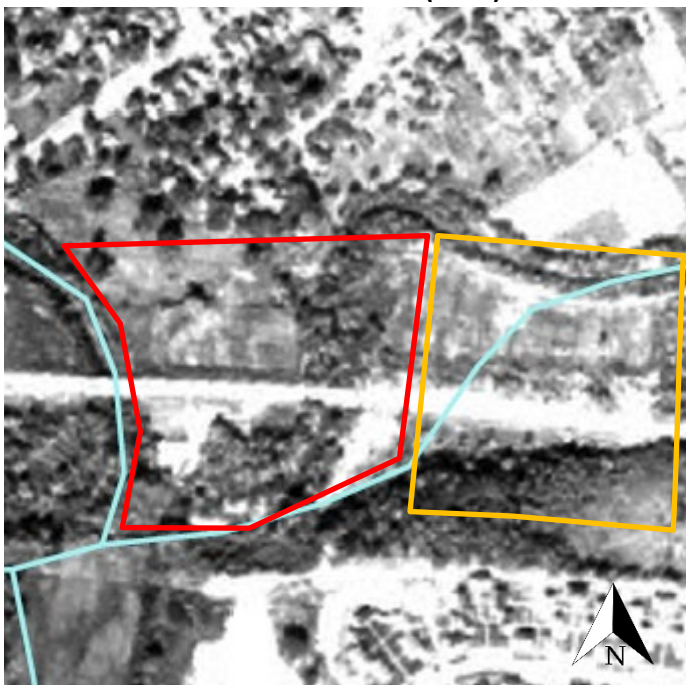
FIGURE 3.15.2-B (1956)

In the aerial photo from 1956 below (Figure 3.15.2-B), note that the East Fork of the Mill Creek is in its original location and I-75 North has not yet been constructed. The areas between the two forks of the Mill Creek are mostly tree covered or open land. In the aerial photo from 1968 (Figure 3.15.2-C) note that the East Fork of the Mill Creek is in its present-day location and I-75 North cuts through the area. The area between the forks of the Mill Creek has been cleared.

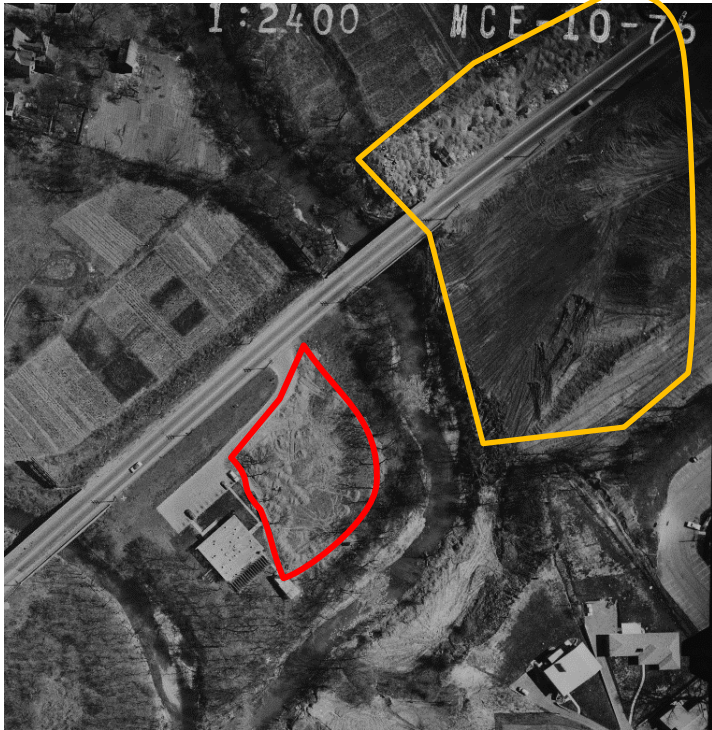
FIGURE 3.15.2-D (1960)

Review of ODOT aerial photographs from 1960 through 1969 (figures 3.15.2-D through G) reveals that filling occurred in the areas outlined in red above as well as in the areas outlined in orange. The areas outlined in orange appear to have fill placed on both the north and south side of Galbraith east of the Mill Creek but these areas are not located within Arlington Heights. It should be noted that filling in any of these areas could have been completed with clean hard fill only. Areas of filling are designated below by the colors that relate to areas in the figures above. The 1969 photograph was taken after a tornado affected the area. Debris resulting from the tornado is evident, but filling of the areas appears to be completed.
