### **3.15.3 OLD NEWTOWN LANDFILL**

Facility Name: Old Newtown Landfill

Location: North/Northeast of Broadwell Road, East of Round Bottom Road

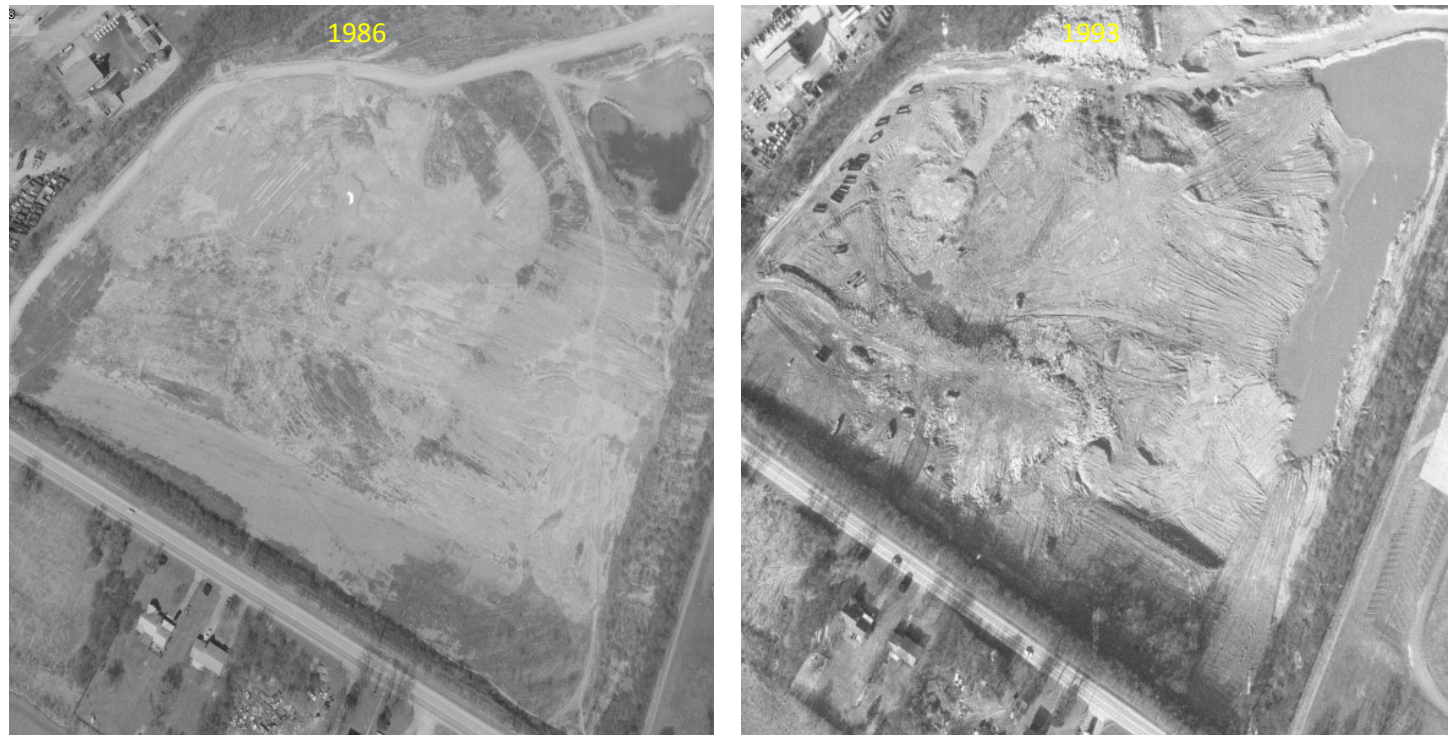
**FIGURE 3.15.3-A**

From review of aerals, it appears the gravel pit was mined in the 1970's. Filling of the former gravel pit began in the1980's. Aerials from the 80's appear to show filling with soil. However, aerials from the 1990's appears to show filling with C&DD (Figure 3.15.3-A). An inspection completed by HCPH in 1995 described the facility as a closed C&DD landfill.

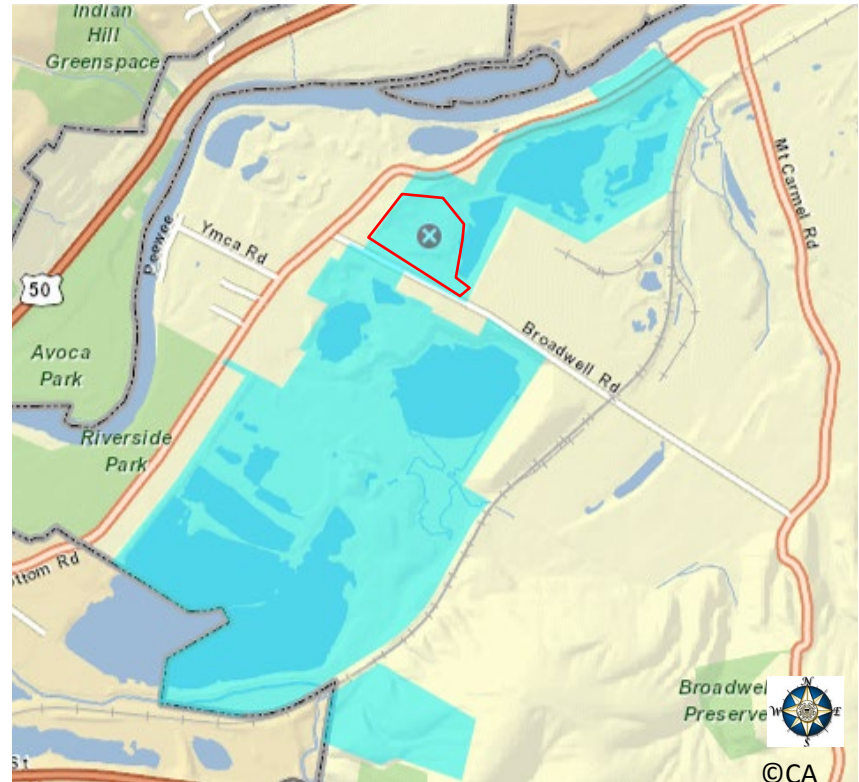
**FIGURE 3.15.3-B**

During the 2006 purchase of the property by Martin Marietta Materials Inc., a combination plat was created from a group of parcels surrounding the landfill. The created parcel, Parcel #50001630001, encompasses approximately 488 acres. Figure 3.15.3-B illustrates the location of the landfill within Parcel #50001630001:

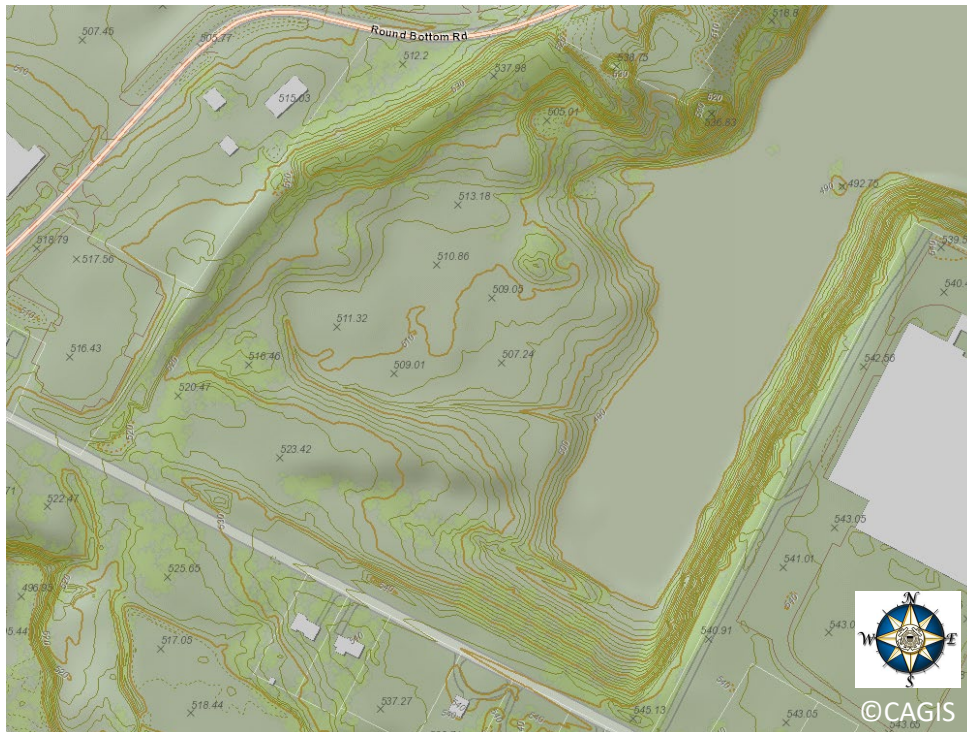
**FIGURE 3.15.3-C**

Topography of the landfill area consists of an elevation change of approximately 20', increasing from the East/Northeast bordering pond to the Southwestern corner of the site. Figure 3.15.3-C illustrating the topography of the site follows:

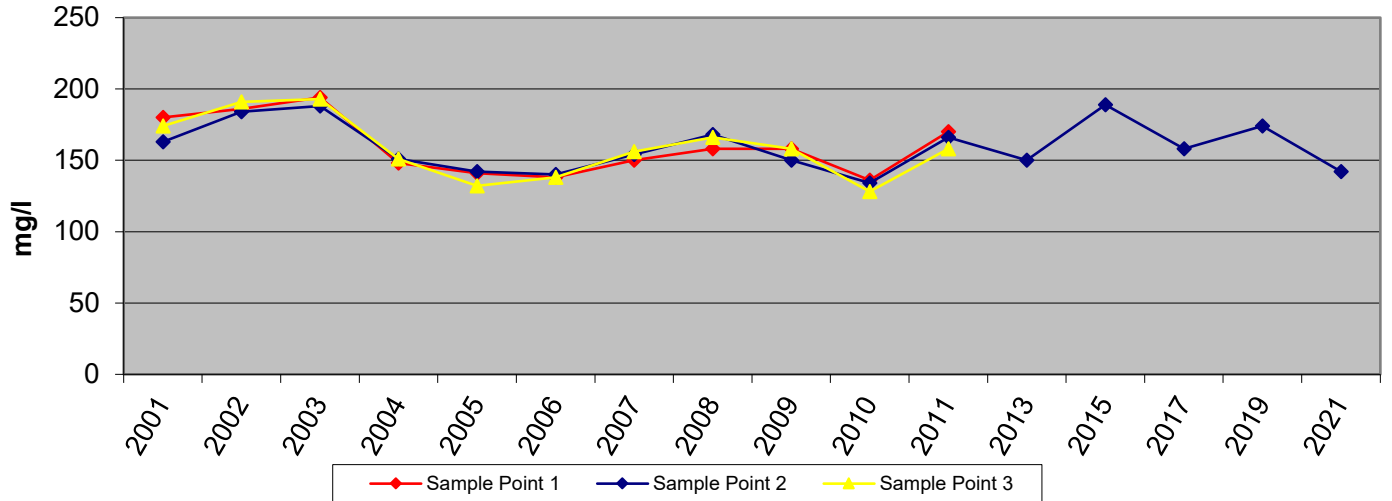
**Old Newtown Alkalinity**

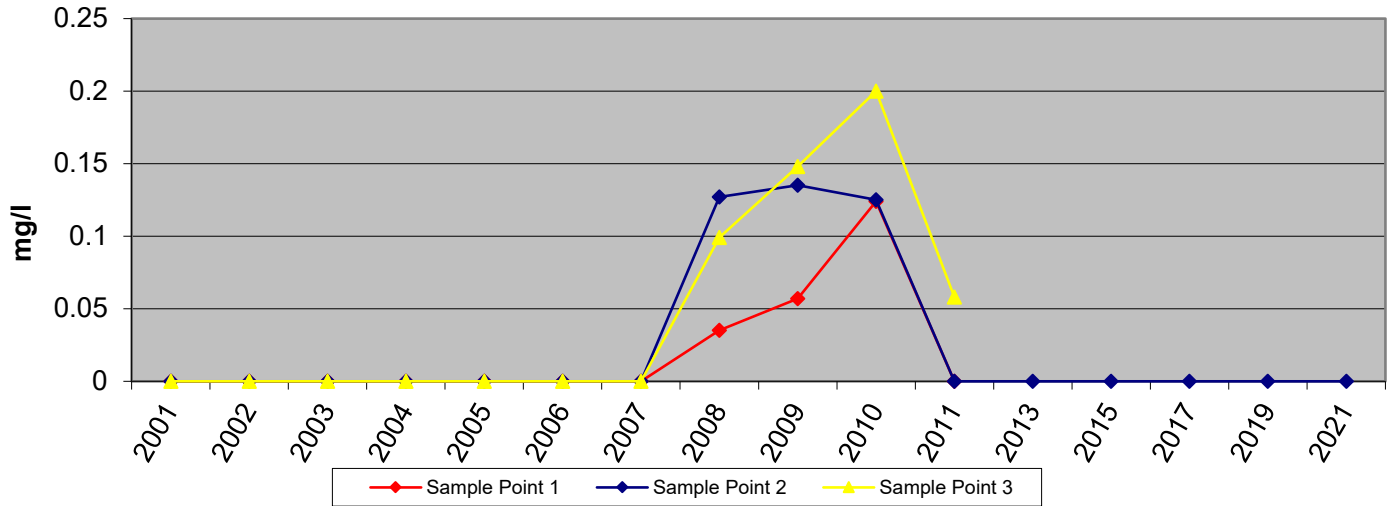
**Old Newtown Ammonia**

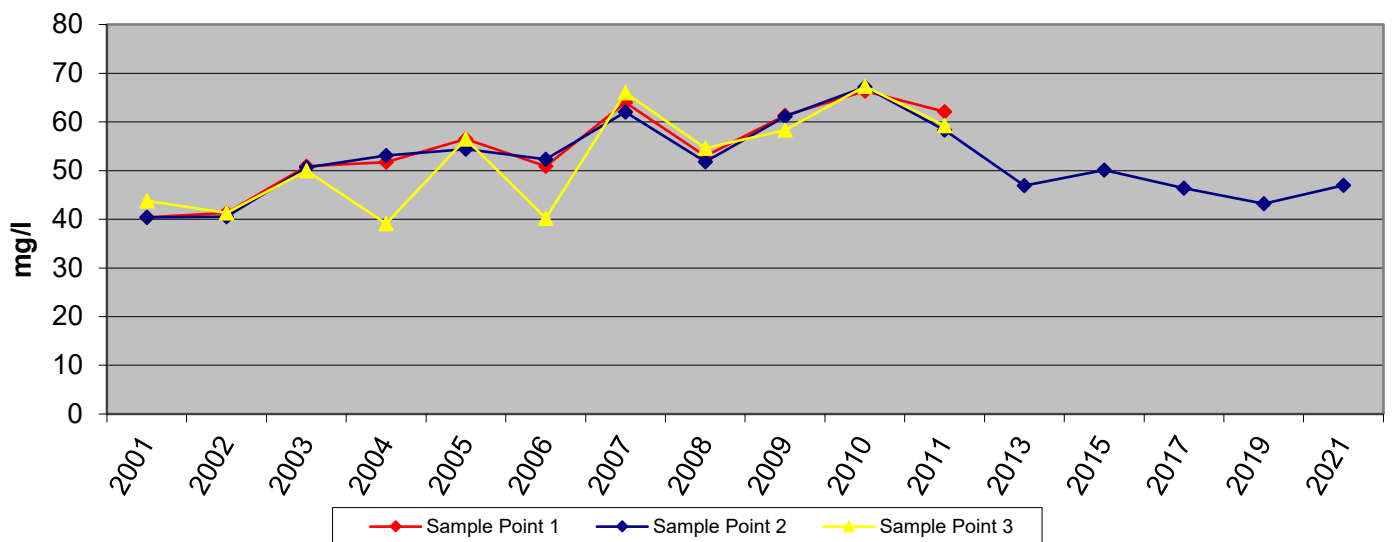
**Old Newtown Chloride (SMCL: 250 mg/l)**

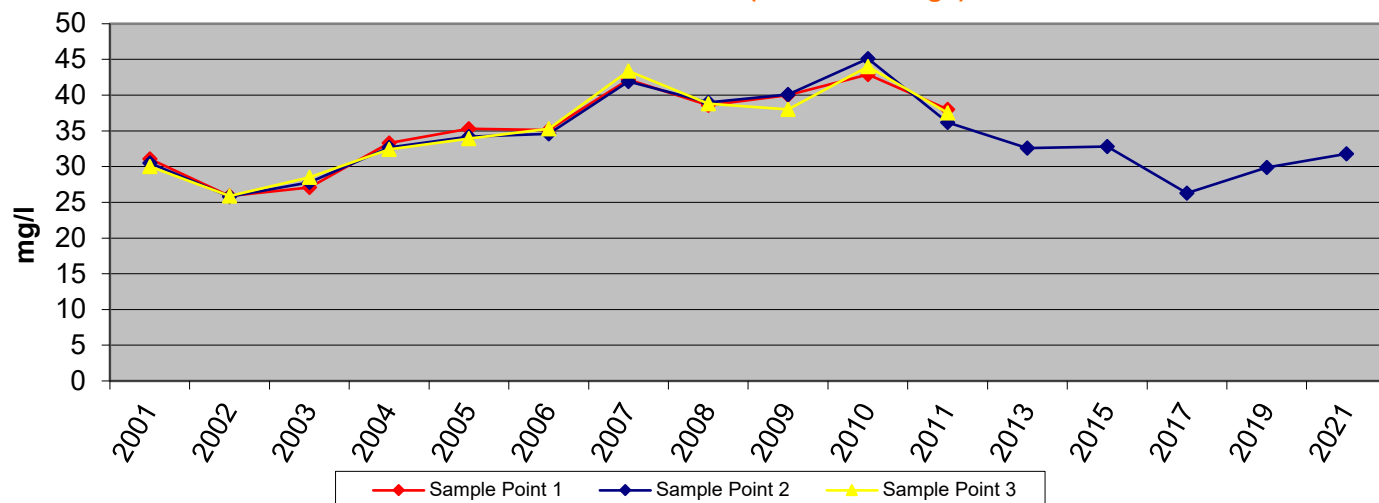
Results for all parameters (Appendix A) sampled in 2021 indicate acceptable water quality, where no MCLs, SMCL's, or action levels were exceeded. Sodium has been trending upwards over the last 2 sampling events but remains well below the SMCL of 250 mg/L. Similarly, sulfate increased when comparing 2019 results to 2021 results, but concentrations remain well below the SMCL of 250 mg/L. During 2015 sampling alkalinity results were the highest ever recorded at sampling point 2. Subsequent results have shown alkalinity returning within the range previously observed at the site. All other parameters were within the ranges previously observed at the site. Surface water chemical data is illustrated for Old Newtown Landfill in the graphs on the subsequent pages.

**Old Newtown Sodium (SMCL: 250 mg/l)**

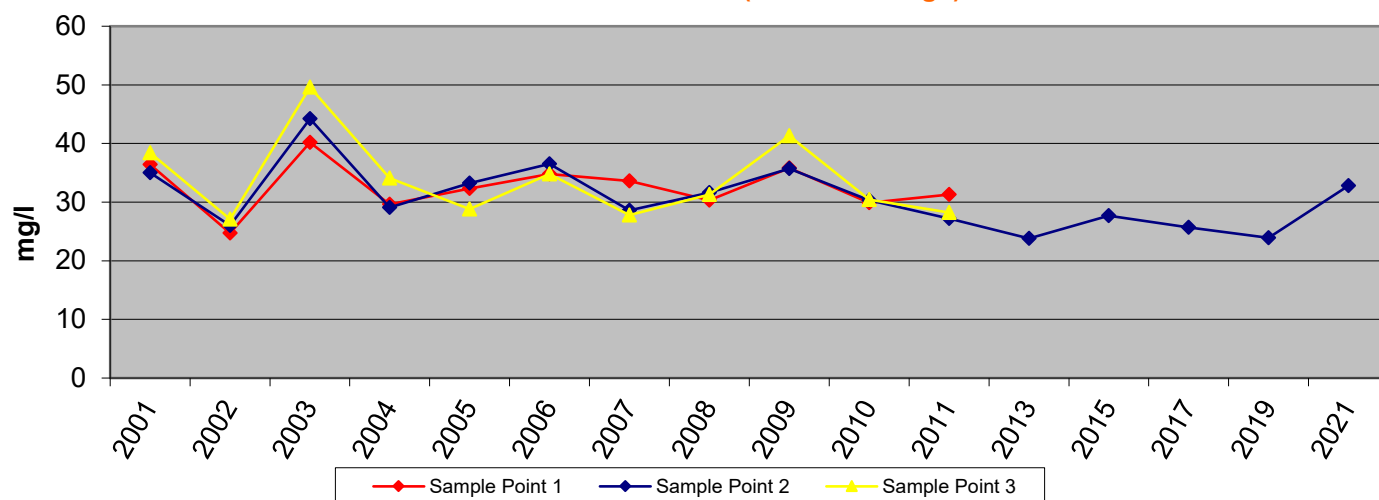
**Old Newtown Sulfate (SMCL: 250 mg/l)**

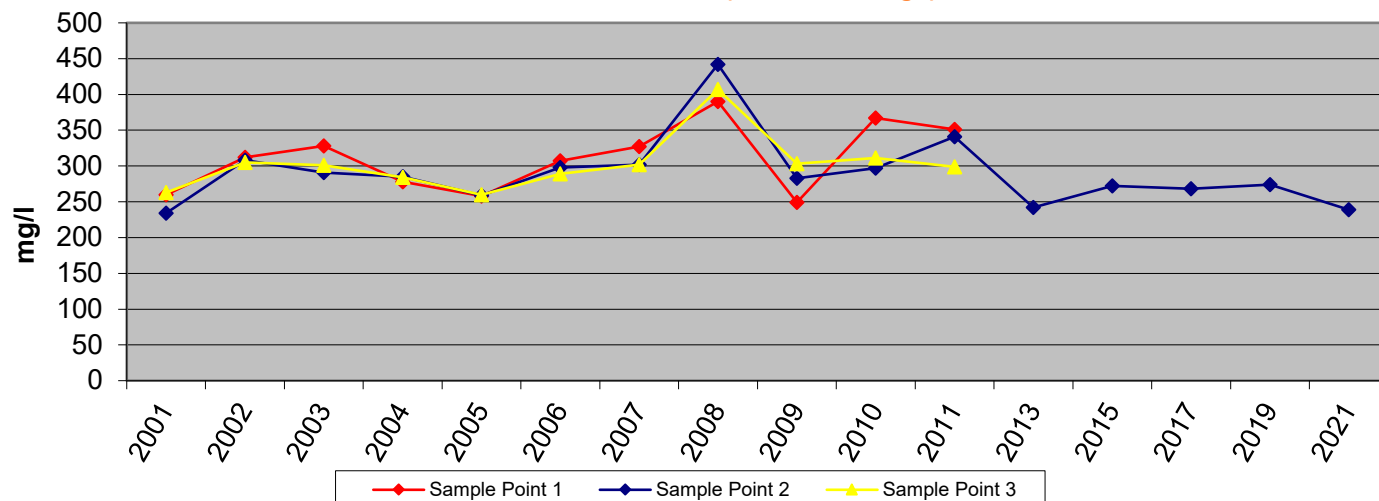
**Old Newtown TDS (SMCL: 500 mg/l)**

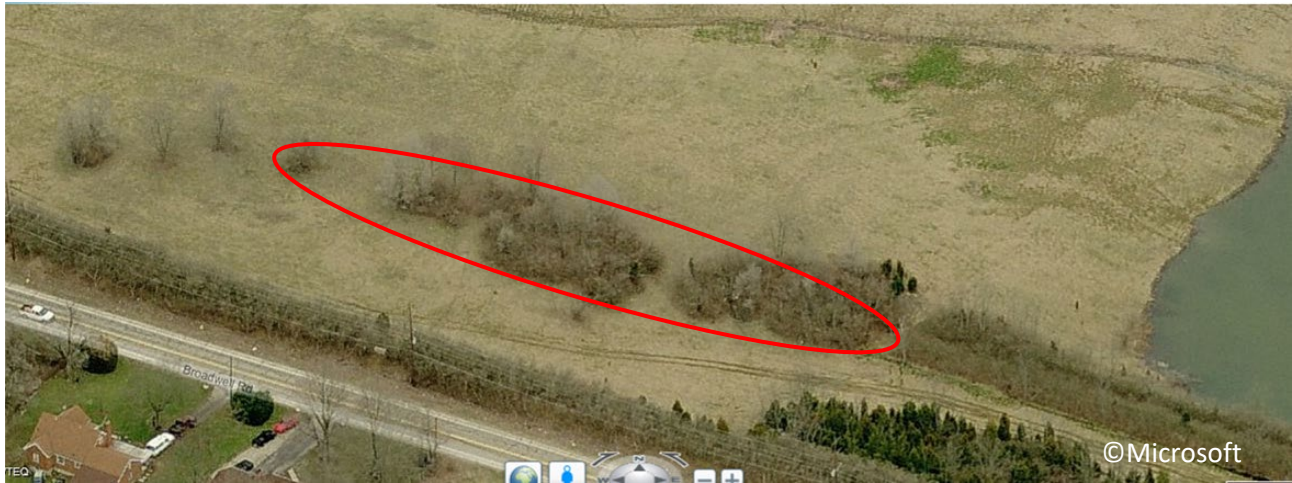
**FIGURE 3.15.3-E**

The site was inspected by HCPH on November 1, 2021. The south end of the property has become increasingly overgrown with honeysuckle, trees, and grass over the last 10 years making it more difficult to access and inspect. Areas of exposed waste which have been identified during previous inspections are still present. Some of the materials appear to be exposed from former landfill activities and other materials may be a result of past open dumping. The areas of exposed waste are completely covered with trees and Honeysuckle. Seeps have also been identified in the same general area during previous inspections but were not present at the time.

Whether the seeps are naturally occurring or related to former landfill activities is unclear. The debris and seeps are located in the wooded areas on the Southern portion of the site as depicted in Figure 3.15.3-E.

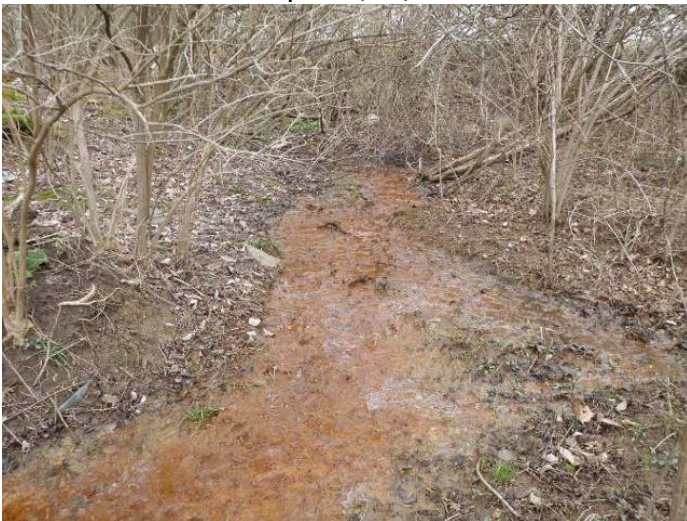
**Seeps - 3/24/2010**

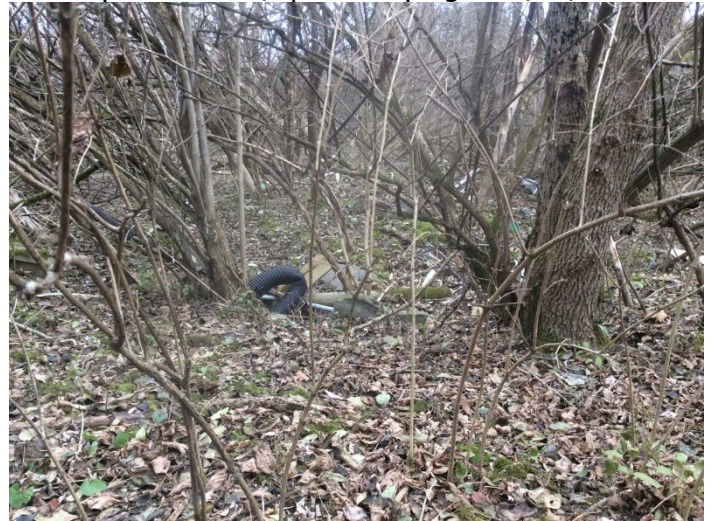
**Exposed waste/open dumping – 12/14/2018**

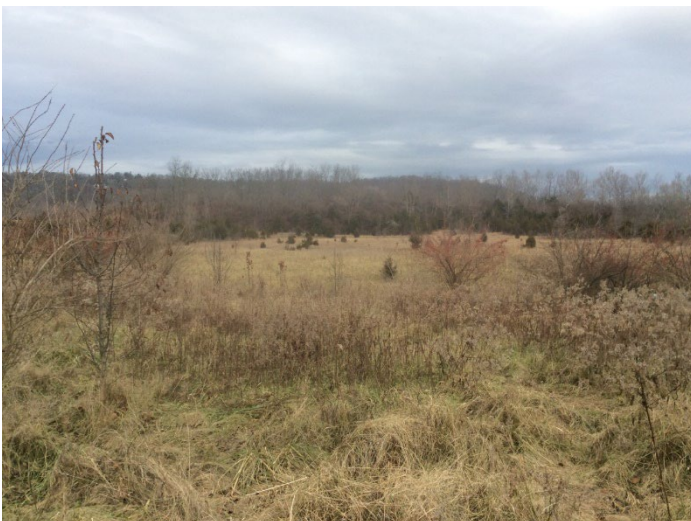
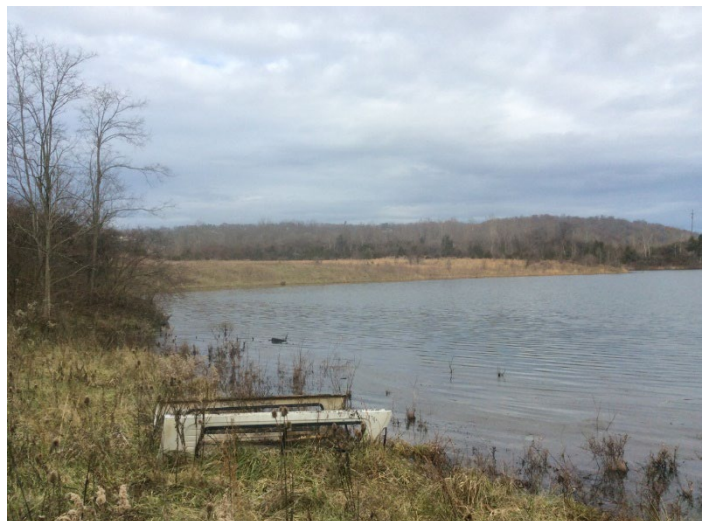
Today, the landfill area sits vacant with little to no activity at the site. The former landfill is covered with established grass, honeysuckle, and trees.

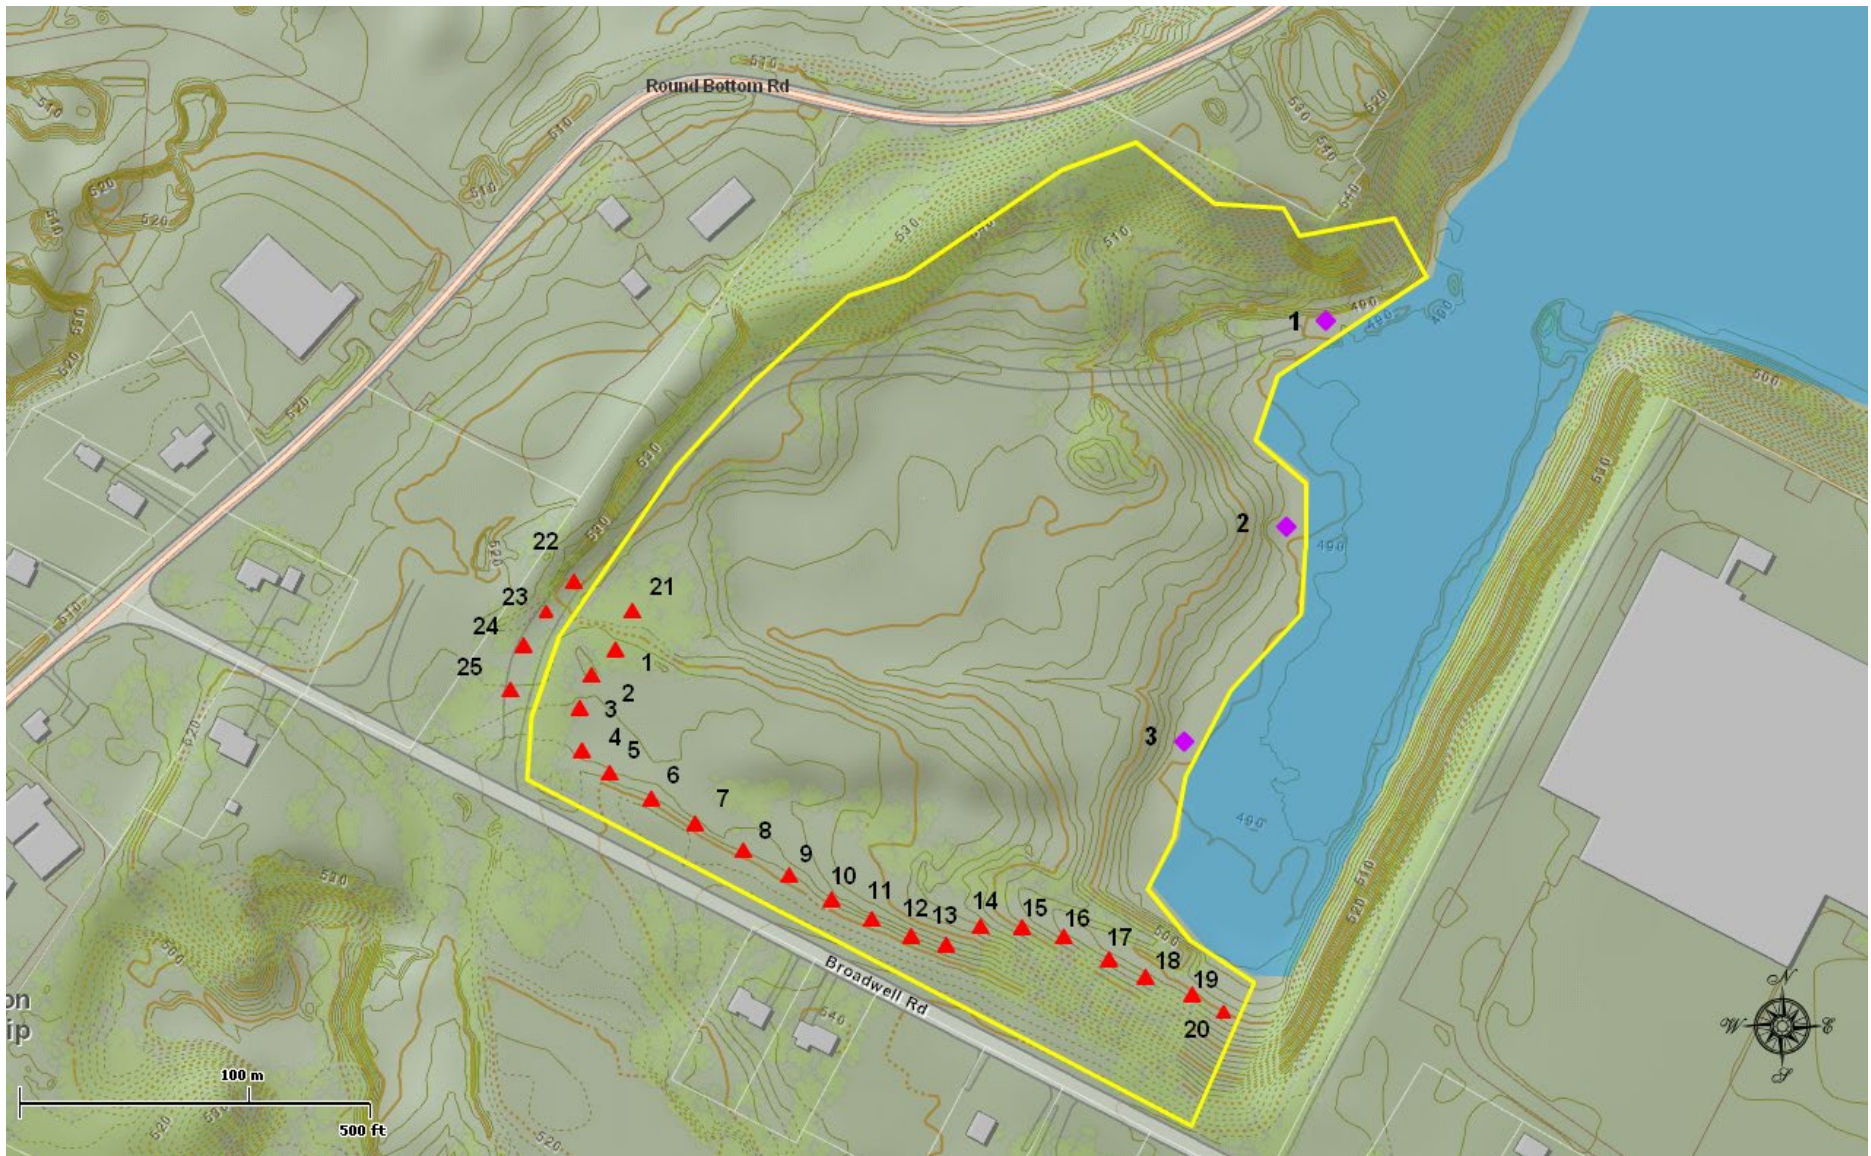
**Figure 3.15.3-F**  
**Old Newtown Closed Landfill**  
**Broadwell Road**

There is a large quarry pond located on the eastside of the Old Newtown Landfill. The pond was historically sampled in three locations. Given the steady findings at all three locations, sample sites S-1 and S-3 were removed from the sampling protocol in 2013. Samples around Old Newtown Landfill were collected on November 1, 2021. The samples were collected when pond levels were average. The area had received approximately 1.3 inches of rain during the previous 7 days. The S-2 pond sample location has a rocky/gravelly bottom with aquatic vegetation. The samples were collected in shallow water less than one foot deep. The referenced locations are shown on Figure 3.15.3-F.

In 2020 methane was detected at sample point 21 at 3% LEL. In 2019 methane was detected at sample points 1 and 2 at 2% and 4% LEL respectively. During several past sampling events methane has been encountered, in low concentrations, at sampling points 1, 2, 3, and 21 which are located on interior portions of the landfill (Figure 3.15.3-F).
