3.19.2 ST. BERNARD LANDFILL

Location: South and southwest of Bank Avenue, east of I75;
Access from intersection of Phillips Avenue and Baker Place in St. Bernard, Ohio.

Facility Overview

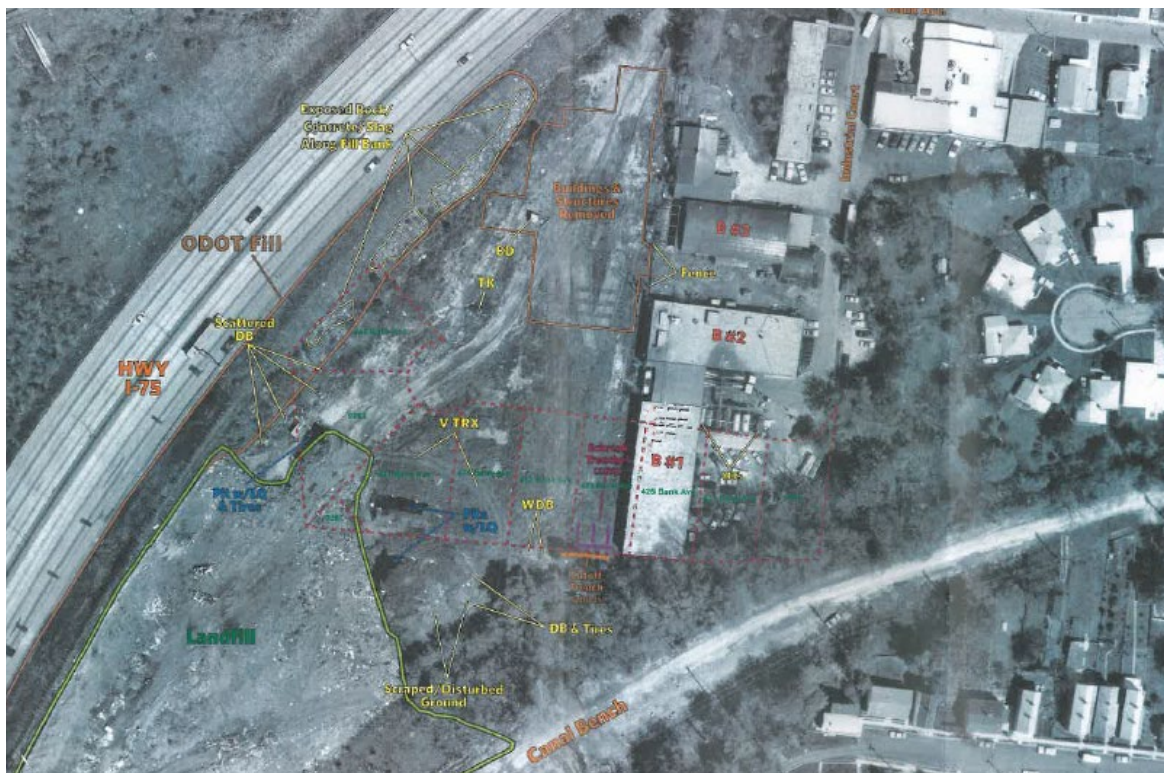
FIGURE 3.19.2-A

used to fill what is now land occupied by residential structures. Figure 3.19.2-A is an aerial from 1974 showing the landfill and industrial buildings in relation to present day homes:

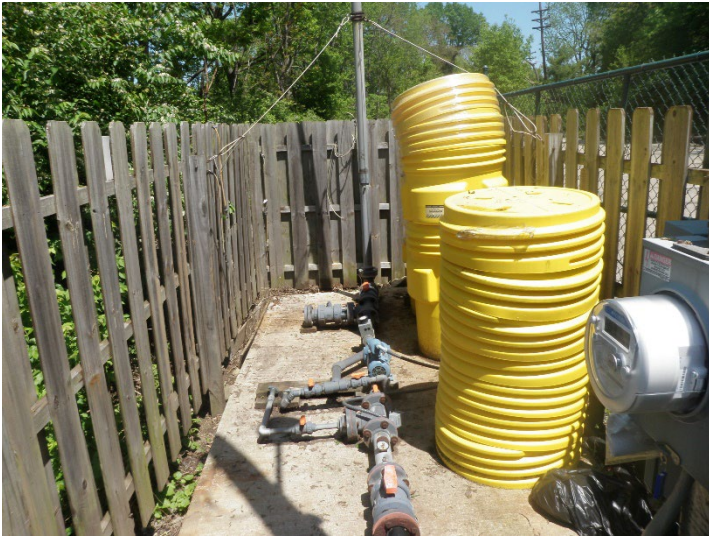
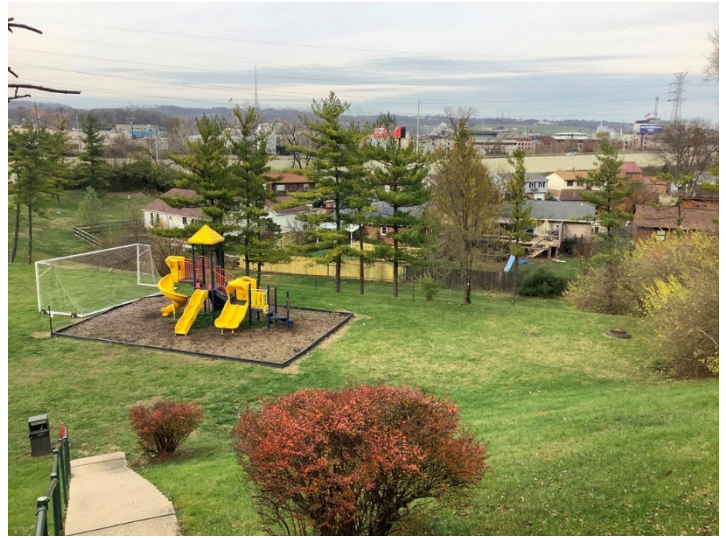
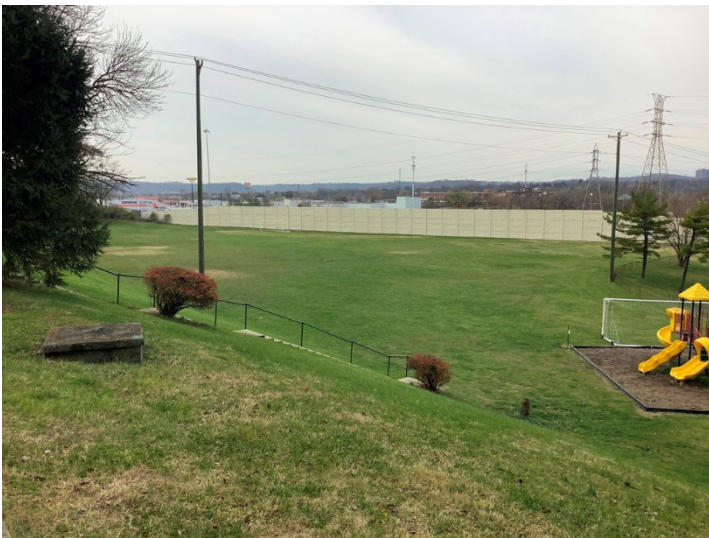
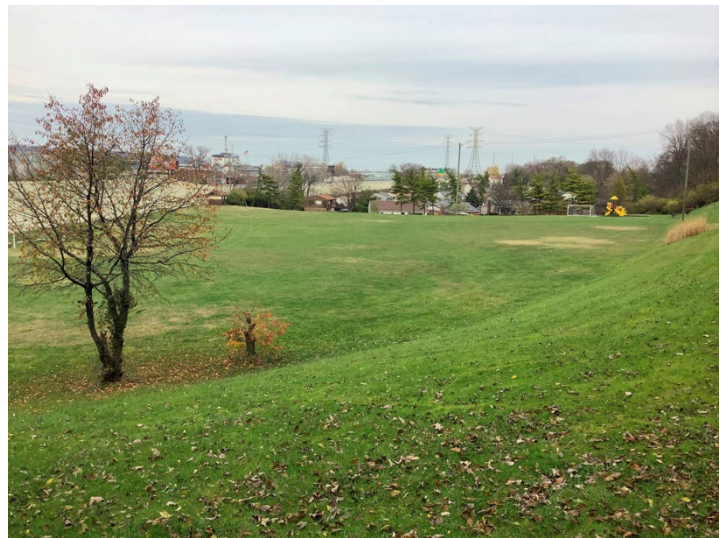
The site was inspected by HCPH on December 27, 2021. No violations or nuisance conditions were observed on the site.

The former landfill is covered mainly with established and maintained grass and is currently used as Ludlow Grove Park. The park contains soccer fields and a playground in the lower portion while a paved walking path is located in the upper portion.
