3.19.3 ST. BERNARD – Oak Street

Location: Oak Street, I-75, and Ross Park in St. Bernard, Ohio.

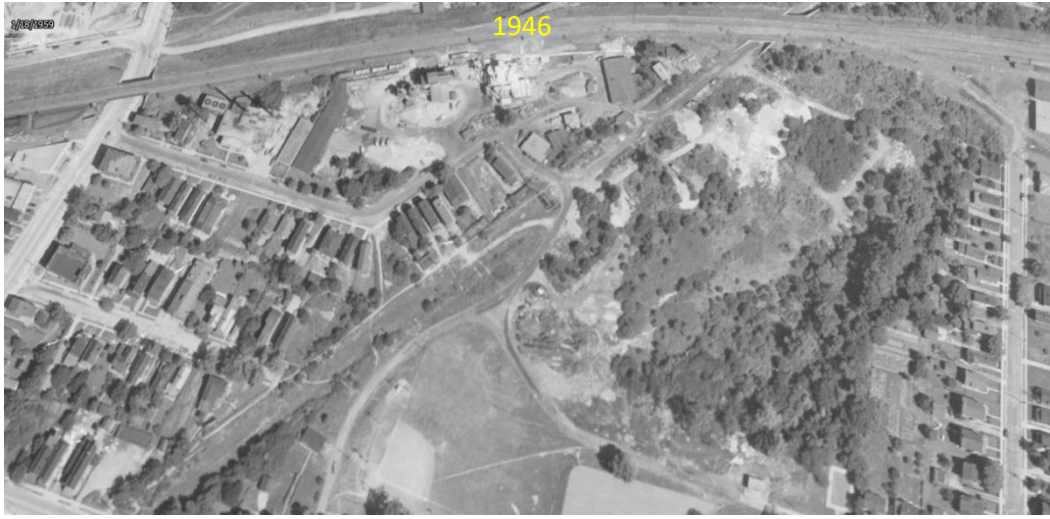
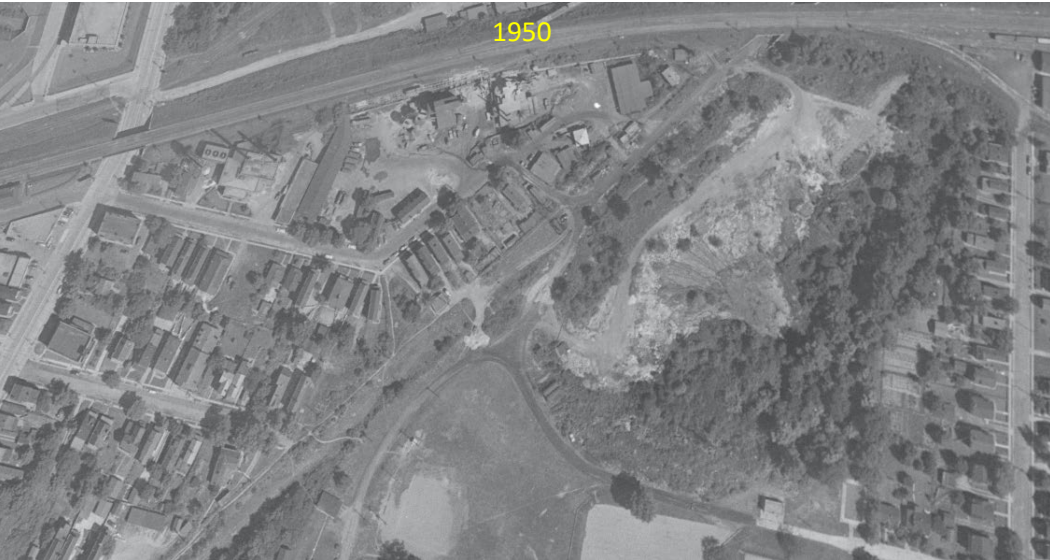
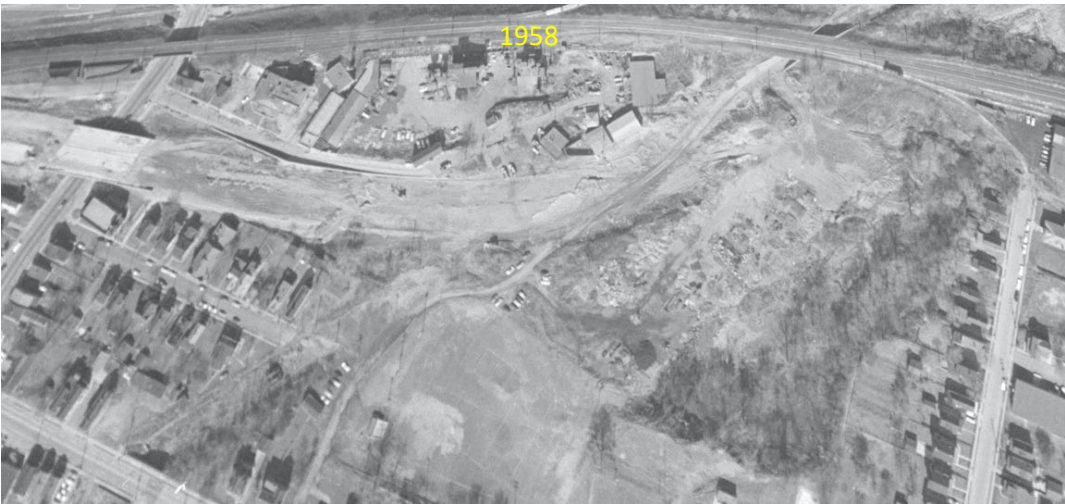
FIGURE 3.19.3-A

Review of aerials from the 1930's show buildings already present in areas south of the railroad and north of present day I-75. In aerials from 1946 and 1950 filling in areas that are now occupied by I-75 and the park is evident. By 1958 filling of these areas continues and construction of I-75 is visible. See Figure 3.19.3-A for aerials

from 1946, 1950, and 1958. Filling in these areas continues in 1962, however in 1963 filling in these areas appears to be complete, and the present-day walking path is under construction.

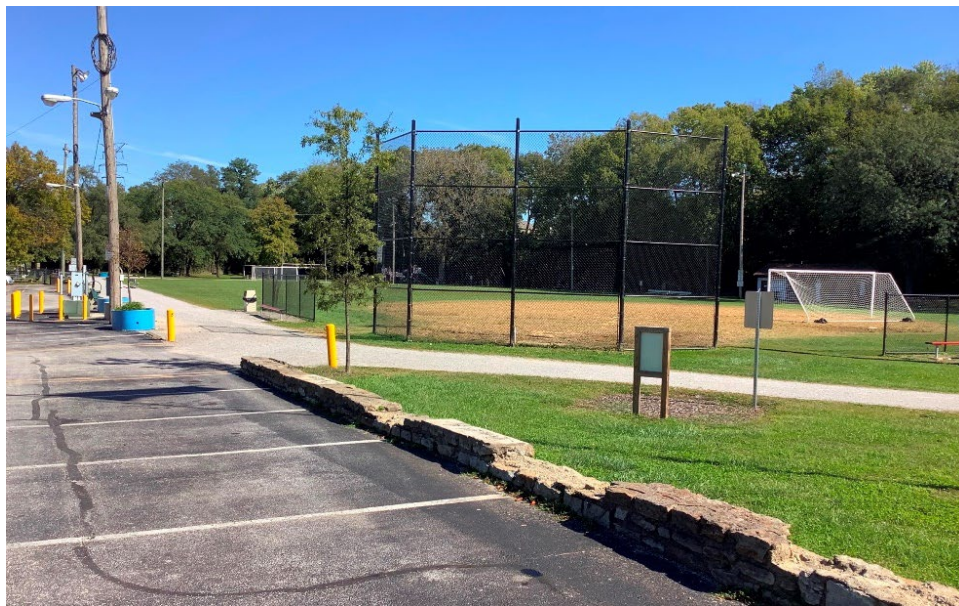
Part of the suspected location of historical filling is now occupied by I-75. The remainder of the suspected areas are now occupied by Ross Park. The park contains a paved parking lot, paved walking path, grass fields, dirt baseball field, and several small buildings.
