3.3.2 CARMICAL LANDFILL

Facility Name: Carmical Landfill

FACILITY OVERVIEW

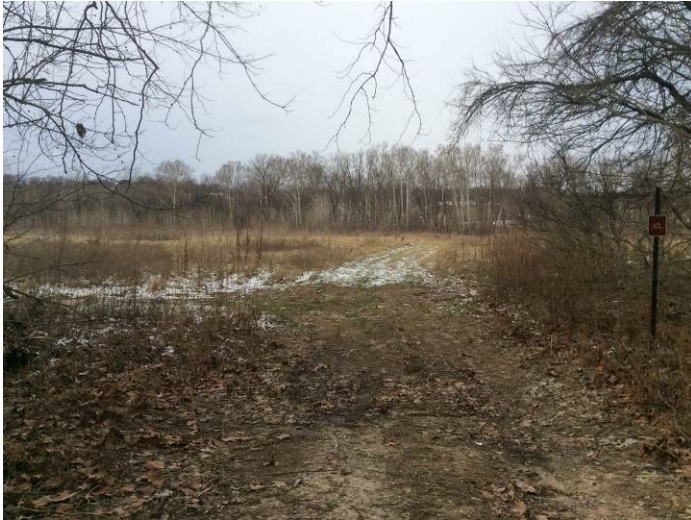
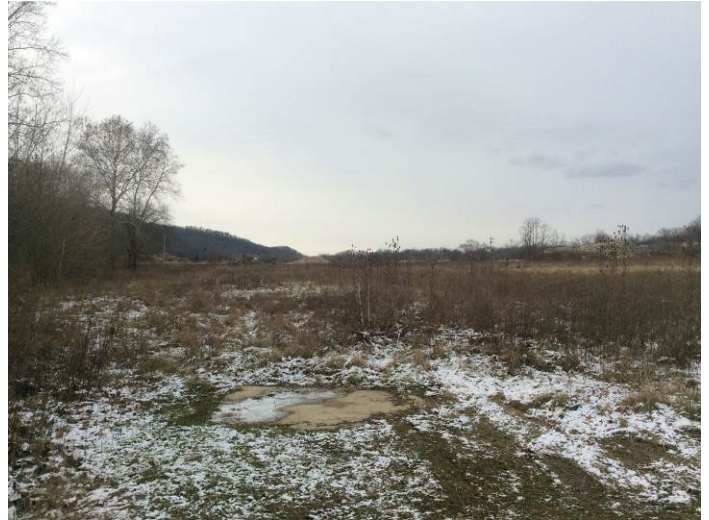
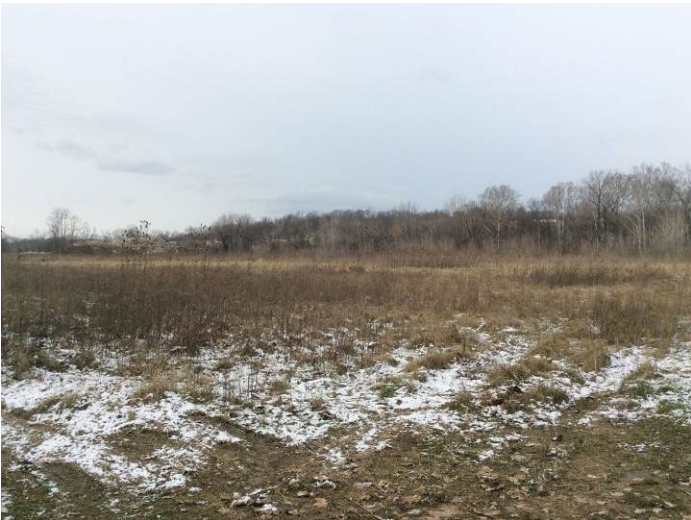
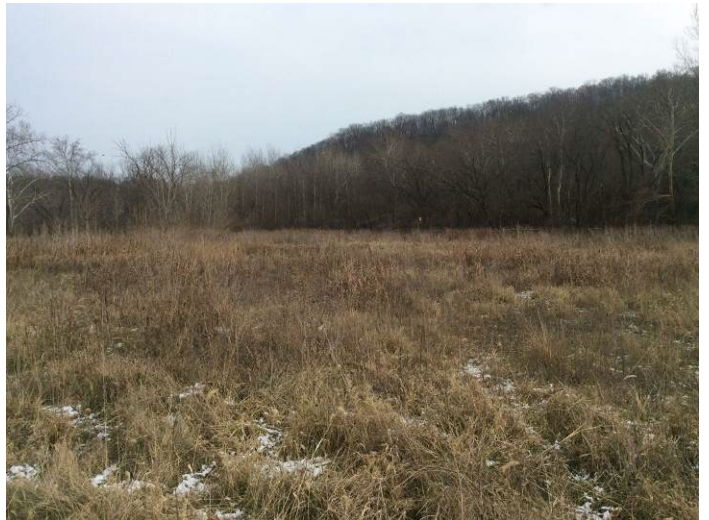
Today the site is open space owned by the Hamilton County Park District. The site is completely covered by grass and weeds with trees around the perimeter of the former landfill. A locked gate blocks vehicle entry to the area.

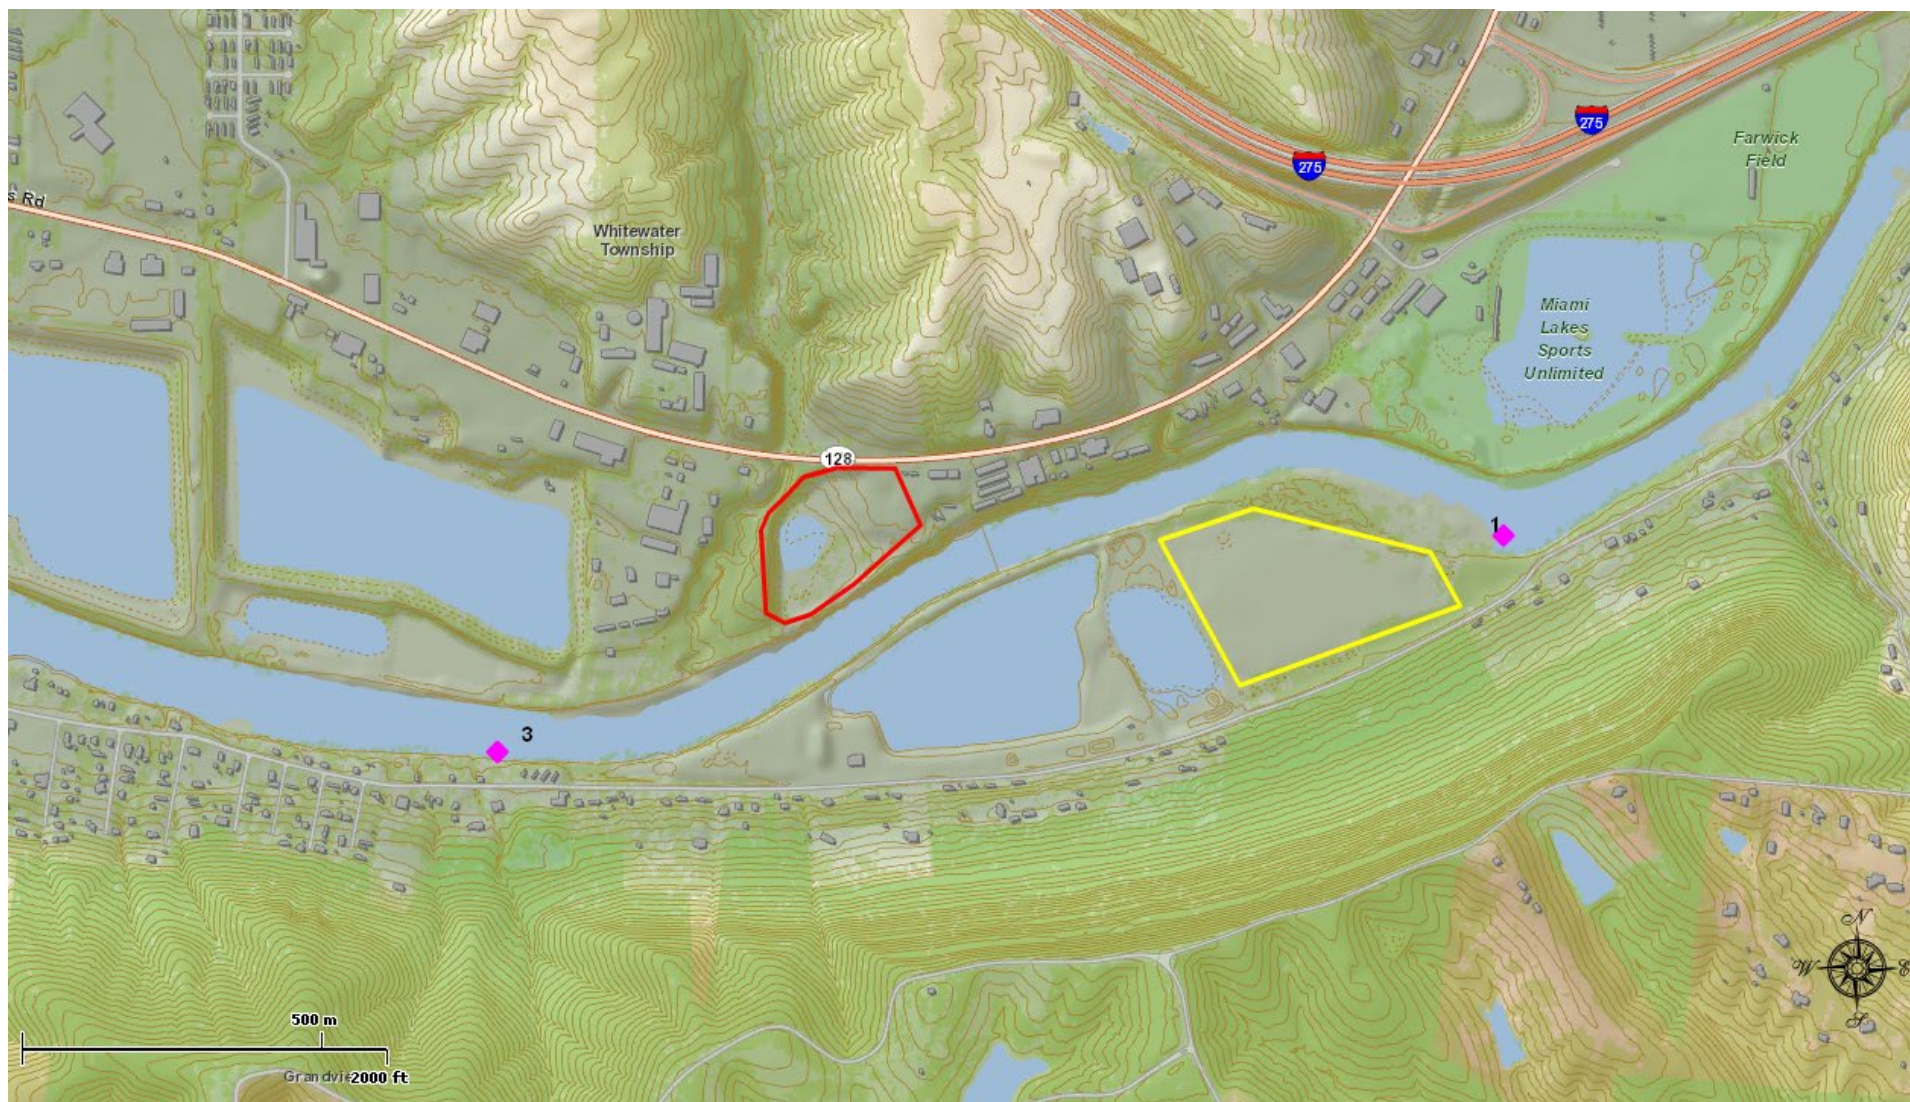
Figure 3.3.2-C
Carmical Closed Landfill
East Miami River Road

The Great Miami River runs along the north side of the Carmical Landfill. Samples are taken above and below the landfill. Historically, stream samples have been taken above (S-1), next to (S-2), and below (S-3) the landfill (Appendix A). Given the steady findings of S-2 and that both upstream and downstream samples are collected around Carmical landfill, sample site S-2 was removed from the sampling protocol in 2007. Samples around Carmical Landfill were collected on October 13, 2020. The upstream sample was in shallow (1'), gravelly, rocky riffle area of the river. The shallow area had rapid flow across the rocks. The downstream sample was taken in a pool about 2 to 3 feet deep with a rocky, silty bottom. The flow at the downstream location was slow. It was noted during the 2010 and 2011 sampling that the riverbank had been significantly reshaped by the owner for recreational use since the 2009 sampling. The referenced locations are shown on Figure 3.3.2-C.

The Great Miami River borders the Carmical Closed Landfill (Figure 3.3.2-C) to the north and east. The adjacent property to the west has a gravel pit pond along much of the west boundary of the landfill. A drainage ditch runs along the southern edge of the landfill. No gas monitoring is conducted at this location.
