3.3.3 CHEVIOT LANDFILL

Facility Name: Cheviot Closed Landfill

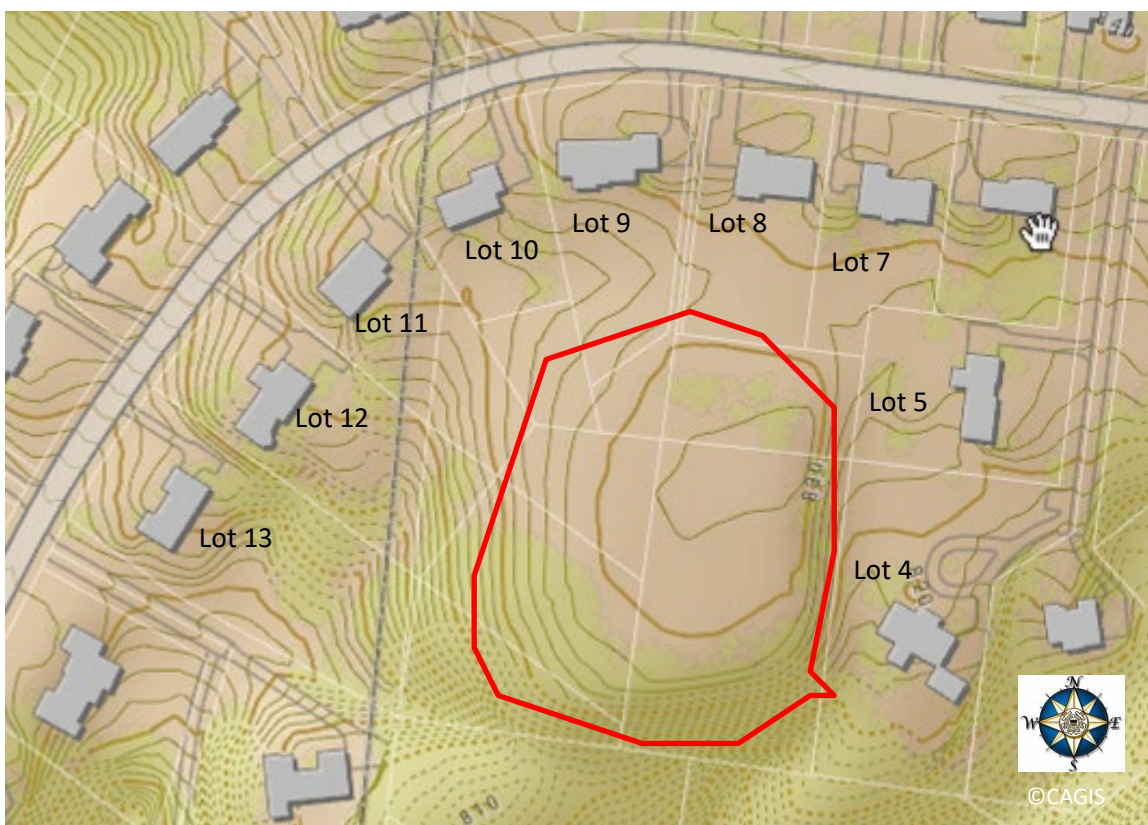
FIGURE 3.3.3-A

Cheviot Landfill was operated and owned by the City of Cheviot, Ohio off South Road (7269 Southpointe Drive) from approximately 1954 to 1975. The City of Cheviot bought the property on South Road for an incinerator

from Mr. George Kirk in 1951. The facility was a licensed facility as a landfill and incinerator. The landfill was mainly an ash landfill although there is evidence that solid waste was disposed in this landfill.

Dr. Ferd Niehaus purchased 65 acres on the west side of the landfill off South Road from a Mr. Moser and Mr. George Kirk in 1967. For many years Dr. Niehaus fought to close the incinerator/landfill and the landfill was finally closed in 1975. Dr. Niehaus bought the landfill property at auction in March, 1976. Niehaus Industries bought the landfill property from Dr. Niehaus and developed the Southpointe Subdivision from 1984 to 1988. During the 1980's Mr. John Niehaus, the developer and owner of Niehaus Industries and Dr. Ferd Niehaus' brother, were permitted to build on lots around the landfill by Hamilton County Regional Planning except for Lots 7, 8, and 9. Figure 3.3.3-A shows the location of these lots in reference to the approximate location of the landfill. These lots had evidence of methane gas production in work conducted by SCS Engineers at that time. It was recommended by OEPA and documented by Hamilton County Regional Planning that the lots should not be built on.

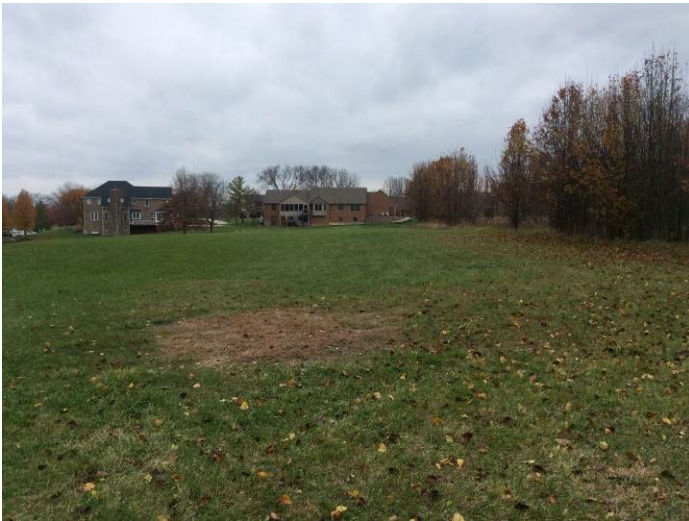
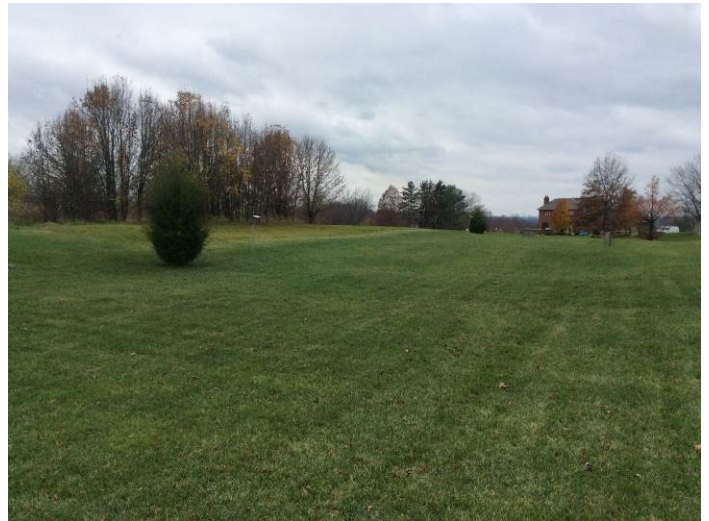
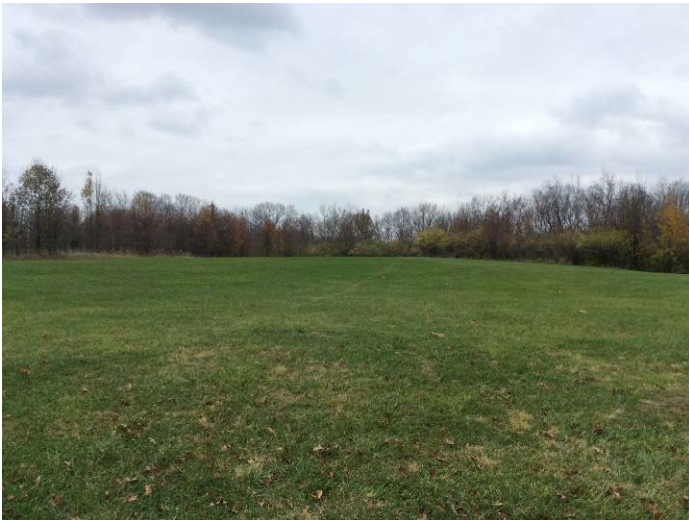
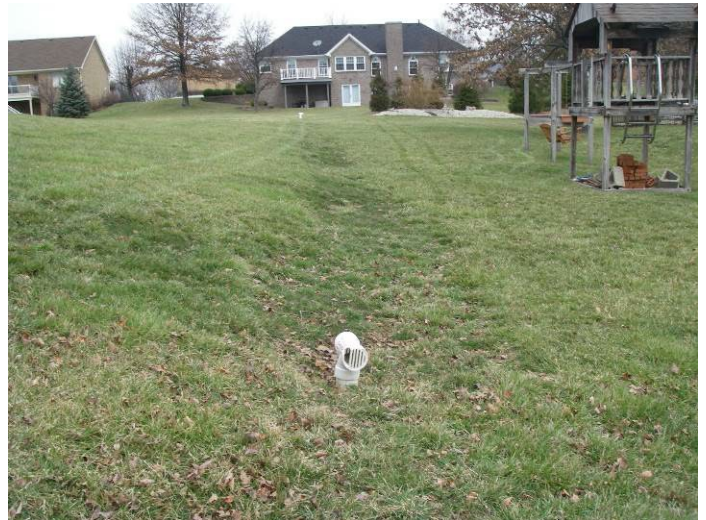
Currently, the property is vacant green space and wooded areas owned by the surrounding homeowners. The current state of the landfill includes areas of short maintained grass, areas of long unmaintained grass, and areas of trees and honeysuckle.

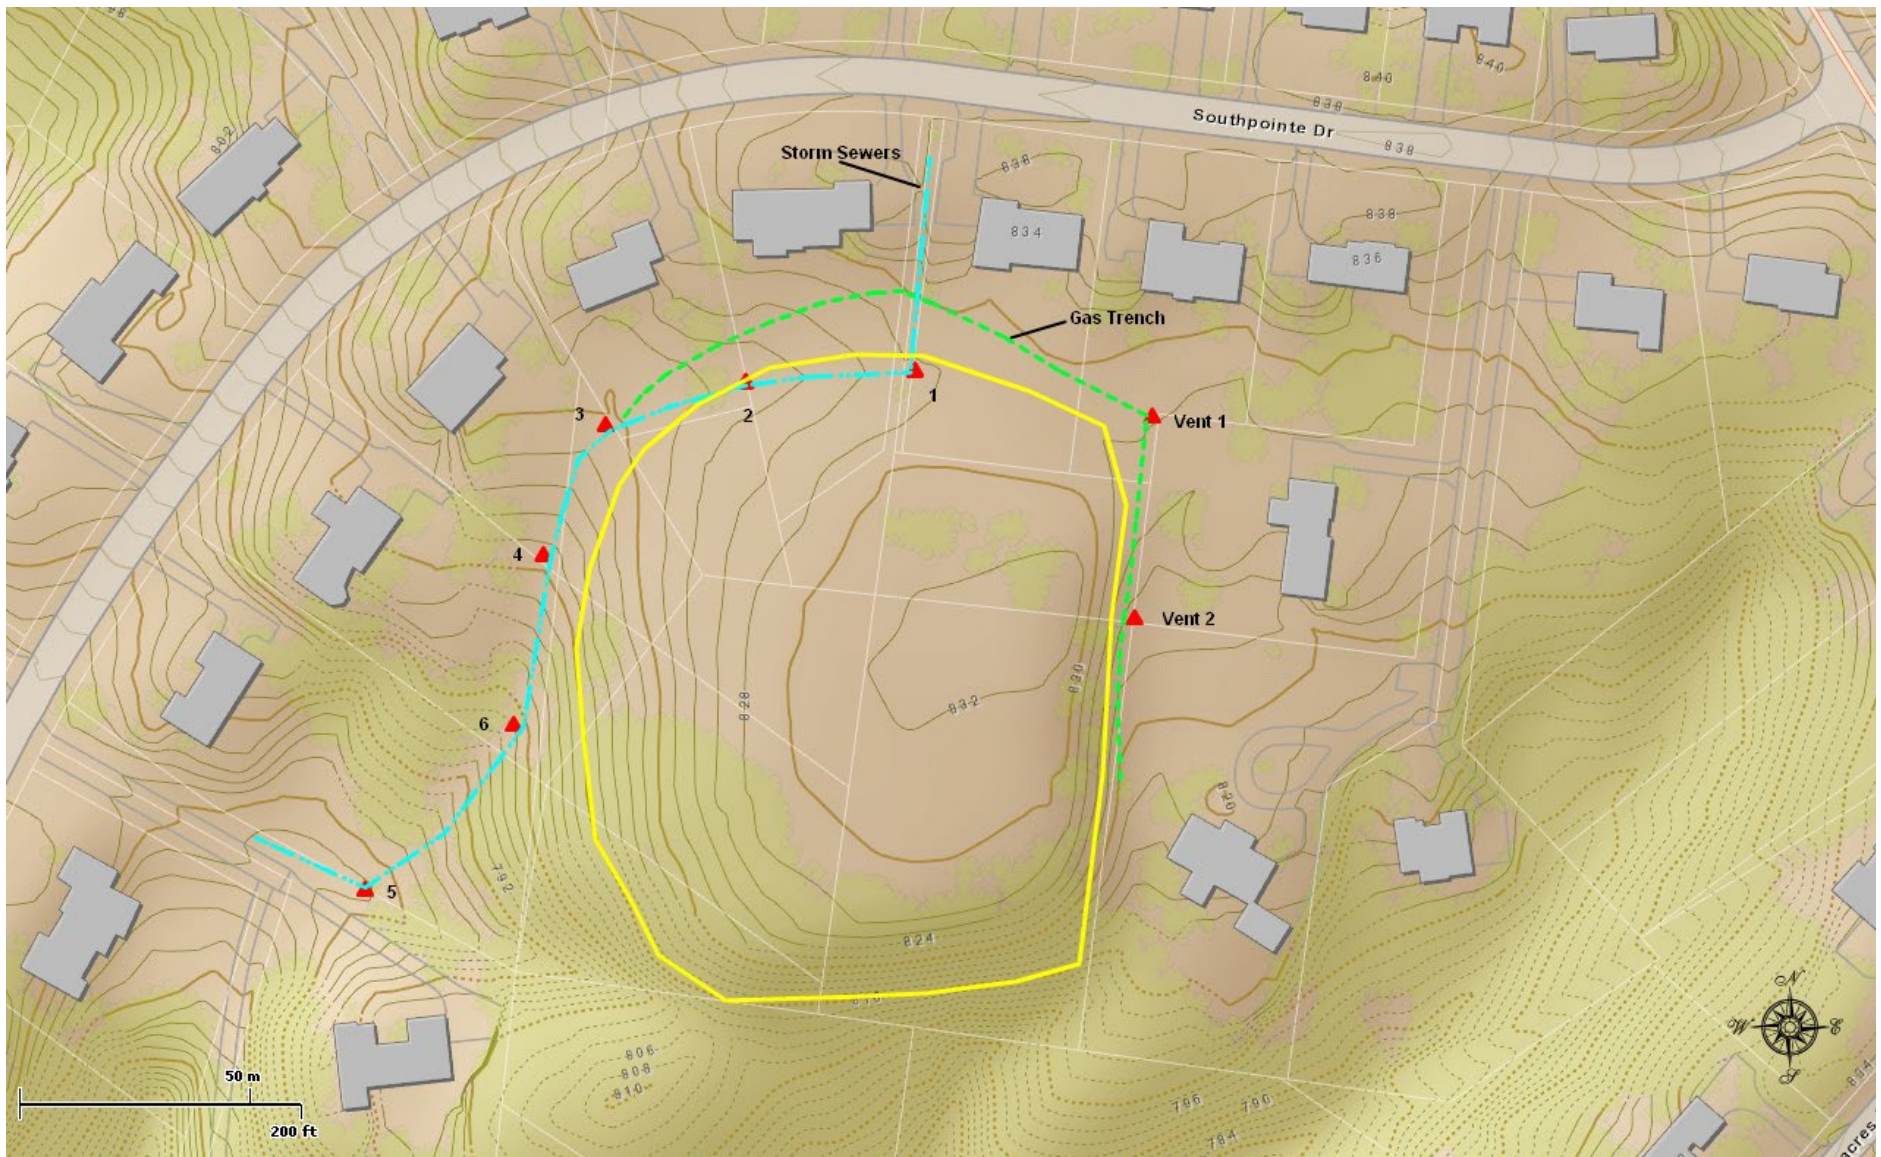
Figure 3.3.3-B
Cheviot Closed Landfill
Southpoint Drive

The Cheviot Closed Landfill was monitored for methane gas four times during 2021 (Tables 3.3.3-A through 3.3.3-D). The Cheviot landfill is monitored along a passive gas vent trench installed at the site in the early 1990's. Figure 3.3.3-B indicates the sample locations, which were two vent pipes along the passive gas trench and six locations along the storm sewers to the north and west of the landfill. No detections of methane occurred during 2021 monitoring. Methane has occasionally been detected in the vents of the passive trench in the past. During 2018 monitoring methane was detected in Vent #2 on June 19, 2018, at a concentration of 0.1% and in Vent #1 on December 26, 2018, at a concentration of 0.25% methane. Methane was detected in Vent #2 during both March 2017 and March 2016 at a concentration of 0.15% methane. There was a detection of 0.05% methane in Vent #2 during the August 2014 sampling and methane gas was detected in Vent #1 at 5% methane during a January 2010 sampling. Based on these results it appears as though the passive vent system is operating as designed. HCPH will continue to monitor these locations on a quarterly basis since houses are close to this area. *(Sampling data for this landfill is in the files at Hamilton County Public Health).*

- = Approximate Limits of Waste
- ▲ = Gas Monitoring Location
