### **3.12.2 LOCKLAND INCINERATOR**

Facility Name: Lockland Incinerator

Location: West terminus of Davis Avenue along the east side of I-75 south

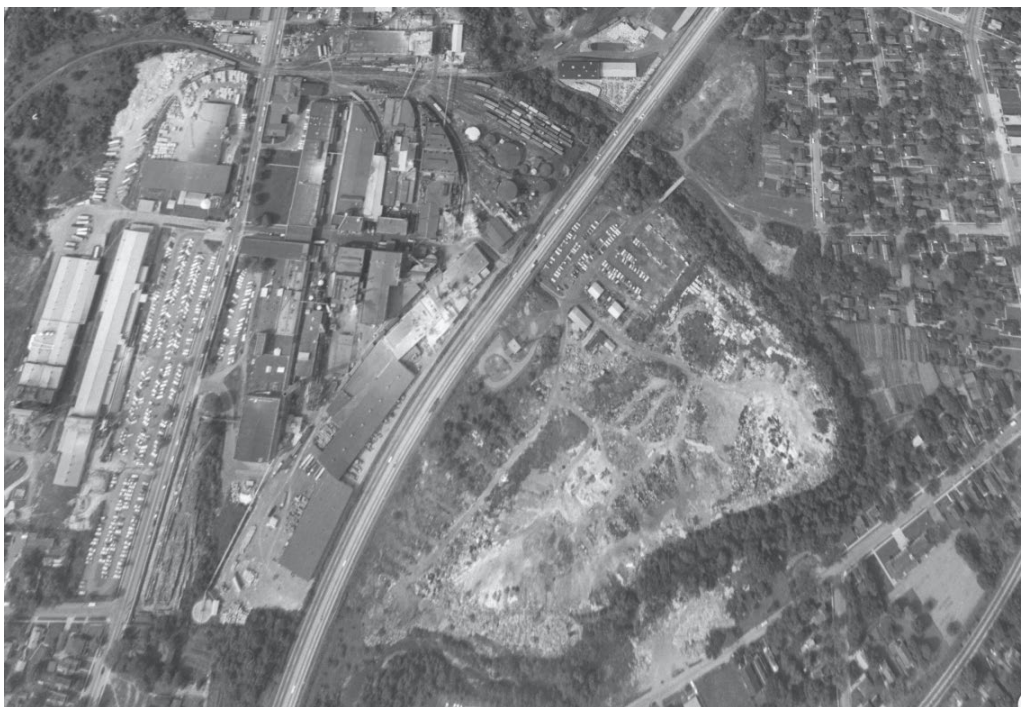
**FIGURE 3.12.2-A (1962)**

The Lockland Incinerator operated from 1936 to the mid 1970's. The incinerator was used to burn residential trash collected by the village of Lockland. According to a 1974 questionnaire completed by the Ohio EPA, the incinerator handled approximately 57 tons a week and generated approximately 1 ton of ash per day. This ash was disposed of in a "pit at landfill". The landfill referenced is most likely Lockland's landfill off Shepherd Lane. The incinerator closed when new stricter air regulations went into effect. According to a Phase I Environmental Site Assessment of the property, completed by Petro Environmental Technologies, dated December 9, 1994, the residual ash was disposed of off the property.

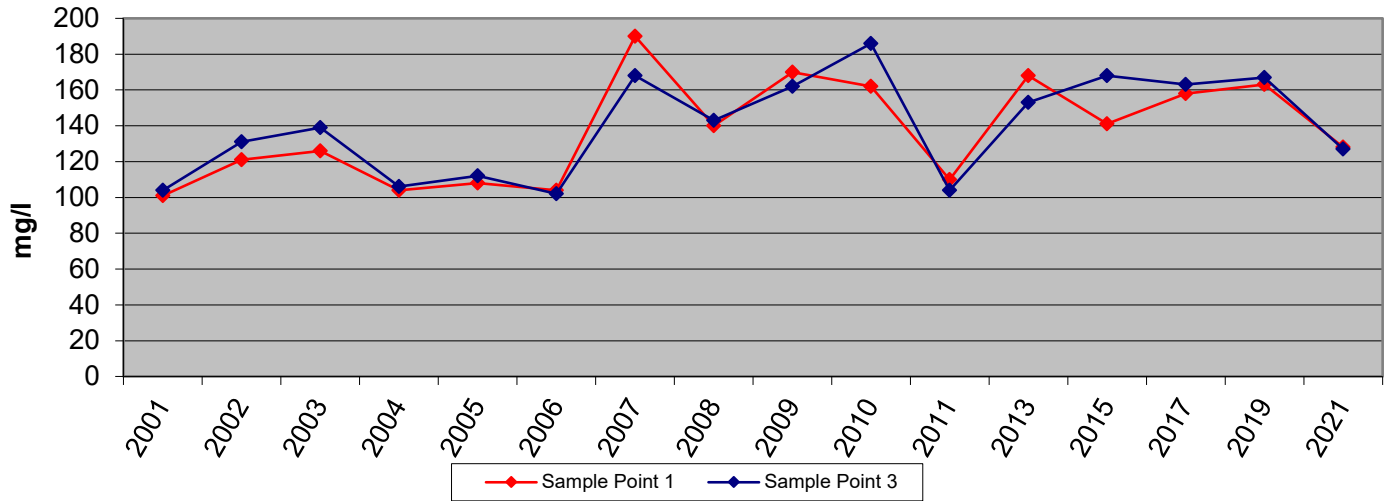
**Lockland Incinerator Alkalinity**

Alkalinity had a concentration of 128 mg/L at sample point 1 and 127 mg/L at sample point 3. These concentrations are the lowest concentrations observed at each point since 2011. Ammonia has been below the detection limit at both sampling locations for the last three sampling events. Chloride concentrations at sample points 1 and 3 were 45.3 mg/L and 43.9 mg/L respectively which is well below the SMCL of 250 mg/L. During 2019 sampling sulfate concentrations at both sampling locations, although well below the SMCL of 250 mg/L, were at historical highs. Both locations trended down during 2021 sampling with an upstream sulfate concentration of 21.7 mg/L and a downstream concentration of 19.8 mg/L. Iron exceeded the SMCL of 0.3 mg/L at sample point 1 with a concentration of 0.402 mg/L. Prior to 2021 Iron had not exceeded the SMCL at sample point 1 since 2015 and sample point 3 has been below the SMCL since 2011. In 2017 manganese concentrations were below the SMCL (0.05 mg/L) at both sampling locations for the first time since sampling for that parameter began in 2010. Since then, sample point 1 has exceeded the SMCL in both 2019 and 2021 (0.0981 mg/L and 1.133 mg/L) while sample point 3 has remained below the SMCL for both years. All other compounds remained below their respective MCL, secondary MCL, or action level. Surface water chemical data is illustrated for Lockland Incinerator Landfill in the graphs on the subsequent pages.
