#### 3.19.1 SCHWEITZER LANDFILL

Facility Name: Schweitzer

Location: 325 Clark Street

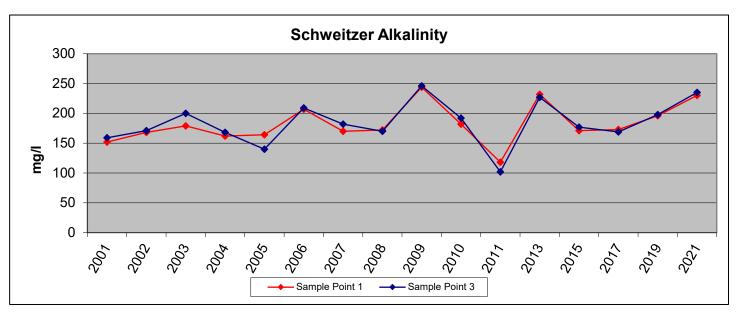
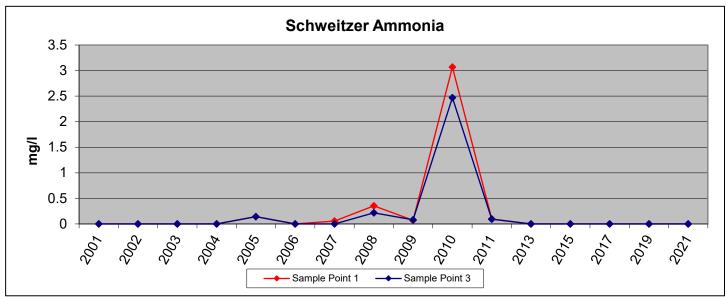
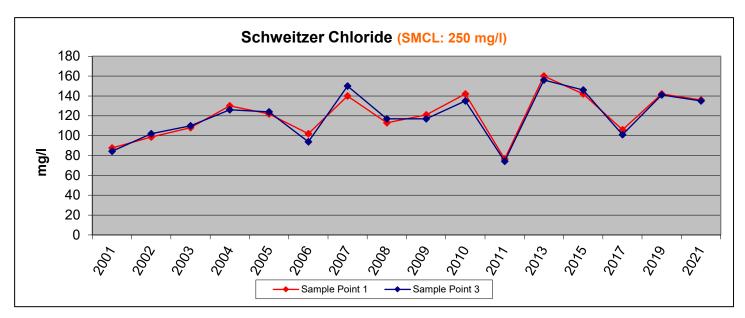
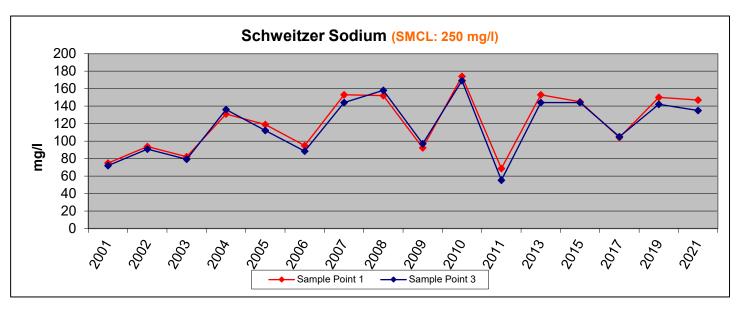
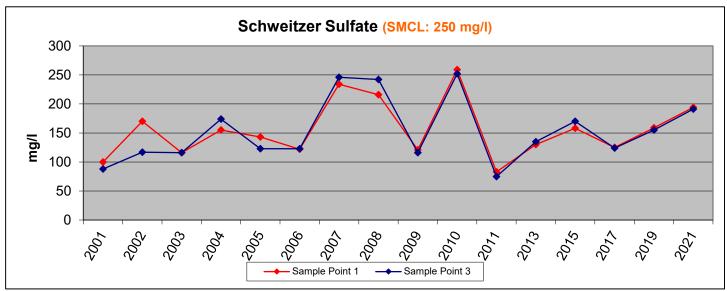
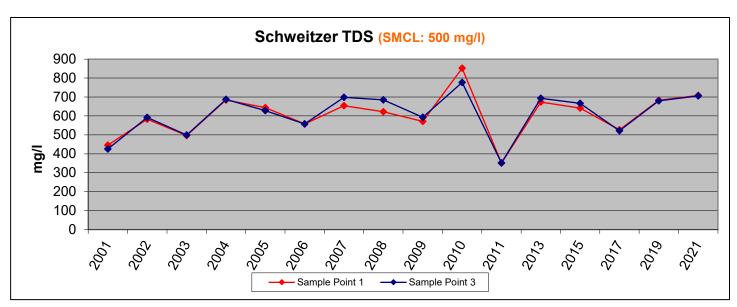
For 2021, TDS again exceeded the SMCL (500 mg/L) in both the upstream and downstream sample. TDS has exceeded the SMCL at both sample locations during the vast majority of sampling events. Manganese concentrations exceeded the SMCL of 0.05 mg/L at sample locations 1 (0.0878 mg/L) and 3 (0.0632mg/L). Prior to 2021 sampling, manganese concentrations had not exceeded the SMCL at either location since 2015. Iron concentrations have increased at both sampling locations during each of the last three sampling events (2017, 2019, 2021) and remain above the SMCL of 0.3 mg/L. However, concentrations show an obvious decrease when comparing upstream to downstream over these same sampling events. All other parameters were below their respective MCL's, SMCL's, and Action Levels as well as within the ranges historically observed at the site. Prior to this year's sampling, boron concentrations had increased at both sampling locations during each sampling event from 2013 to 2019. Results of 2021 monitoring revealed decreasing concentrations at both locations to the lowest levels observed at each location. Alkalinity and sulfate continued the recent, 2 sampling event, trend upwards but remain within historic ranges for the site. Conversely, chloride and sodium concentrations both showed a slight decreasing trend in 2021 after increases in 2019 at both sample locations. Surface water chemical data is illustrated for Schweitzer Landfill in the graphs on the subsequent pages.

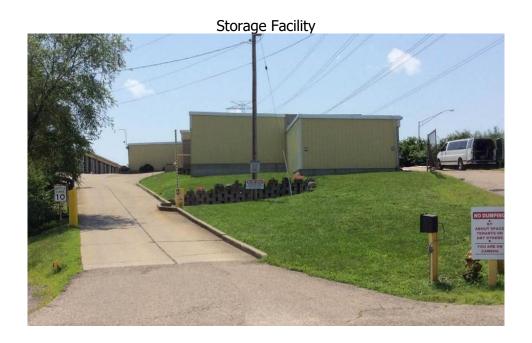
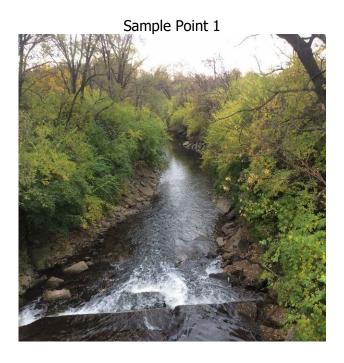
## **Figure 3.19.1-D**

The Mill Creek flows along the east and south side of Schweitzer Landfill from north to south. Steep banks border each side of the creek in this area. The creek was sampled above and below the landfill. The sample location (S-1) upstream and north of the landfill is located near the Clark Road Bridge. The sample site is characterized as a pool, just north of a spillway, with a rocky bottom. The mid-landfill sample location (S-2) has not been sampled since 2001. S-3 is below the landfill, under and south of Galbraith Road, and below a spillway. The southern sample site (S-3), is an area with both shallow, rocky riffle areas and 2-4 foot deep pools. Access to the shallow riffle areas is occasionally not possible depending on stream conditions (flow volume, depth of pools, etc). Samples around Schweitzer Landfill were collected on October 13, 2021 (Appendix A). The samples were collected during normal flow as the area had received approximately 1.5 inches of rain during the previous 14 days, none of which occurred over the 5 days prior to sampling. The referenced locations are shown on Figure 3.19.1-D.
