3.1.6 Aston Oaks

Facility Name: Aston Oaks
A.K.A.: N/A
Location: North of US 50, East of Symmes Avenue, West of St Annes Drive
Parcel(s): 57300050013, 57300050100, 57300050101, 57300050102
Lat, Long: 39.150537 -84.743126
Region: North Bend, OH
Owner: Tisch Properties LLC & Larry & Christine Terzian TR
Operation (yrs): Late 1970's – Early 1980's

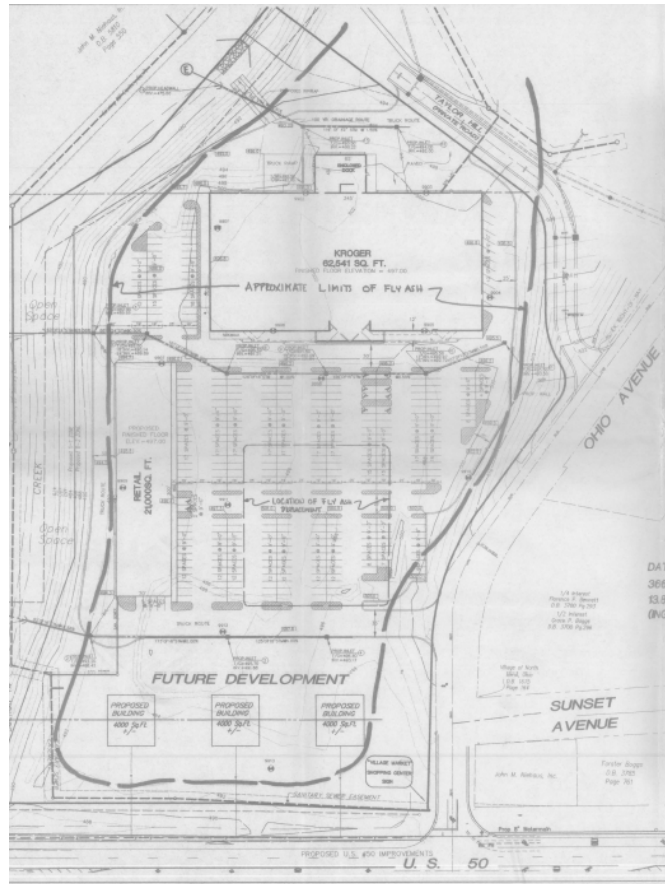
FIGURE 3.1.6-A

Ohio EPA approved the Rule 13 request in June 1999. Figure 3.1.6-A shows a proposed Kroger store that was ultimately not built. However, the drawing shows the approximate limits of Fly Ash.

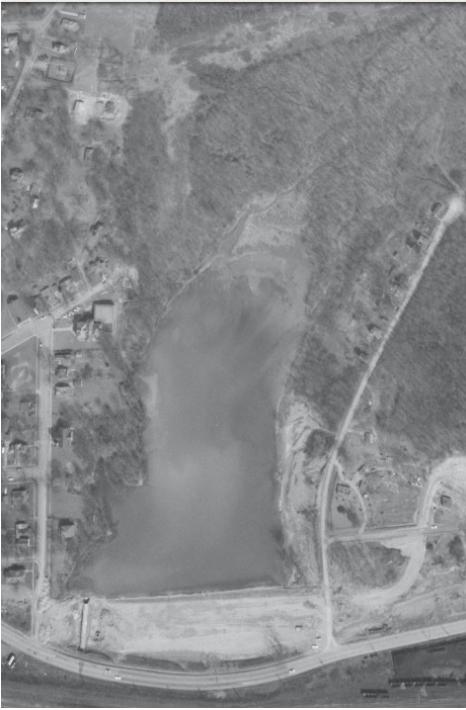
FIGURE 3.1.6-B

Review of available ariels supports the timeline provided in the 1999 Rule 13 request. Figure 3.1.6-B shows the area as a lake in 1960 although construction activities related to US 50 have begun on the south end. By 1964 the lake is dry and US 50 construction is complete. The area remains dry with no obvious filling activity until 1973 when it appears filling begins in the southeast corner of the area. Figure 3.1.6-C shows the area with filling noticeable in the southeast. By 1980 (Figure 3.1.6-D) it appears as though the bulk of the filling has been completed. In a 1986 aerial it appears as though earthwork may be continuing at the site but mainly in areas northeast of the historical lake.

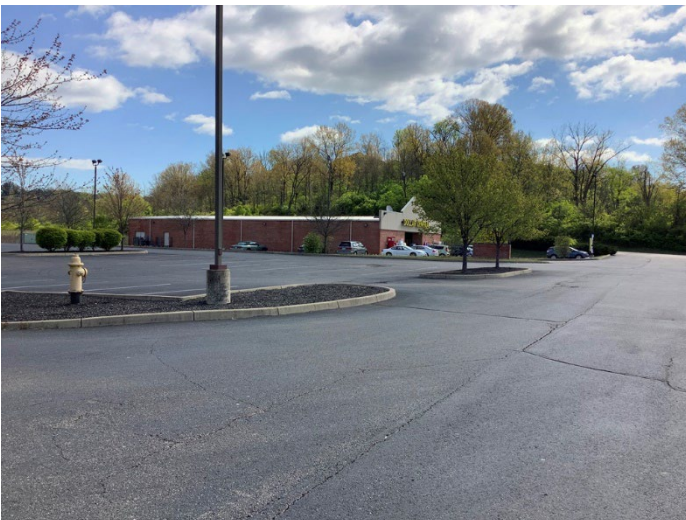
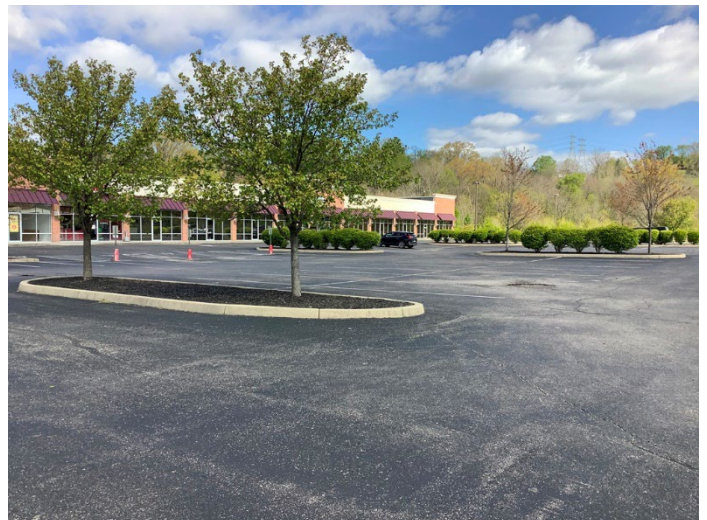
Today, the central portion of the property is occupied by two commercial buildings and the remainder of the property is vacant.
