### **3.12.1 Little Dry Run**

Facility Name: Little Dry Run  
A.K.A.: Newtown  
Location: 7701 Main Street, Southeast corner of Little Dry Run and State Route 32  
Parcel(s): 50100100159 & 50100100156  
Lat, Long: 39.124318 -84.340541  
Region: Village of Newtown, OH  
Owner: SCF RC Funding IV LLC & Burger Environmental Inc  
Operation (yrs): Approximately 1961 -1970

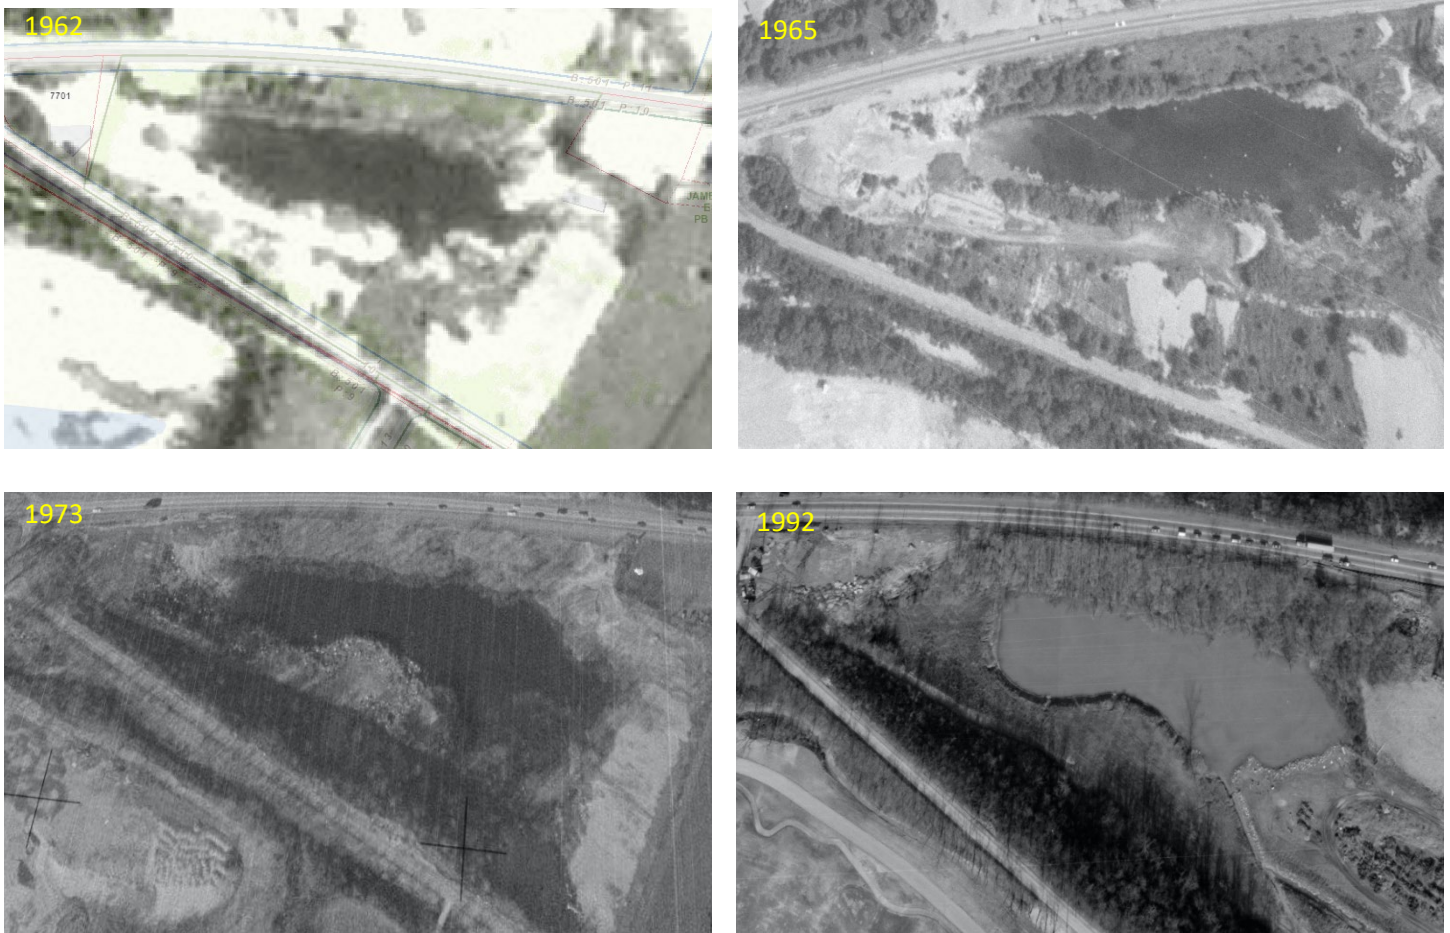
**FIGURE 3.12.1-A**

Review of aerial photographs reveals a rough timeline for the property. Several of these aerals can be seen in (Figure 3.12.1-A). Mining of the property is evident in the 1950's. The aerial photo from 1962 is overlaid onto the present-day parcel lines and the "lake" can be seen as the dark area of the photo. Filling is evident on the west and south shores of the "lake". Filling of these areas continues in 1965 and 1973. The area then has little activity until 1986 when mining of sand and gravel is evident on the land adjacent to the east. In 1988 and 1992 additional fill is occurring on the east shore of the lake and on the far west side near the intersection of Little Dry Run and SR 32. This far western part of the property was split into a new parcel in 1999 and a gas station was constructed. The remaining portion of the property along with land to the east was licensed as a C&DD landfill in 1997. Statements made during the initial application included *"As early as the 1960's, the Village of Newtown began reclaiming the western portion [of] the hole by disposing of C&DD, stumps, tires and other materials."* Filling of the lake continues into the 2000's. This second period of filling in the "lake" was reportedly completed with soil and clean hard fill. This property remains a licensed C&DD landfill to this day. Filling over top of the former landfill with C&DD occurred from approximately 2006 to 2015 after which a cap was installed.

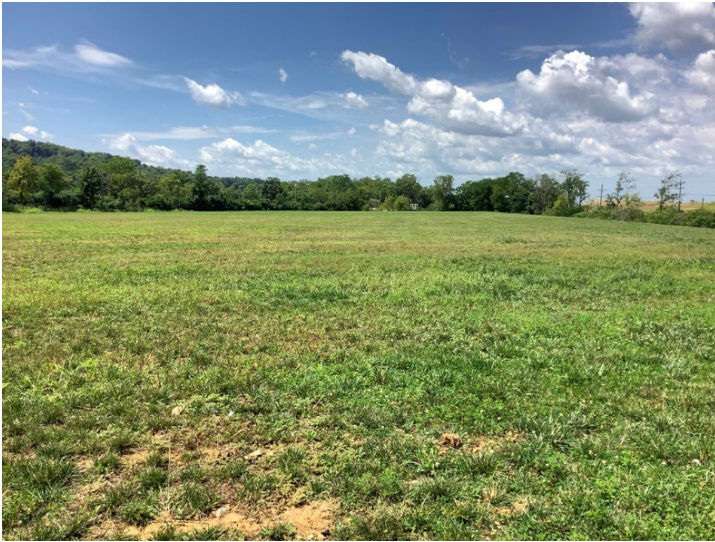
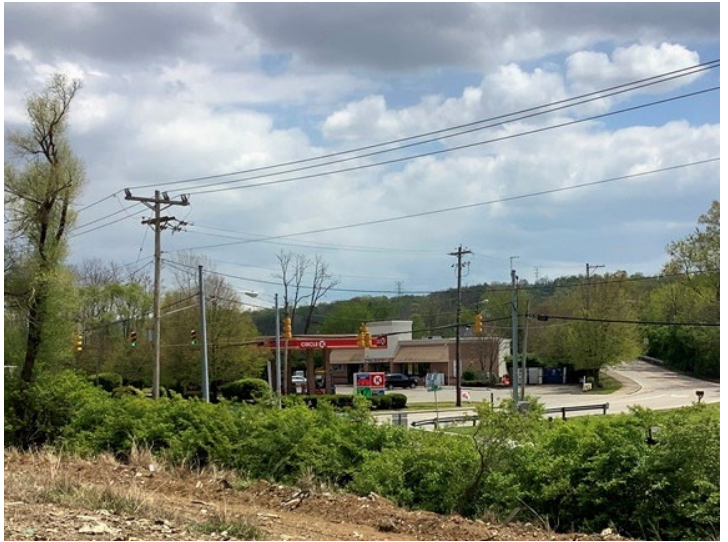
The western portion of the former fill area is occupied by a gas station with a building and paved pump area. The eastern portion was previously operated as a C&DD landfill. Filling has been completed in this area and a cap has been installed. A small wooded area exists between the gas station and the former C&DD landfill.
