3.2.3 Bevis Towing

Facility Name: Bevis Towing
A.K.A.: N/A
Location: 11594 & 11586 Old Colerain Avenue.
Parcel(s): 51002800082
Lat, Long: 39.296992 -84.619890
Region: Colerain Township, OH 45252
Owner: Douglas Bevis
Operation (yrs): Approximately 1990 – 1996 (based on aerial photos)

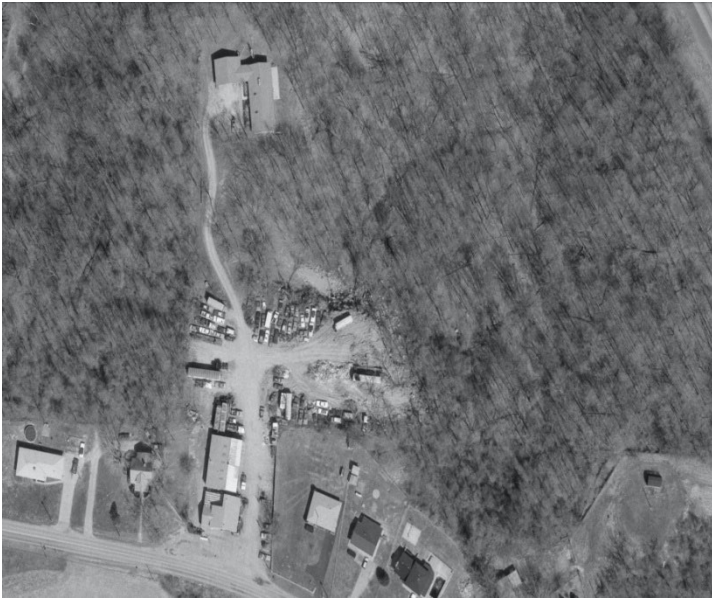
FIGURE 3.2.3-A (1986)

Review of ODOT aerials shows no fill activity occurring at the site in 1976. The residence northwest of the fill is present by 1980. Figure 3.2.3-A from 1986 shows a small area of filling occurring in the southwest corner of the approximate limits of fill. By 1992 (Figure 3.2.3-B) a large area of fill is visible. Figures 3.2.3-C and 3.2.3-D show the progression of filling in 1996 and 2009 respectively. Filling with clean hard fill continued until approximately 2015.
