3.8.4 HARRISON LANDFILL

Facility Name: City of Harrison Municipal Landfill

Location: 10999 Campbell Road.

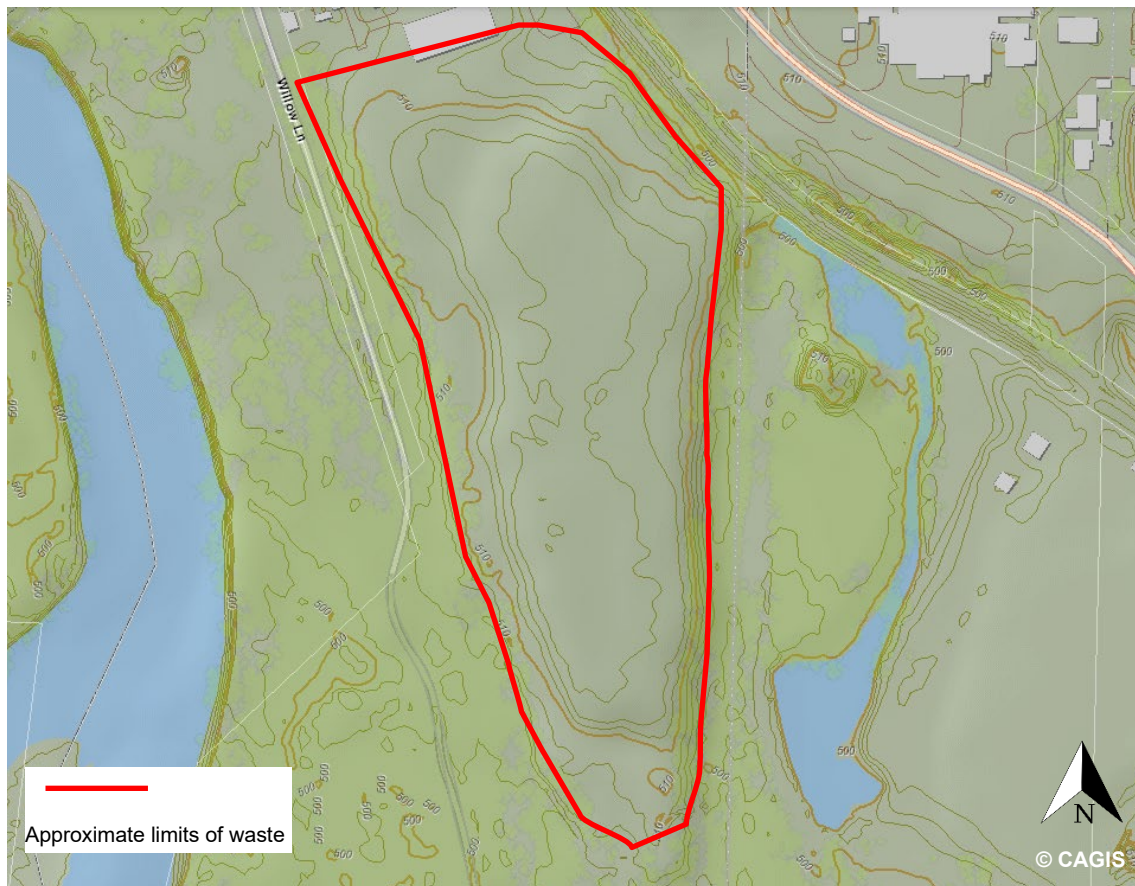
FIGURE 3.8.4-A

Topography of the former landfill is evident with a localized topographic high created in the area of waste placement; relief in the vicinity of waste placement is approximately twenty-two feet. Topography generally

risers to the north and east of the landfill, and is relatively flat toward the south and west (along the Whitewater River flood plain). Figure 3.8.4-A illustrates the topography of the site:

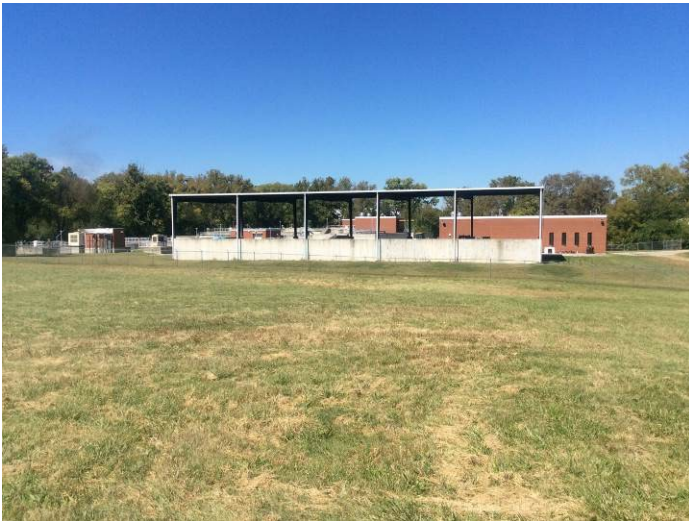
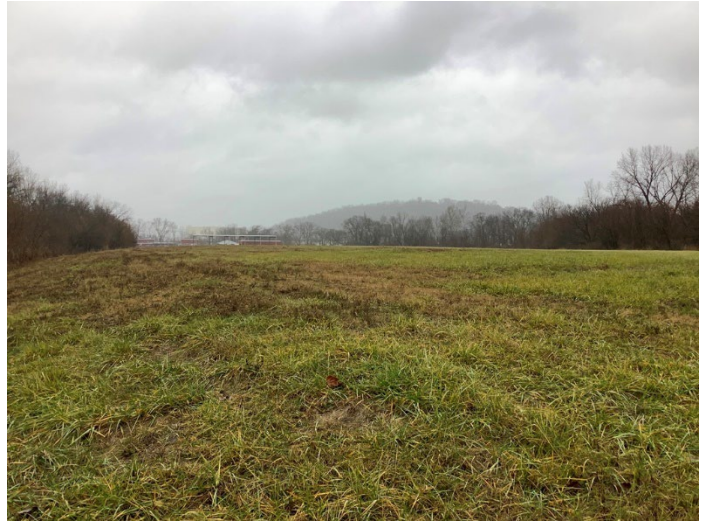
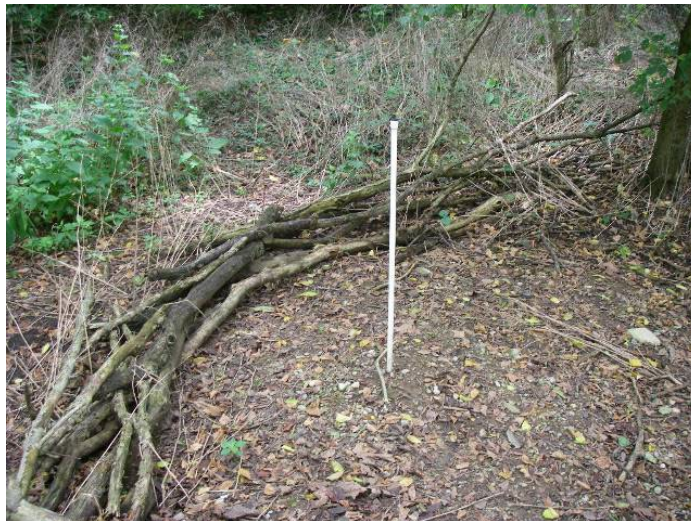
The above mentioned wastewater treatment plant occupies the northern section of the parcel. The former landfill is covered with established and maintained grass. The areas surrounding the landfill are undeveloped wooded land with no current activities other than an ATV/Motocross trail park that borders the landfill to the southwest and south.

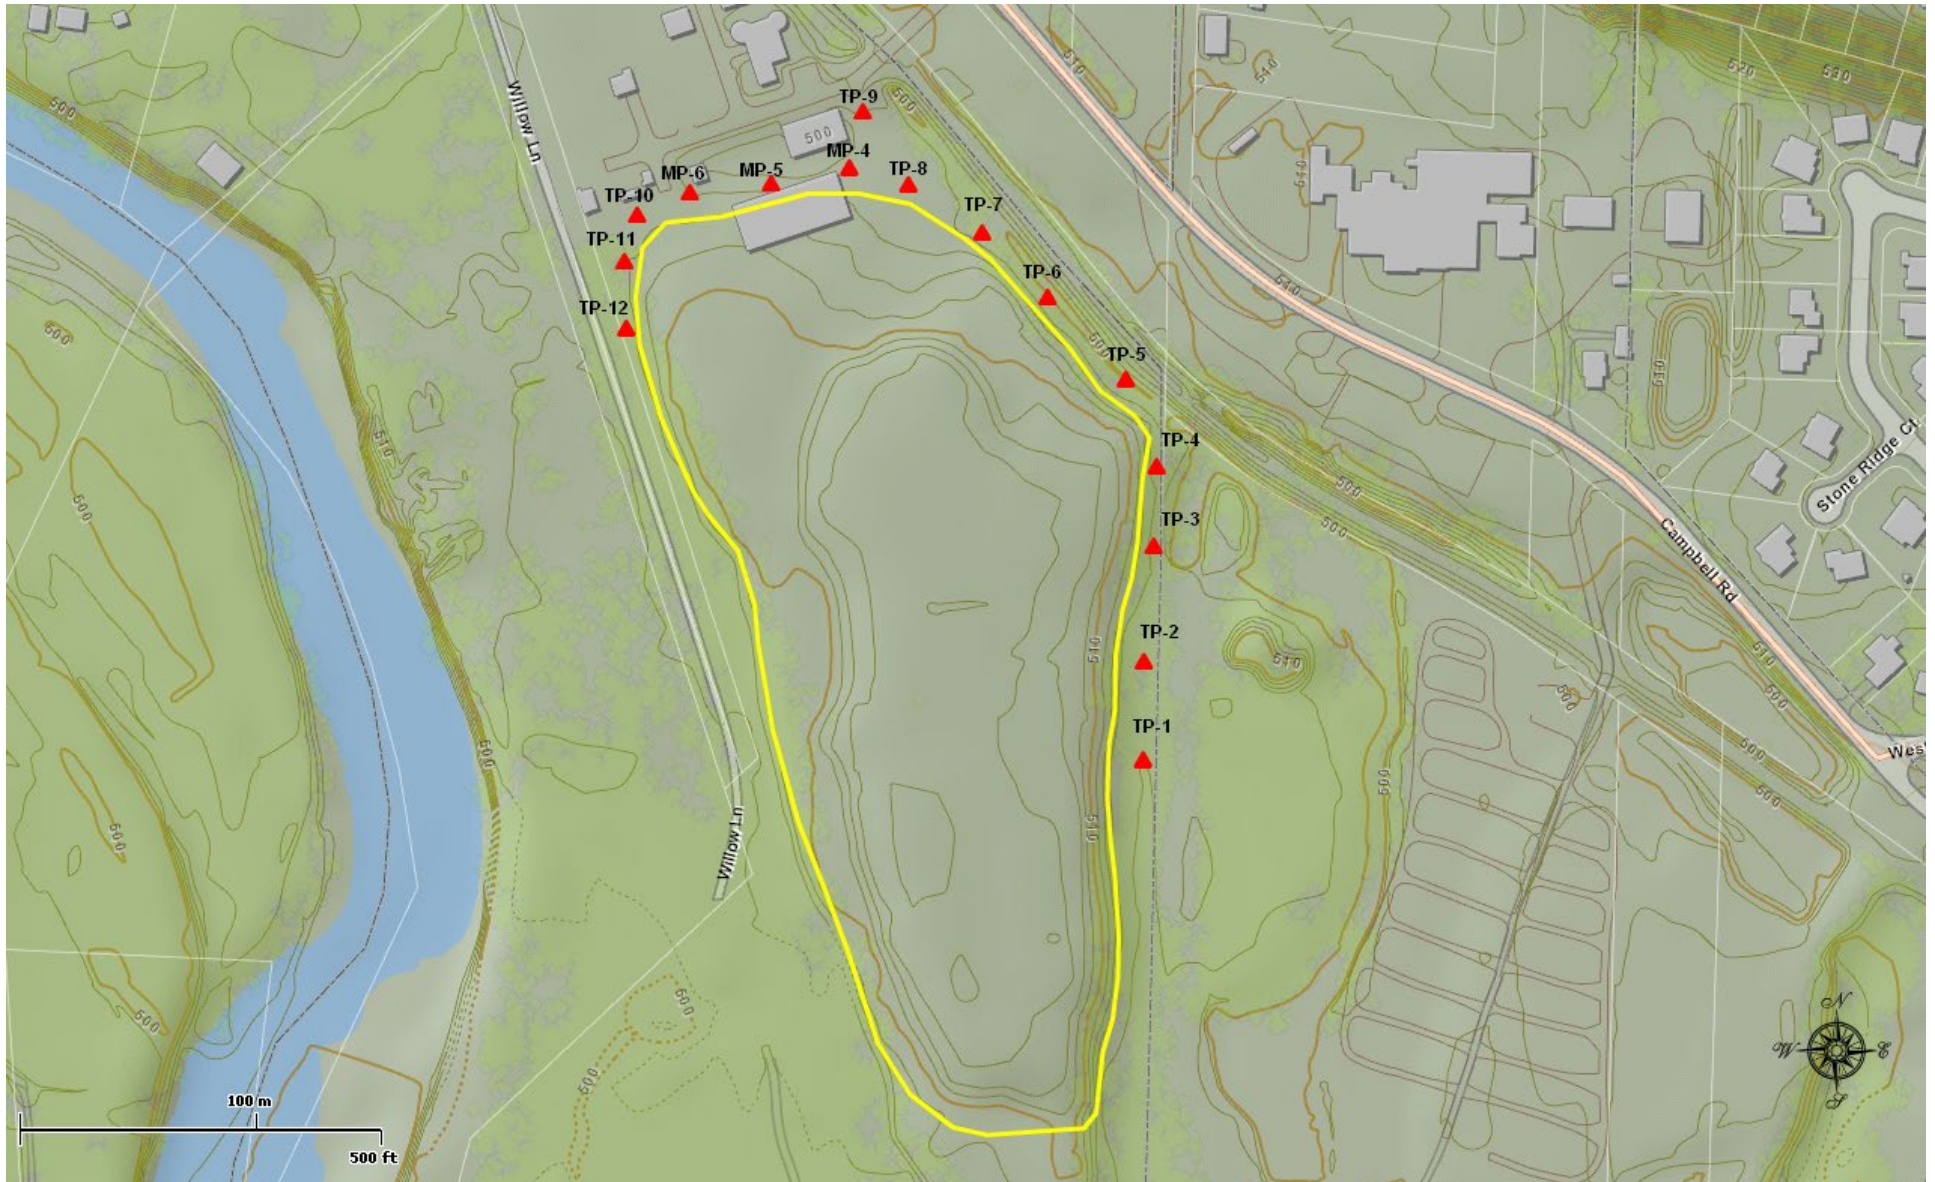
Figure 3.8.4-B
Harrison Closed Landfill
10999 Campbell Road

The original explosive gas monitoring plan (EGMP) approved in 1998 included 15 sampling locations. In 2002 MP-1, MP-2, MP-3, TP-9, and TP-10 were removed due to construction. Three replacement gas monitoring probes (MP-4, MP-5, and MP-6) were installed in 2004 to replace these removed sampling locations. Under the current EGMP, there are a total of thirteen monitoring locations (Figure 3.8.4-B). City of Harrison personnel monitored the closed landfill monthly through 2014. In 2015 the Ohio EPA authorized the city to reduce gas monitoring to semi-annually but recommended quarterly monitoring to account for seasonal variability in the event the city requests cessation of the monitoring in the future. The facility was notified in August 2021 that due to recent rule changes they would need to submit a revised EGMP by March 28, 2022.

▲ = Gas Monitoring Location

— = Approximate Limits of Waste
